Defect Listing

Pipe Segment Refere... D3-2_D3-1	City Oliver Springs	Street Highway 62	Material Concrete Pipe (non-...	Location C... Easement/R...	Sewer Use Sanitary
Upstream MH D3-2	Total Length 224.9	Year Laid	Shape Circular	Location Details	
DS Manhole D3-1	Length surveyed 224.9	Year Renewed	Height 8	Width 8	Pipe Joint... 4

SPR	N/A	MPR	5	PO Number 4397-03	Customer GRW
SPRI	N/A	MPRI	5	Work Order 4397-02	Purpose Pre-Rehabilitation Survey
QSR	N/A	QMR	5100		
OPR 5	Surveyed By Barry_Rogers	Direction Downstream	Date 20150708	Media label	
OPRI 5	Certificate Number U-1012-16405	Pre-Cleaning Jetting	Time 09:09	Weather Damp	
	Date Cleaned 20150708		End Time 09:24	Additional Info

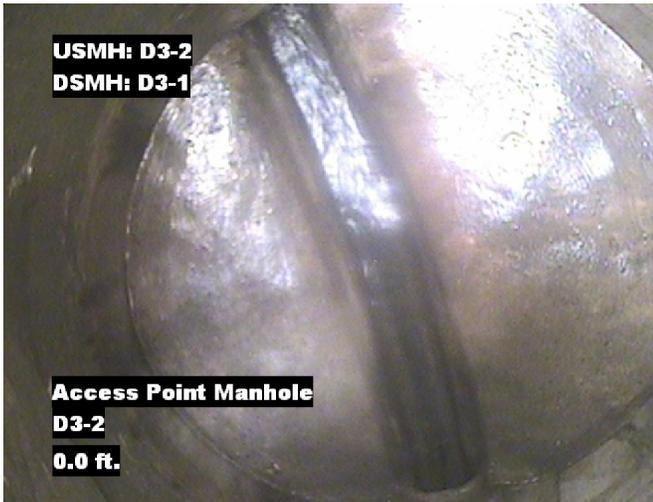
Access Point Manhole
D3-2
0.0 ft.

Distance: 0.0 ft. Grade: 0
 Condition: Access Point Manhole
 Remarks: D3-2

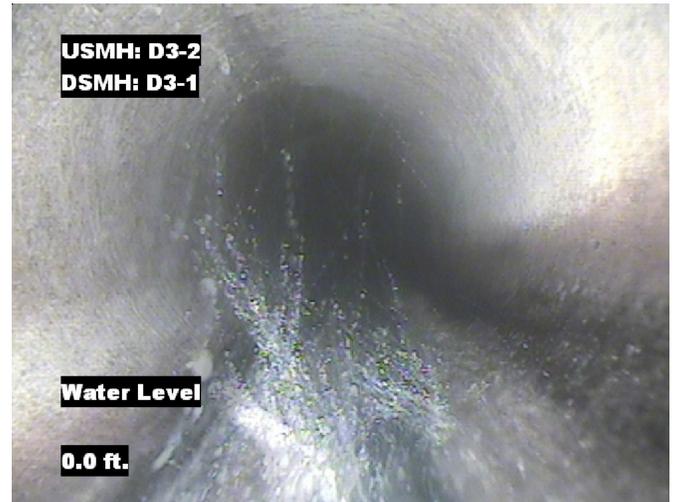
Water Level
0.0 ft.

Distance: 0.0 ft. Grade: 0
 Condition: Water Level
 Remarks: N/A

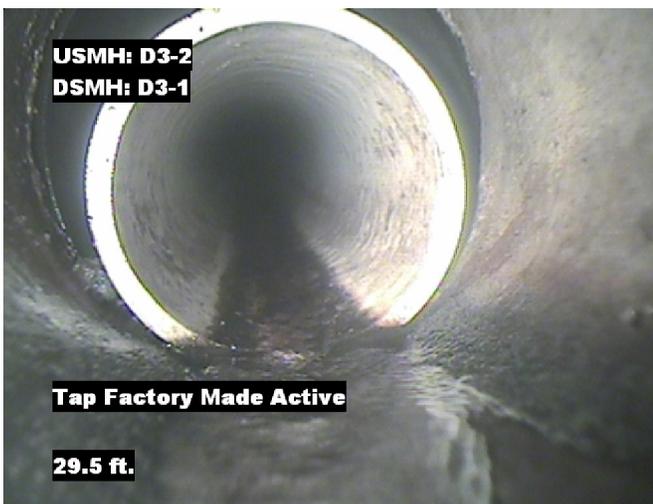
Tap Factory Made Active
29.5 ft.

Distance: 29.5 ft. Grade: 0
 Condition: Tap Factory Made Active
 Remarks: N/A

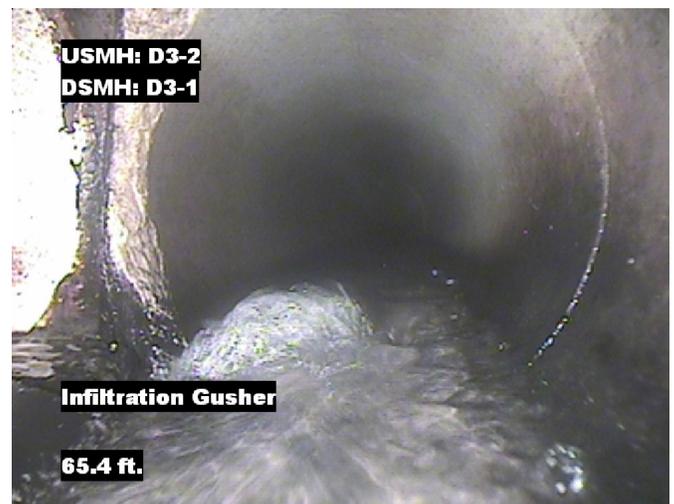
Infiltration Gusher
65.4 ft.

Distance: 65.4 ft. Grade: 5
 Condition: Infiltration Gusher
 Remarks: N/A

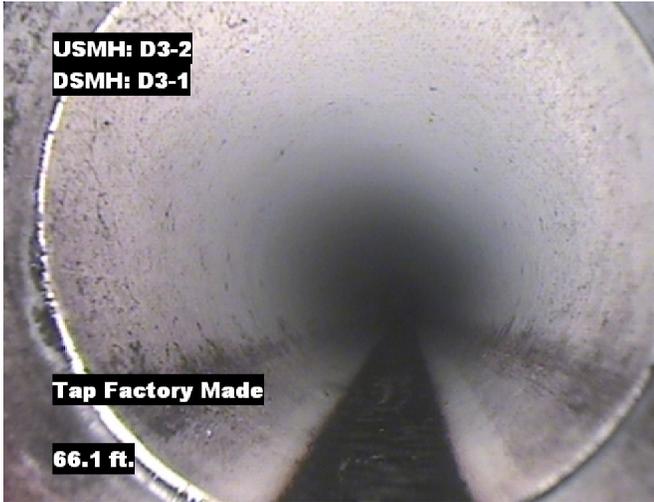
Distance: 66.1 ft. Grade: 0
 Condition: Tap Factory Made
 Remarks: N/A

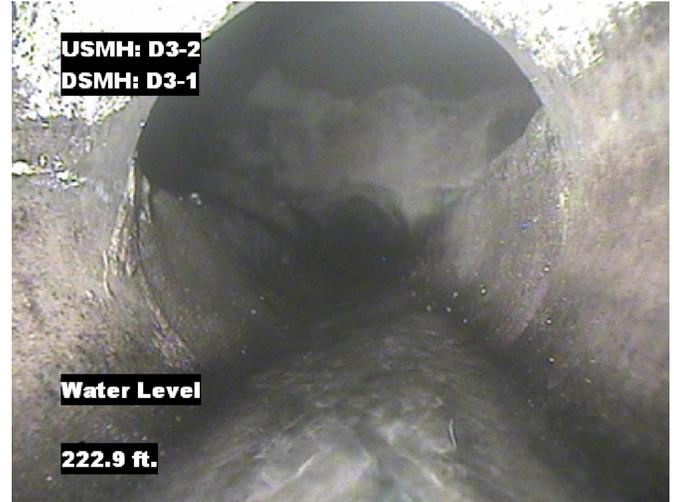
Distance: 222.9 ft. Grade: 0
 Condition: Water Level
 Remarks: N/A

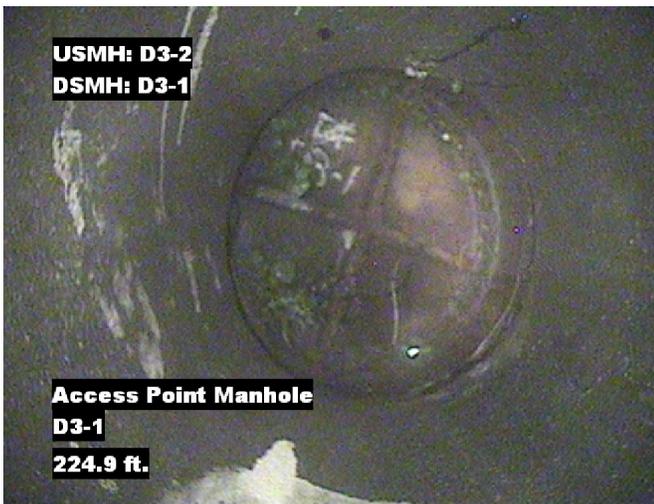
Distance: 224.9 ft. Grade: 0
 Condition: Access Point Manhole
 Remarks: D3-1
