Defect Listing

Pipe Segment Refere... D3-3_D3-2	City Oliver Springs	Street Highway 62	Material Concrete Pipe (non-...	Location C... Easement/R...	Sewer Use Sanitary
Upstream MH D3-3	Total Length 228.7	Year Laid	Shape Circular	Location Details	
DS Manhole D3-2	Length surveyed 228.7	Year Renewed	Height 8	Width 8	Pipe Joint... 4

SPR N/A	MPR N/A	PO Number 4397-03		Customer GRW	
SPRI N/A	MPRI N/A	Work Order 4397-02		Purpose Pre-Rehabilitation Survey	
QSR N/A	QMR N/A				
OPR N/A	Surveyed By Barry Rogers	Direction Upstream	Date 20150708	Media label	
OPRI N/A	Certificate Number U-1012-16405	Pre-Cleaning Jetting	Time 08:31	Weather Damp	
Date Cleaned 20150708			End Time 08:44	Additional Info

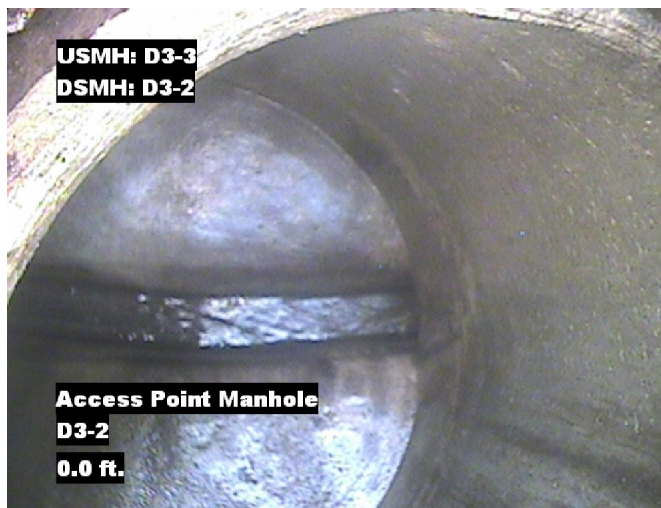
Distance: 0.0 ft. Grade: 0
Condition: Access Point Manhole
Remarks: D3-2

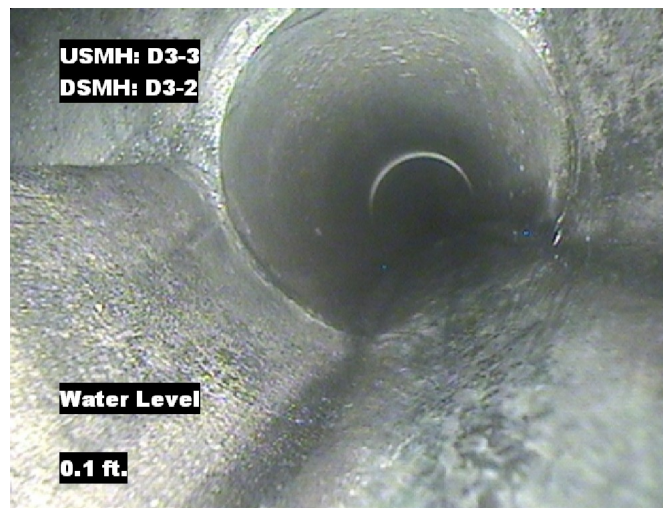
Distance: 0.0 ft. Grade: 0
Condition: Water Level
Remarks: N/A

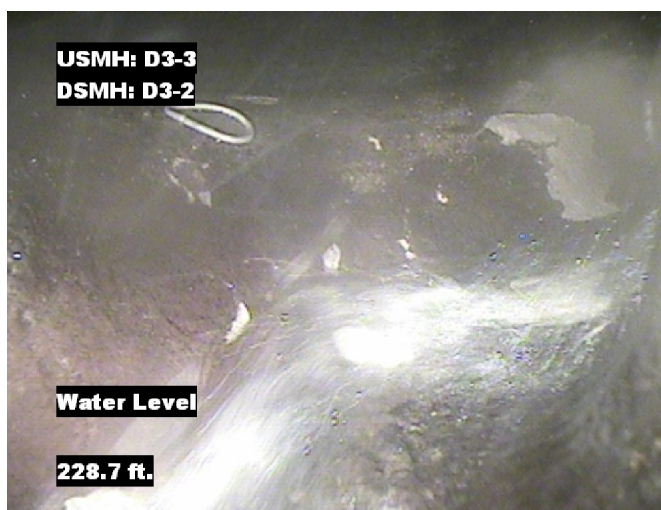
Distance: 228.7 ft. Grade: 0
Condition: Water Level
Remarks: N/A

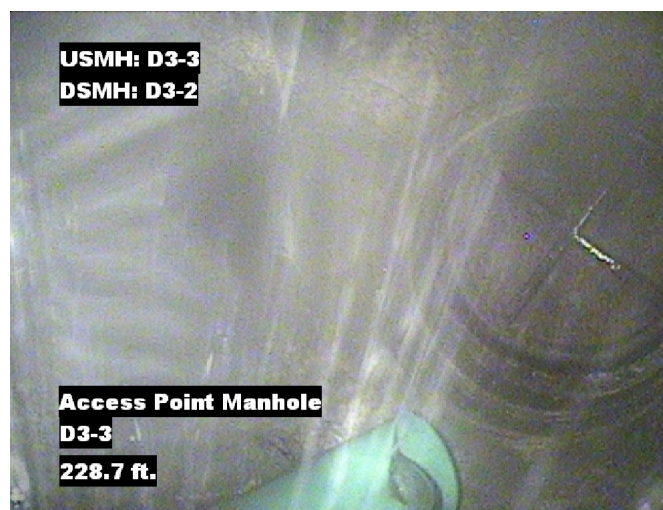
Distance: 228.7 ft. Grade: 0
Condition: Access Point Manhole
Remarks: D3-3
