## Defect Listing

Pipe Segment Refere... <b>D3-4_D3-3</b>	City <b>Oliver Springs</b>	Street <b>Norwood Elementary ...</b>	Material <b>Vitrified Clay Pipe</b>	Location C... <b>Easement/R...</b>	Sewer Use <b>Sanitary</b>
Upstream MH <b>D3-4</b>	Total Length <b>11.7</b>	Year Laid	Shape <b>Circular</b>	Location Details <b>East Side of School</b>	
DS Manhole <b>D3-3</b>	Length surveyed <b>11.7</b>	Year Renewed	Height <b>6</b>	Width <b>6</b>	Pipe Joint... <b>13</b>

SPR <b>N/A</b>	MPR <b>6</b>	PO Number <b>4397-03</b>		Customer <b>GRW</b>	
SPRI <b>N/A</b>	MPRI <b>3</b>	Work Order <b>4397-02</b>		Purpose <b>Pre-Rehabilitation Survey</b>	
QSR <b>N/A</b>	QMR <b>3200</b>				
OPR <b>6</b>	Surveyed By <b>Barry Rogers</b>	Direction <b>Downstream</b>	Date <b>20150709</b>	Media label	
OPRI <b>3</b>	Certificate Number <b>U-1012-16405</b>	Pre-Cleaning <b>No Pre-Cleaning</b>	Time <b>14:49</b>	Weather <b>Dry</b>	
Date Cleaned			End Time <b>14:52</b>	Additional Info

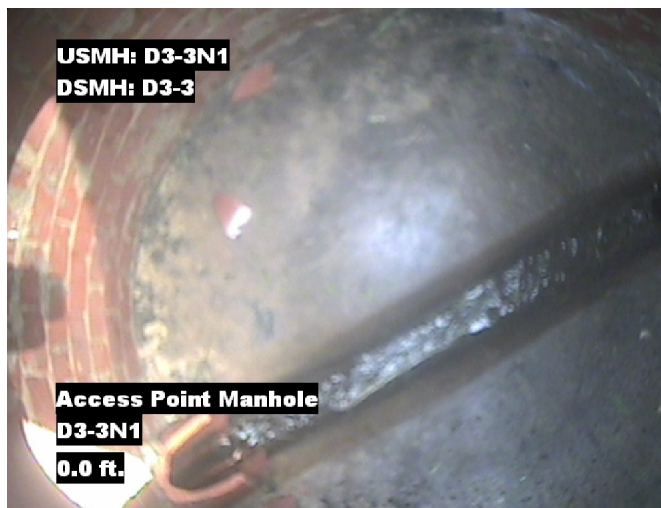
Distance: 0.0 ft. Grade: 0  
Condition: Access Point Manhole  
Remarks: D3-4

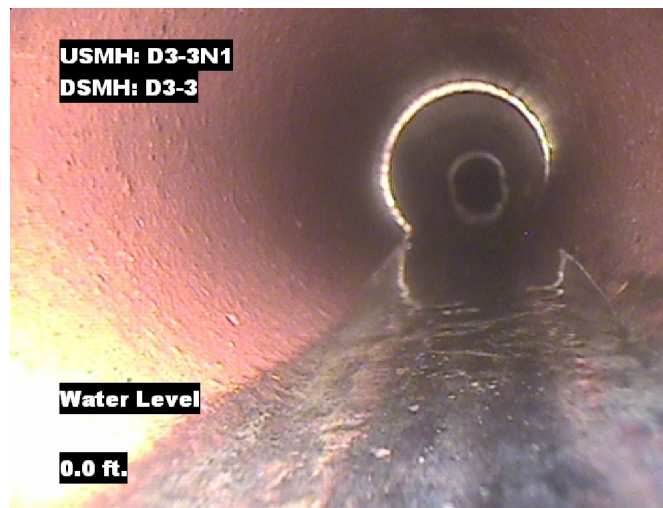
Distance: 0.0 ft. Grade: 0  
Condition: Water Level  
Remarks: N/A

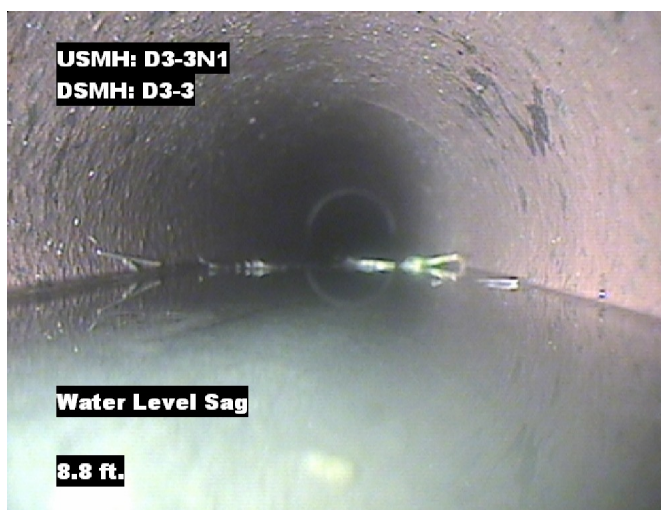
Distance: 8.8 ft. Grade: 3  
Condition: Water Level Sag  
Remarks: N/A

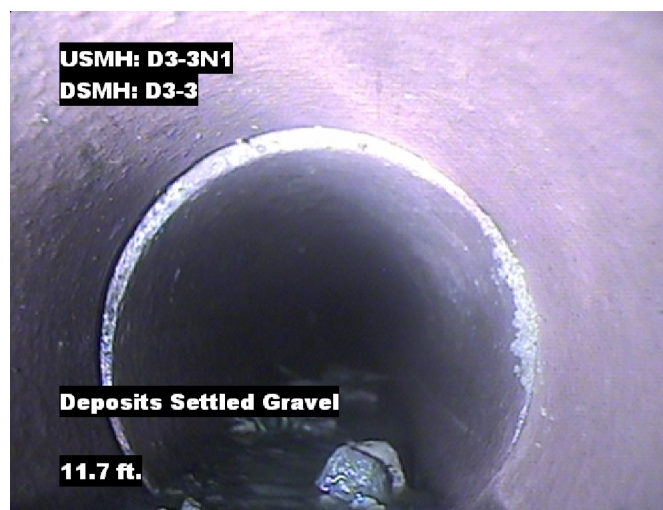
Distance: 11.7 ft. Grade: 3  
Condition: Deposits Settled Gravel  
Remarks: N/A

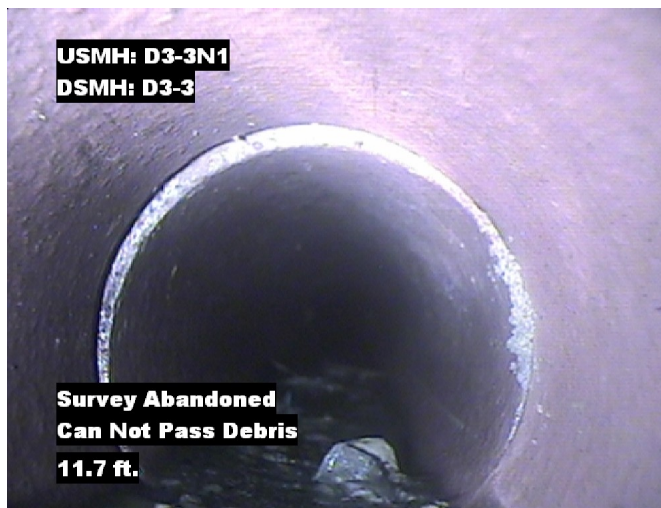
Distance: 11.7 ft. Grade: 0  
Condition: Survey Abandoned  
Remarks: Can Not Pass Debris
