Defect Listing

Pipe Segment Refere... D3-5_D3-4	City Oliver Springs	Street Norwood Elementary ...	Material Vitrified Clay Pipe	Location C... Easement/R...	Sewer Use Sanitary
Upstream MH D3-5	Total Length 39.5	Year Laid	Shape Circular	Location Details	
DS Manhole D3-4	Length surveyed 39.5	Year Renewed	Height 6	Width 6	Pipe Joint... 13

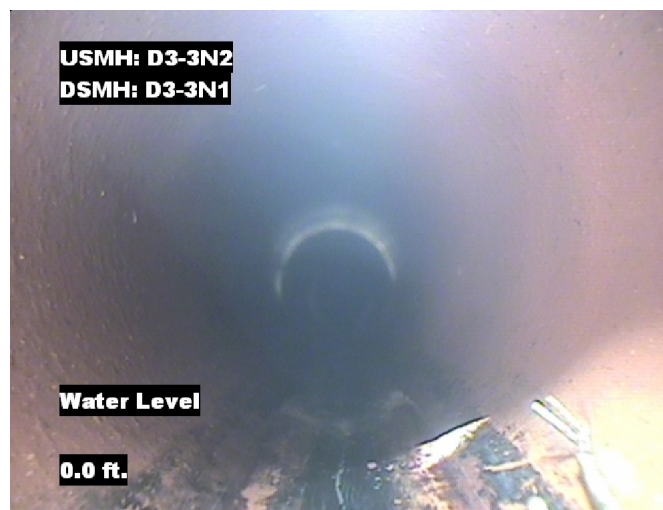
Distance: 0.0 ft. Grade: 0
Condition: Water Level
Remarks: N/A

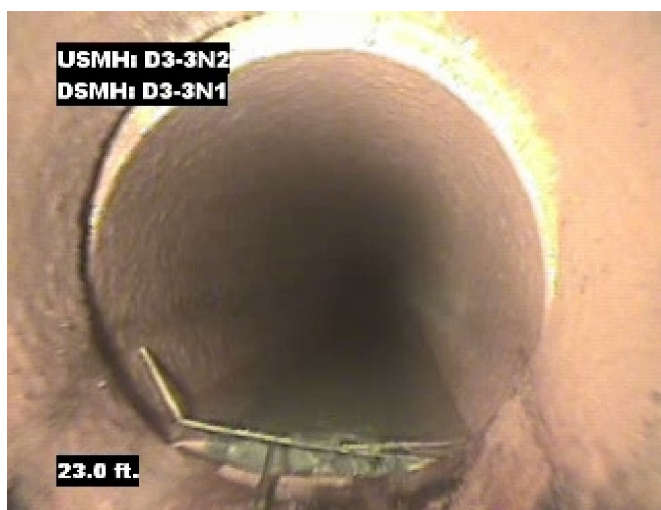
Distance: 23.0 ft. Grade: 1
Condition: Joint Offset Medium
Remarks: N/A

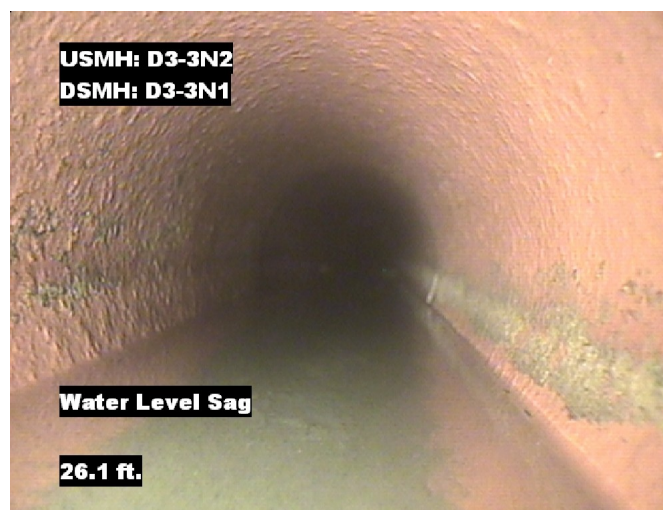
Distance: 26.1 ft. Grade: 2
Condition: Water Level Sag
Remarks: N/A

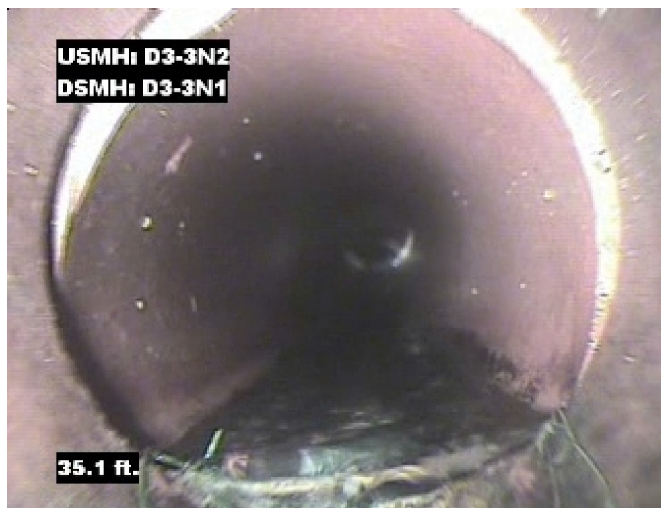
Distance: 35.1 ft. Grade: 1
Condition: Joint Offset Medium
Remarks: N/A

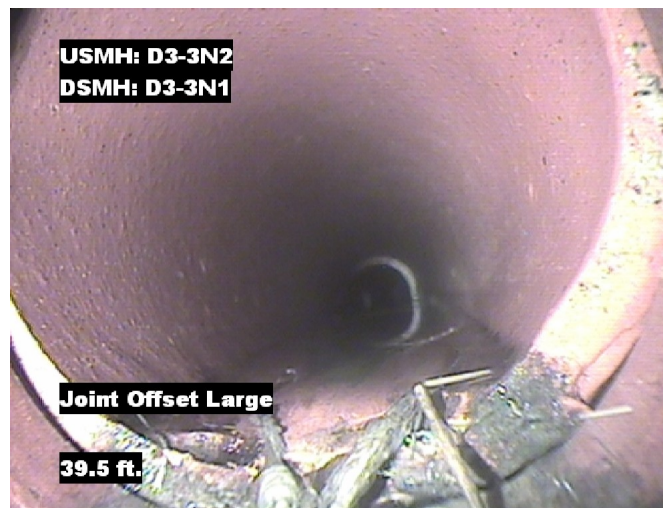
Distance: 39.5 ft. Grade: 2
Condition: Joint Offset Large
Remarks: N/A

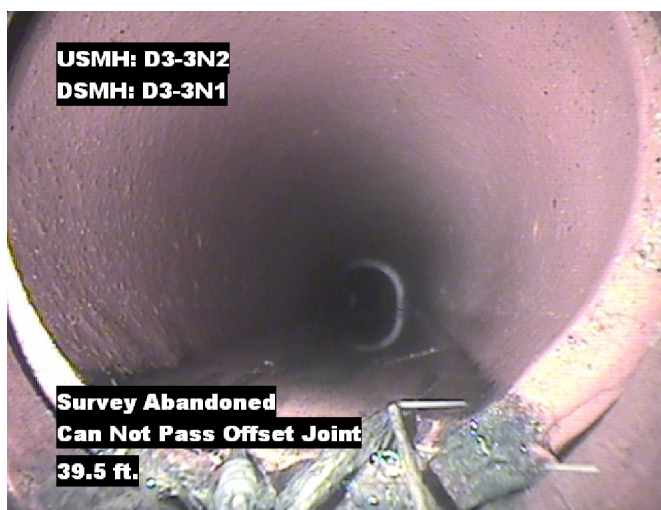
Distance: 39.5 ft. Grade: 0
Condition: Survey Abandoned
Remarks: Can Not Pass Offset Joint
