Defect Listing

Pipe Segment Refere... D3-6_D3-5	City Oliver Springs	Street Easement at Norwood...	Material PolyVinyl Chloride	Location C... Easement/R...	Sewer Use Sanitary
Upstream MH D3-6	Total Length 164.3	Year Laid	Shape Circular	Location Details east side of School	
DS Manhole D3-5	Length surveyed 164.3	Year Renewed	Height 6	Width 6	Pipe Joint... 13

SPR N/A	MPR 31	PO Number 4397-03		Customer GRW	
SPRI N/A	MPRI 3.4	Work Order 4397-02		Purpose Pre-Rehabilitation Survey	
QSR N/A	QMR 4533				
OPR 31	Surveyed By Barry Rogers	Direction Upstream	Date 20150709	Media label	
OPRI 3.4	Certificate Number U-1012-16405	Pre-Cleaning Jetting	Time 14:03	Weather Dry	
Date Cleaned 20150709			End Time 14:13	Additional Info

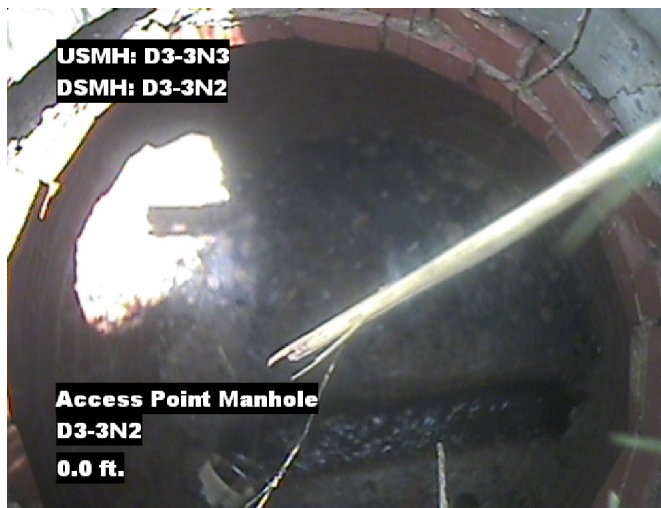
Distance: 0.0 ft. Grade: 0
Condition: Access Point Manhole
Remarks: D3-6

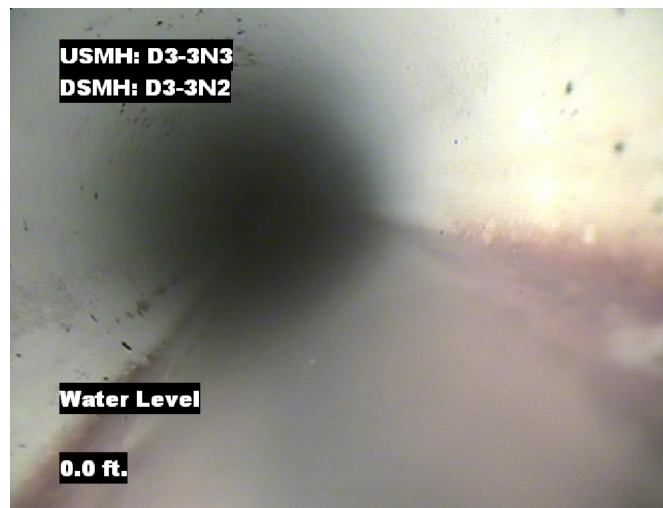
Distance: 0.0 ft. Grade: 0
Condition: Water Level
Remarks: N/A

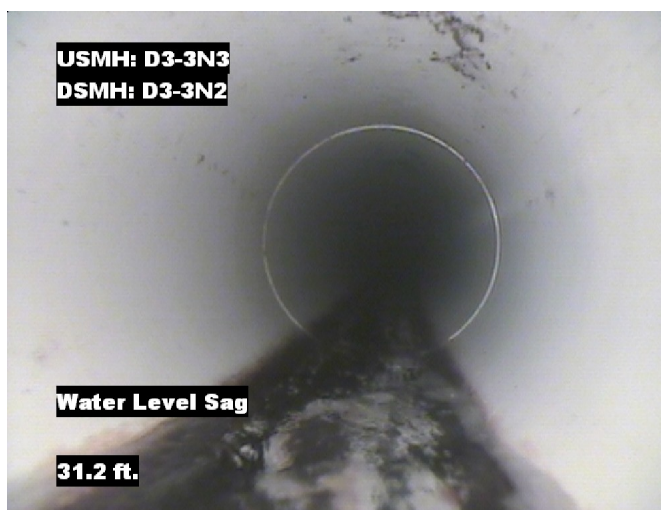
Distance: 31.1 ft. Grade: 2
Condition: Water Level Sag
Remarks: N/A

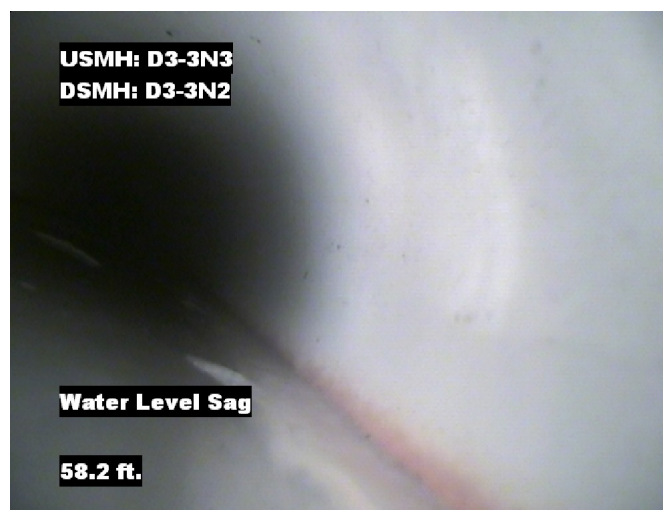
Distance: 58.2 ft. Grade: 3
Condition: Water Level Sag
Remarks: N/A

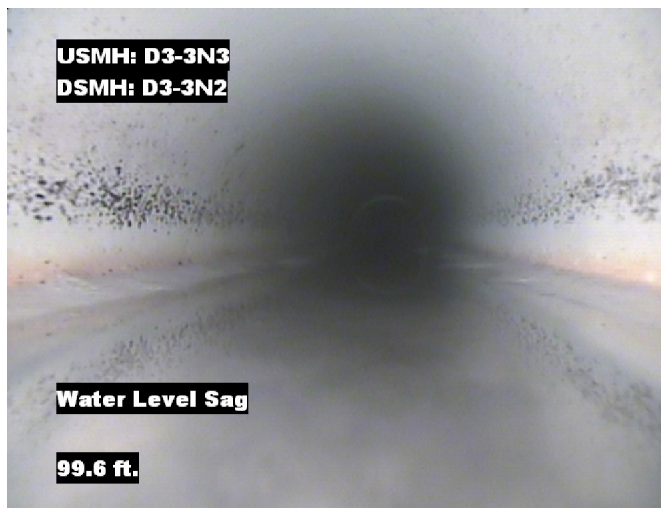
Distance: 99.6 ft. Grade: 3
Condition: Water Level Sag
Remarks: N/A

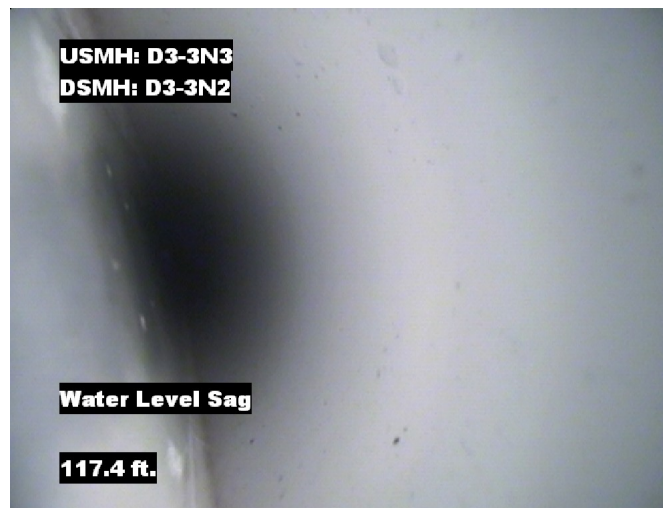
Distance: 117.4 ft. Grade: 3
Condition: Water Level Sag
Remarks: N/A

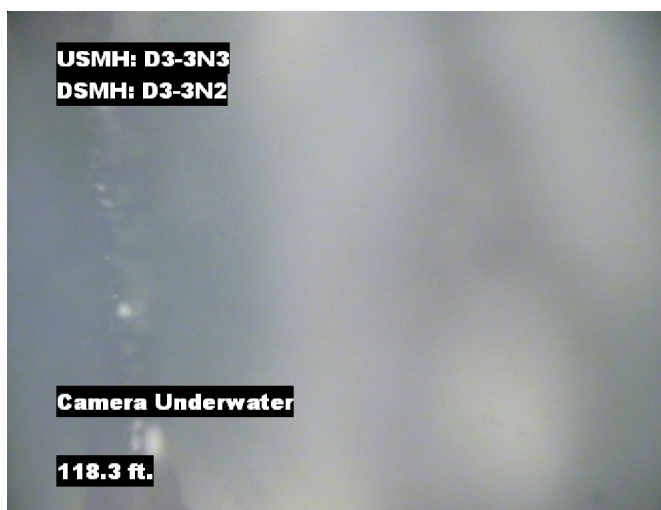
Distance: 118.3 ft. Grade: 4
Condition: Camera Underwater
Remarks: N/A

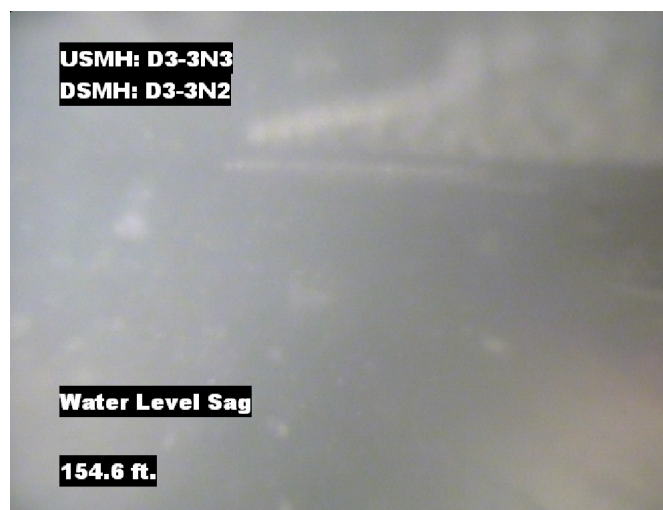
Distance: 154.6 ft. Grade: 4
Condition: Water Level Sag
Remarks: N/A

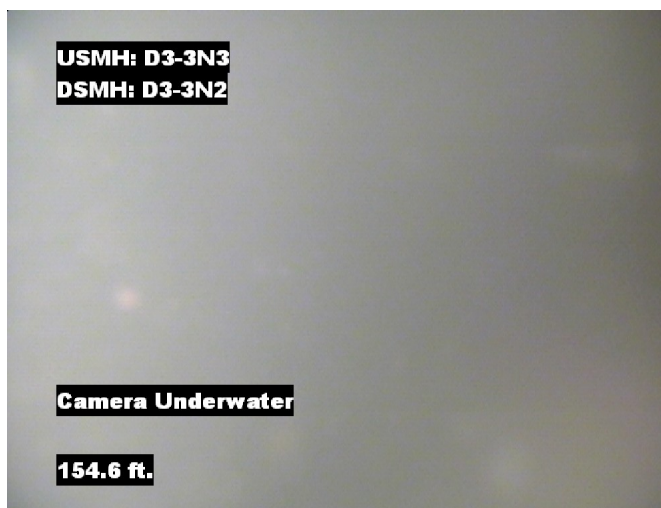
Distance: 154.6 ft. Grade: 4
Condition: Camera Underwater
Remarks: N/A

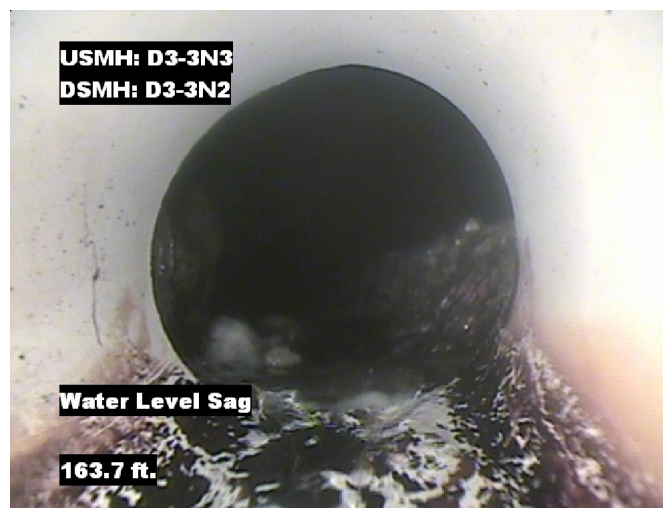
Distance: 163.7 ft. Grade: 4
Condition: Water Level Sag
Remarks: N/A

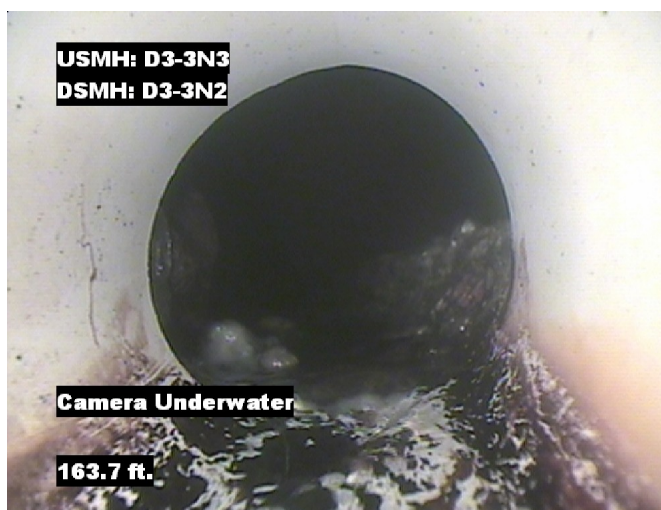
Distance: 163.7 ft. Grade: 4
Condition: Camera Underwater
Remarks: N/A

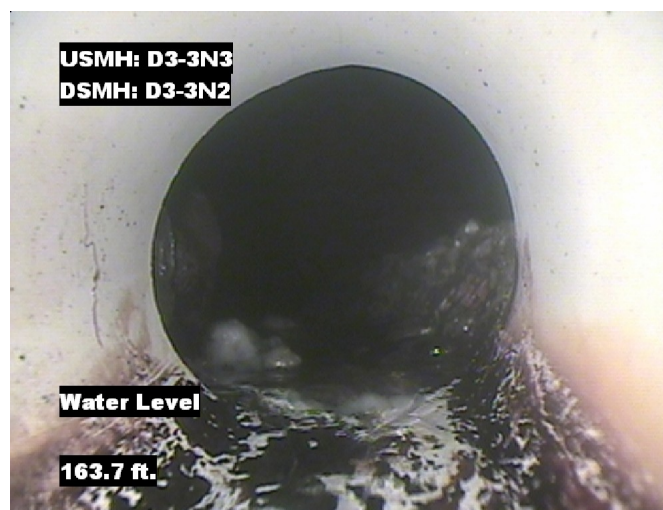
Distance: 163.7 ft. Grade: 0
Condition: Water Level
Remarks: N/A

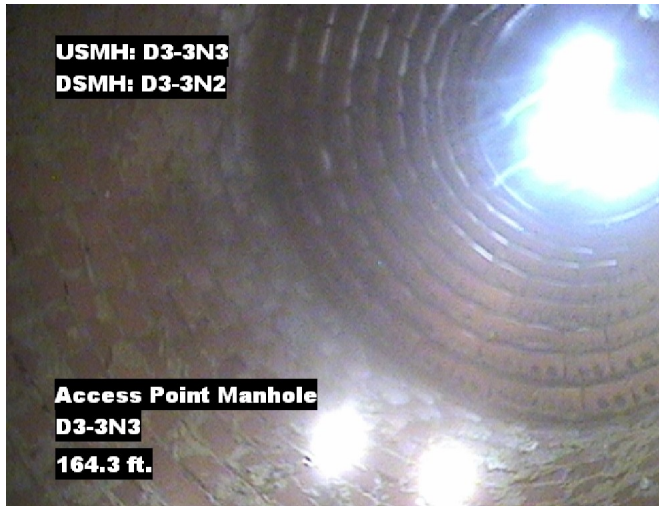
Distance: 164.3 ft. Grade: 0
Condition: Access Point Manhole
Remarks: D3-5
