Defect Listing

Pipe Segment Refere... D4-1_D-14	City Oliver Springs	Street Haven Rd	Material Fibreglass Reinforc...	Location C... Easement/R...	Sewer Use Sanitary
Upstream MH D4-1	Total Length 107.5	Year Laid	Shape Circular	Location Details	
DS Manhole D-14	Length surveyed 107.5	Year Renewed	Height 8	Width 8	Pipe Joint... N/A

SPR N/A	MPR 2	PO Number 4397-03	Customer GRW
SPRI N/A	MPRI 2	Work Order 4397-02	Purpose Pre-Rehabilitation Survey
QSR N/A	QMR 2100		
OPR 2	Surveyed By Barry Rogers	Direction Downstream	Date 20150703
OPRI 2	Certificate Number U-1012-16405	Pre-Cleaning Jetting	Time 10:33
	Date Cleaned 20150703	End Time 10:42	Weather Damp
			Media label
			Additional Info

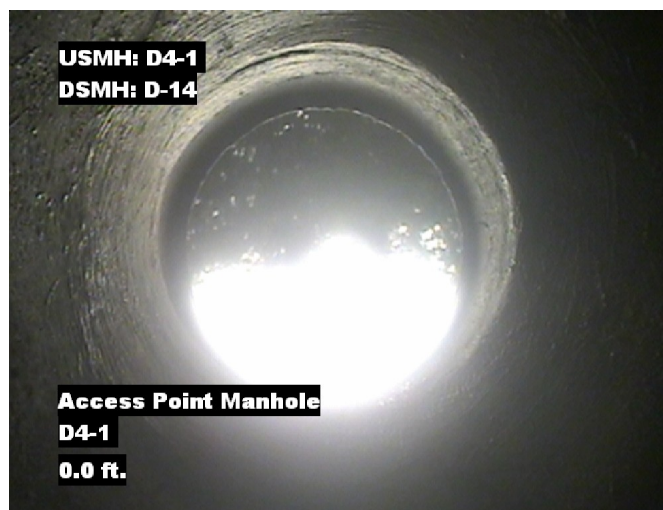
Distance: 0.0 ft. Grade: 0
Condition: Access Point Manhole
Remarks: D4-1

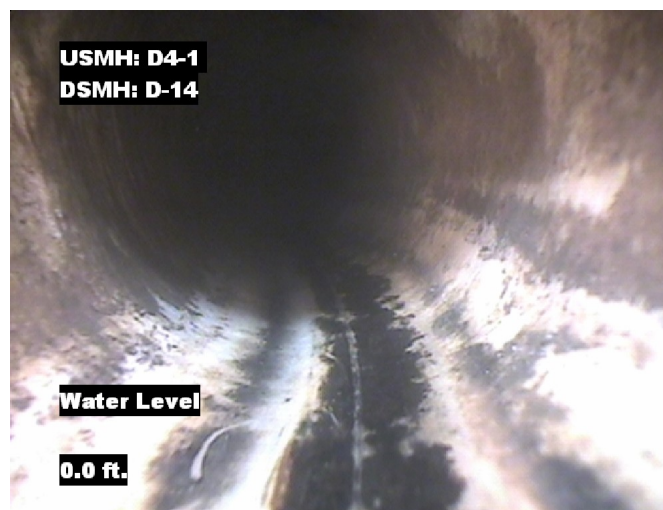
Distance: 0.0 ft. Grade: 0
Condition: Water Level
Remarks: N/A

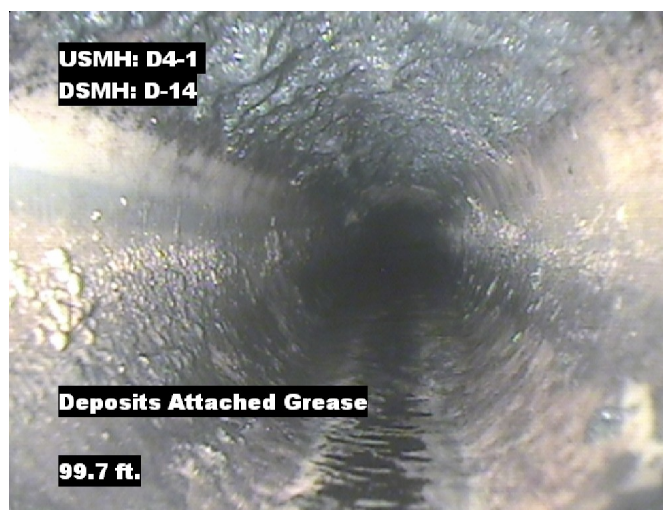
Distance: 99.7 ft. Grade: 2
Condition: Deposits Attached Grease
Remarks: N/A

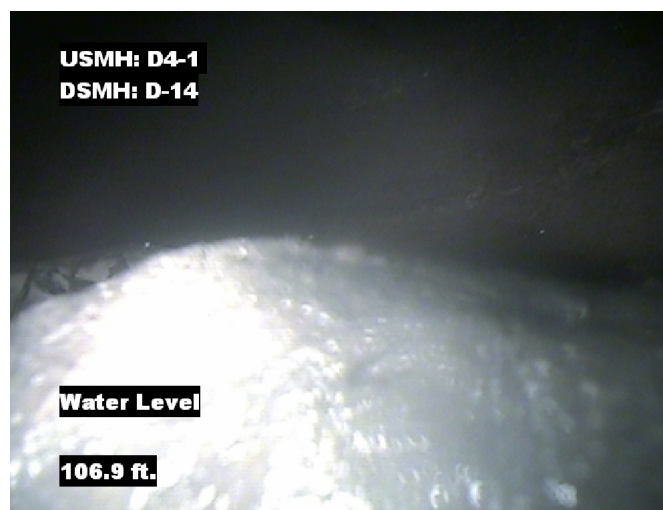
Distance: 106.9 ft. Grade: 0
Condition: Water Level
Remarks: N/A

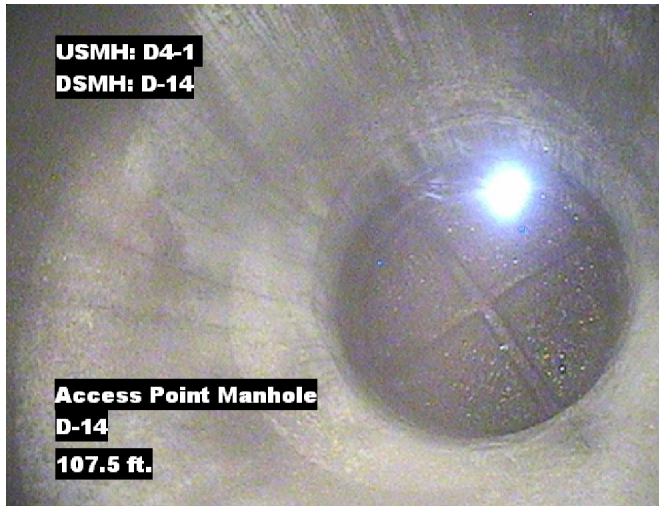
Distance: 107.5 ft. Grade: 0
Condition: Access Point Manhole
Remarks: D-14
