Defect Listing

Pipe Segment Refere... D4-2_D4-1	City Oliver Springs	Street Haven Rd	Material Fibreglass Reinforc...	Location C... Light High...	Sewer Use Sanitary
Upstream MH D4-2	Total Length 309.6	Year Laid	Shape Circular	Location Details	
DS Manhole D4-1	Length surveyed 309.6	Year Renewed	Height 8	Width 8	Pipe Joint... N/A

SPR N/A	MPR N/A	PO Number 4397-03		Customer GRW	
SPRI N/A	MPRI N/A	Work Order 4397-02		Purpose Pre-Rehabilitation Survey	
QSR N/A	QMR N/A				
OPR N/A	Surveyed By Barry Rogers	Direction Downstream	Date 20150703	Media label	
OPRI N/A	Certificate Number U-1012-16405	Pre-Cleaning Jetting	Time 10:10	Weather Damp	
Date Cleaned 20150703			End Time 10:27	Additional Info

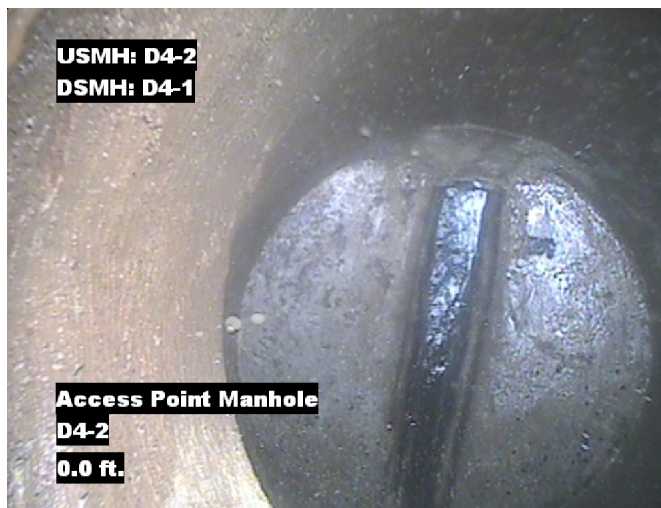
Distance: 0.0 ft. Grade: 0
Condition: Access Point Manhole
Remarks: D4-2

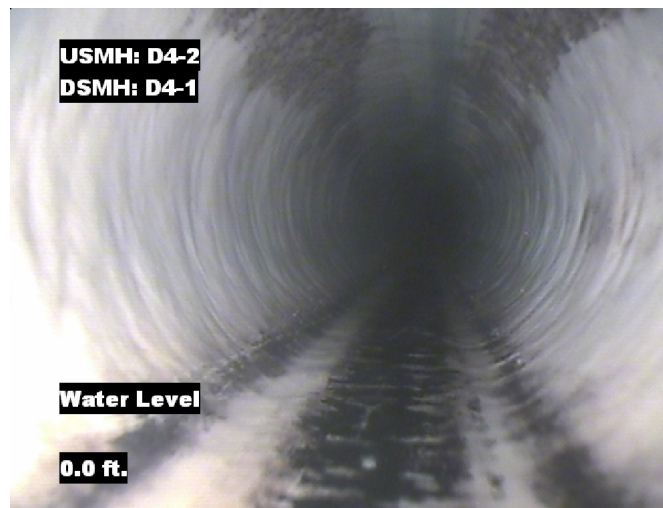
Distance: 0.0 ft. Grade: 0
Condition: Water Level
Remarks: N/A

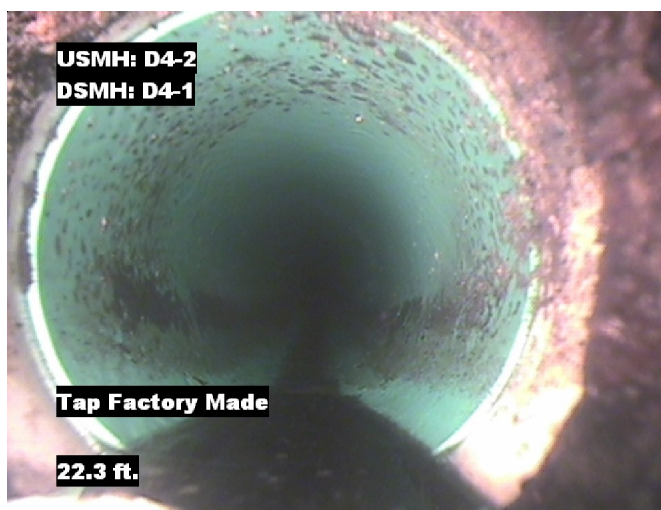
Distance: 22.3 ft. Grade: 0
Condition: Tap Factory Made
Remarks: N/A

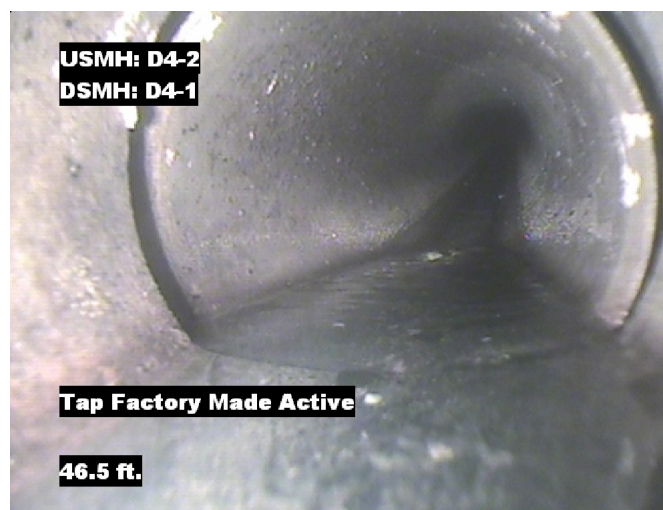
Distance: 46.5 ft. Grade: 0
Condition: Tap Factory Made Active
Remarks: N/A

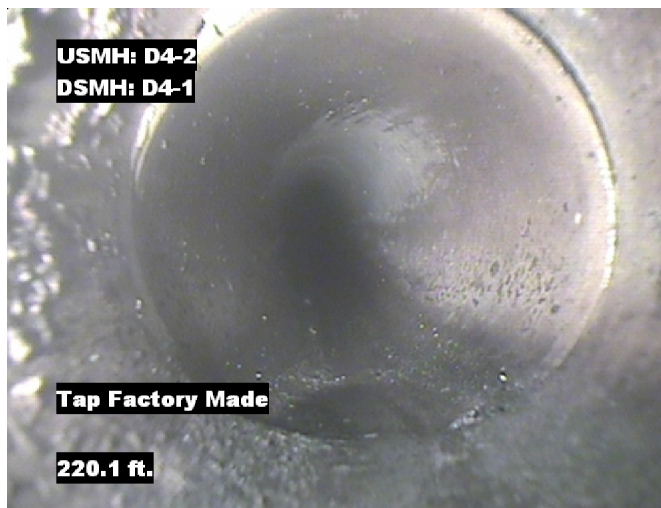
Distance: 220.1 ft. Grade: 0
Condition: Tap Factory Made
Remarks: N/A

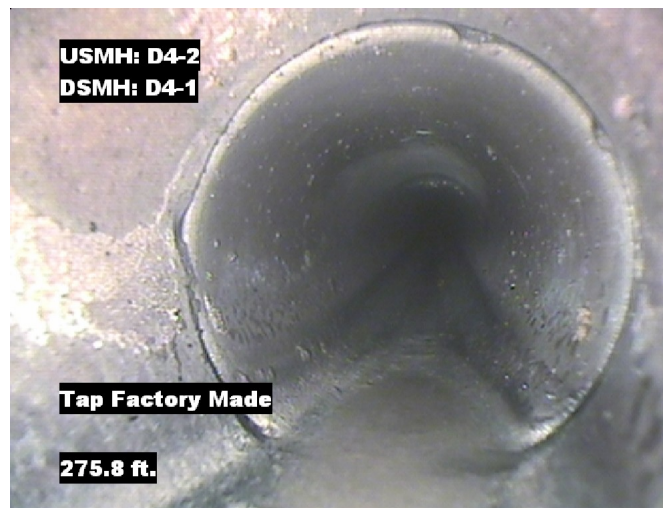
Distance: 275.8 ft. Grade: 0
Condition: Tap Factory Made
Remarks: N/A

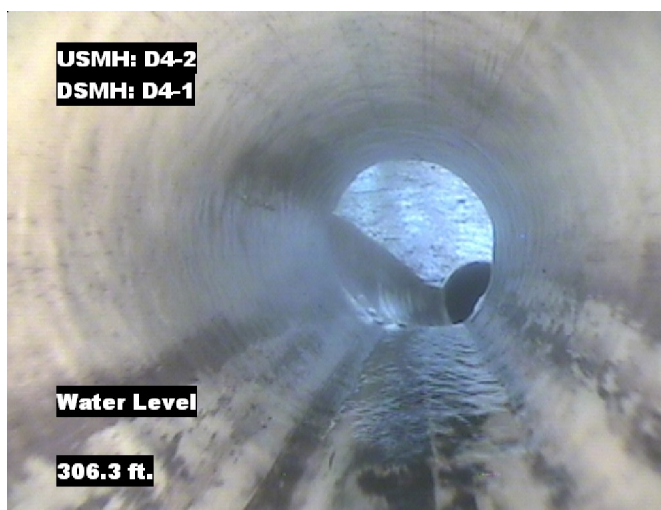
Distance: 306.2 ft. Grade: 0
Condition: Water Level
Remarks: N/A

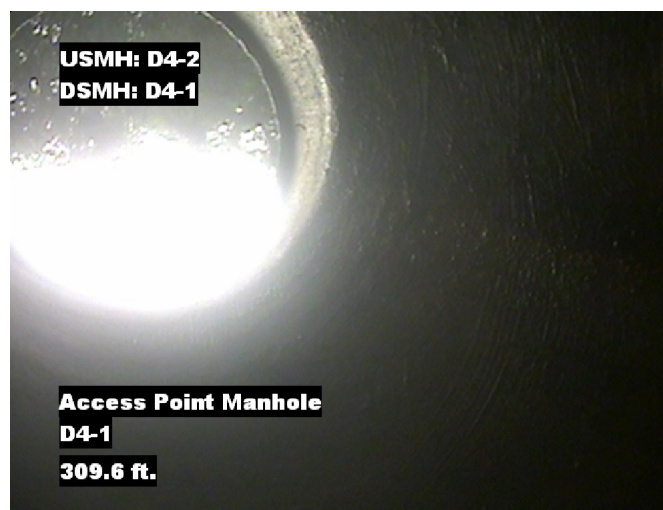
Distance: 309.6 ft. Grade: 0
Condition: Access Point Manhole
Remarks: D4-1
