## Defect Listing

Pipe Segment Refere...	City	Street	Material	Location C...	Sewer Use
<b>D4-3_D4-2</b>	<b>Oliver Springs</b>	<b>Haven Rd</b>	<b>Concrete Pipe (non-...</b>	<b>Light High...</b>	<b>Sanitary</b>
Upstream MH	Total Length	Year Laid	Shape	Location Details	
<b>D4-3</b>	<b>358.3</b>		<b>Circular</b>		
DS Manhole	Length surveyed	Year Renewed	Height	Width	Pipe Joint...
<b>D4-2</b>	<b>358.3</b>		<b>8</b>	<b>8</b>	<b>4</b>

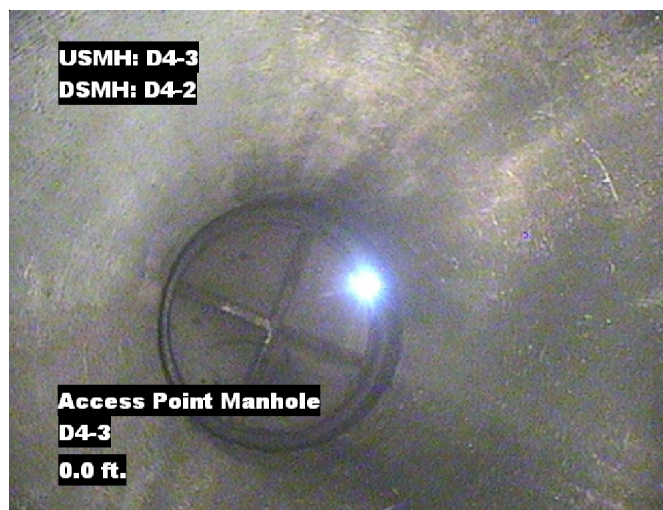
Distance: 0.0 ft. Grade: 0  
Condition: Access Point Manhole  
Remarks: D4-3

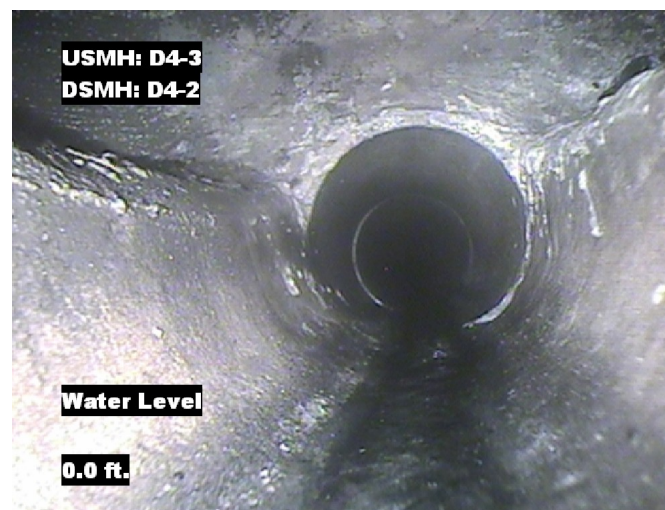
Distance: 0.0 ft. Grade: 0  
Condition: Water Level  
Remarks: N/A

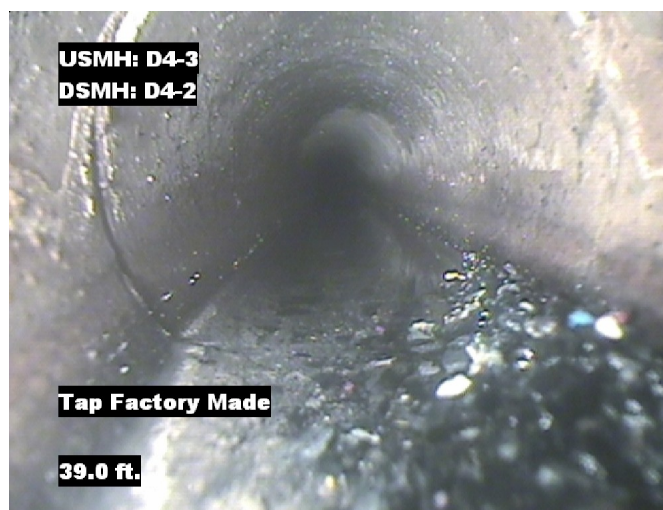
Distance: 39.0 ft. Grade: 0  
Condition: Tap Factory Made  
Remarks: N/A

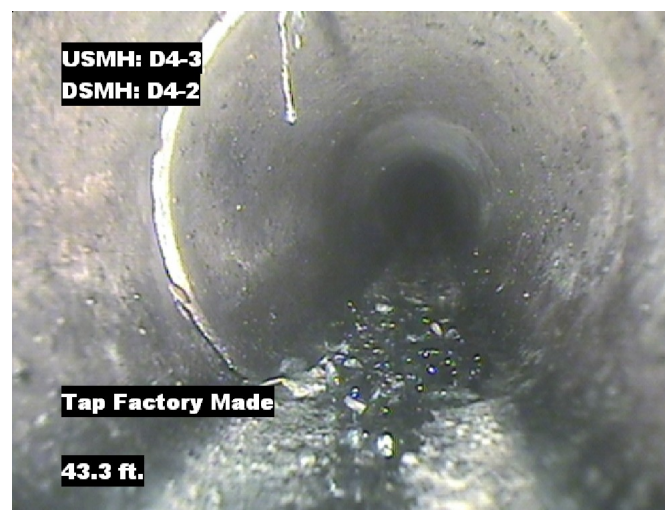
Distance: 43.3 ft. Grade: 0  
Condition: Tap Factory Made  
Remarks: N/A

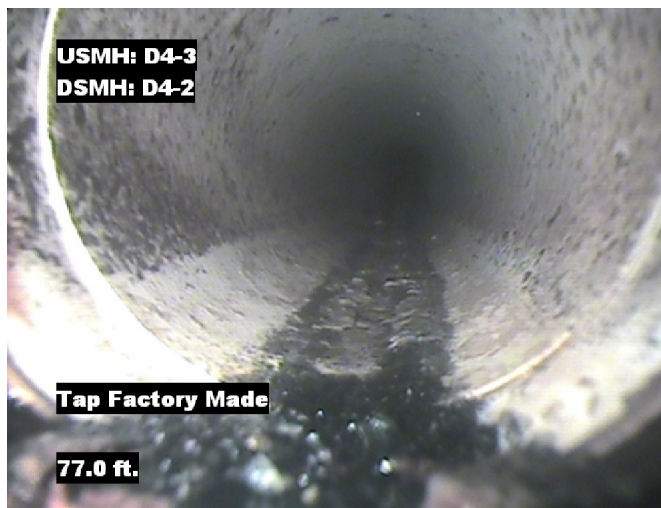
Distance: 77.0 ft. Grade: 0  
Condition: Tap Factory Made  
Remarks: N/A

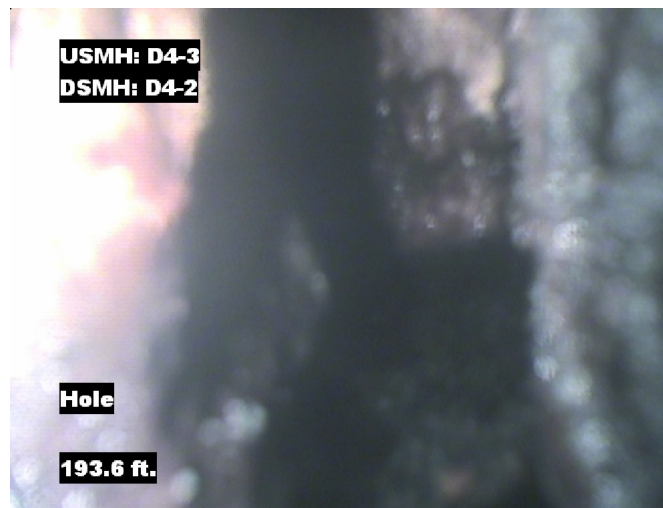
Distance: 193.6 ft. Grade: 3  
Condition: Hole  
Remarks: N/A

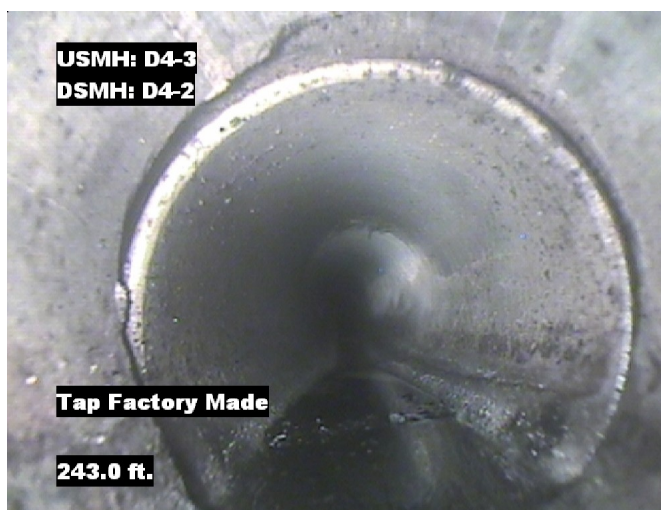
Distance: 243.0 ft. Grade: 0  
Condition: Tap Factory Made  
Remarks: N/A

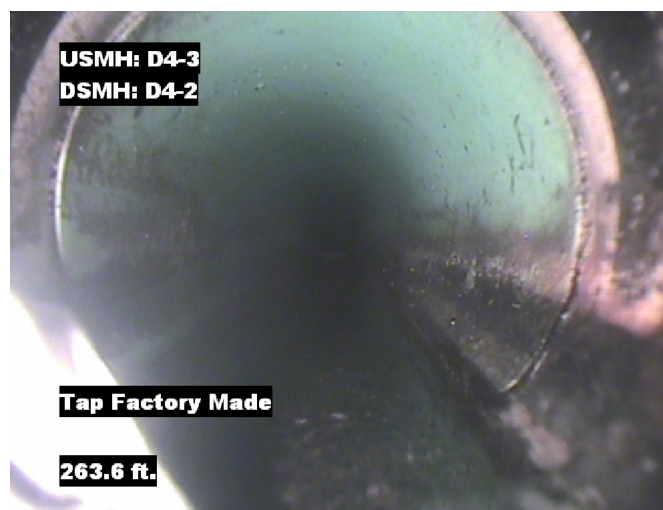
Distance: 263.6 ft. Grade: 0  
Condition: Tap Factory Made  
Remarks: N/A

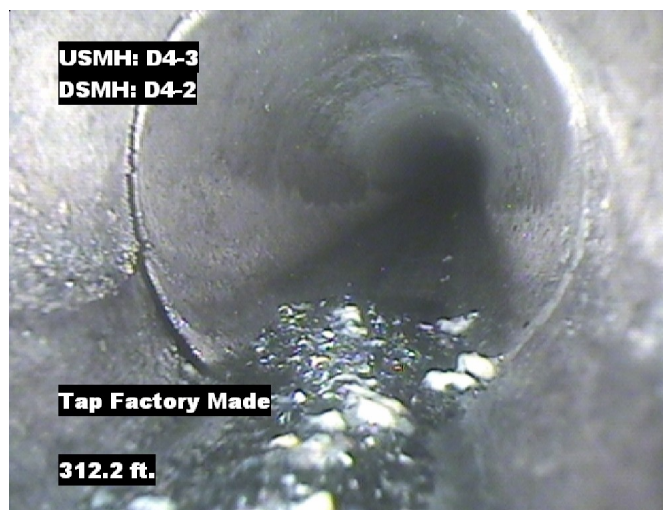
Distance: 312.2 ft. Grade: 0  
Condition: Tap Factory Made  
Remarks: N/A

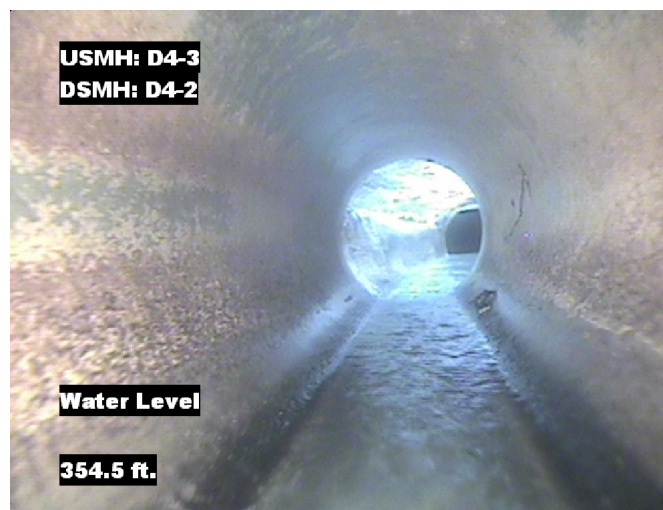
Distance: 354.5 ft. Grade: 0  
Condition: Water Level  
Remarks: N/A

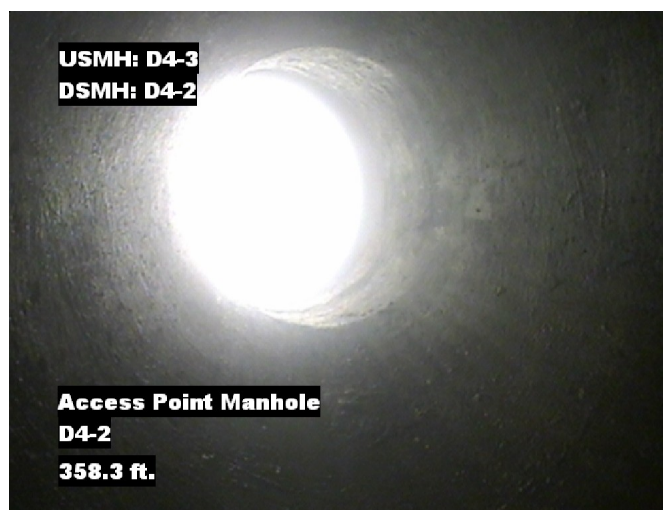
Distance: 358.3 ft. Grade: 0  
Condition: Access Point Manhole  
Remarks: D4-2
