Defect Listing

Pipe Segment Refere... D4-4_D4-3	City Oliver Springs	Street Haven Rd	Material Concrete Pipe (non-...	Location C... Light High...	Sewer Use Sanitary
Upstream MH D4-4	Total Length 53.8	Year Laid	Shape Circular	Location Details	
DS Manhole D4-3	Length surveyed 53.8	Year Renewed	Height 8	Width 8	Pipe Joint... 4

SPR N/A	MPR N/A	PO Number 4397-03		Customer GRW	
SPRI N/A	MPRI N/A	Work Order 4397-02		Purpose Pre-Rehabilitation Survey	
QSR N/A	QMR N/A				
OPR N/A	Surveyed By Barry Rogers	Direction Downstream	Date 20150703	Media label	
OPRI N/A	Certificate Number U-1012-16405	Pre-Cleaning Jetting	Time 09:24	Weather Damp	
Date Cleaned 20150703			End Time 09:29	Additional Info

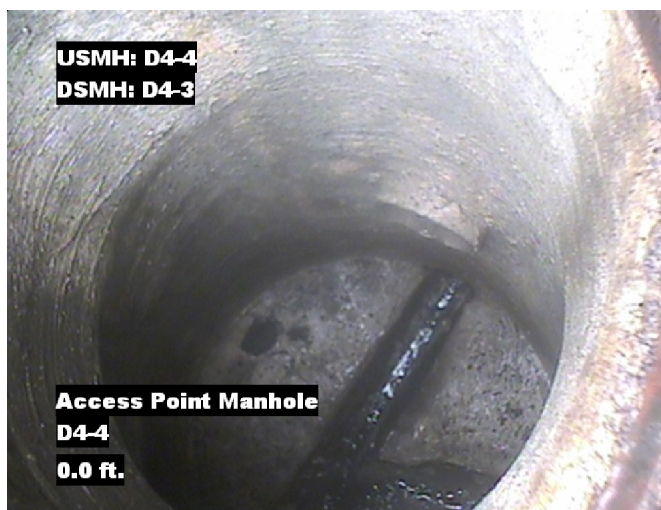
Distance: 0.0 ft. Grade: 0
Condition: Access Point Manhole
Remarks: D4-4

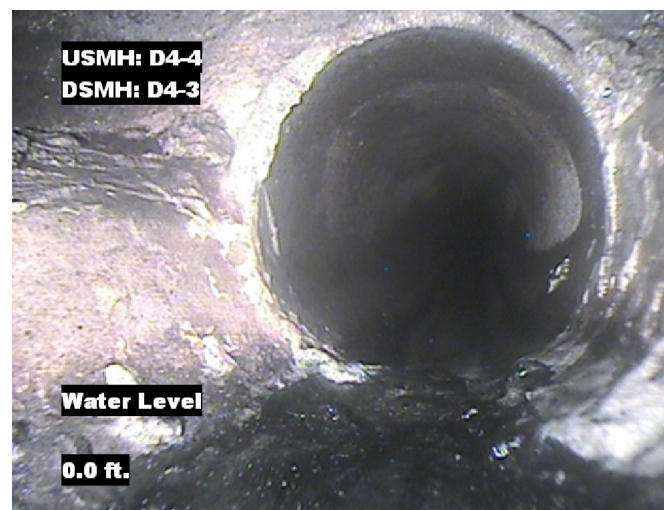
Distance: 0.0 ft. Grade: 0
Condition: Water Level
Remarks: N/A

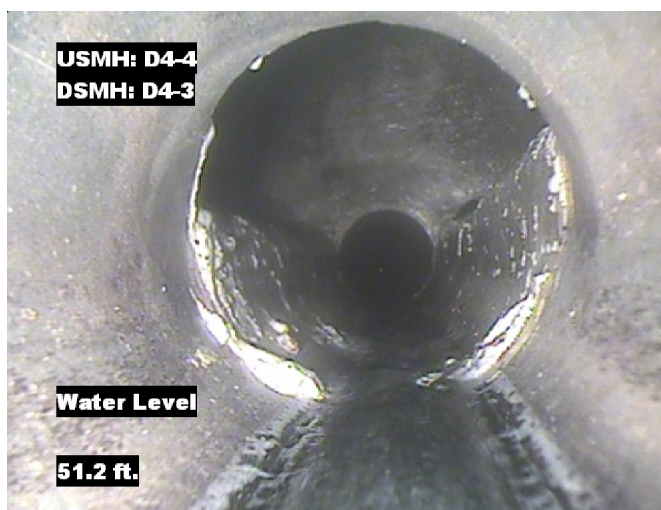
Distance: 51.2 ft. Grade: 0
Condition: Water Level
Remarks: N/A

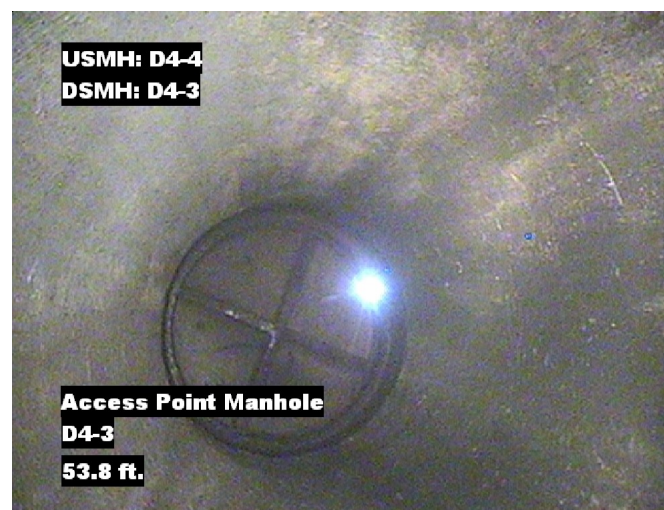
Distance: 53.8 ft. Grade: 0
Condition: Access Point Manhole
Remarks: D4-3
