## Defect Listing

Pipe Segment Refere... <b>D4-5_D4-4</b>	City <b>Oliver Springs</b>	Street <b>Haven Rd</b>	Material <b>Concrete Pipe (non-...</b>	Location C... <b>Light High...</b>	Sewer Use <b>Sanitary</b>
Upstream MH <b>D4-5</b>	Total Length <b>340.5</b>	Year Laid	Shape <b>Circular</b>	Location Details	
DS Manhole <b>D4-4</b>	Length surveyed <b>340.5</b>	Year Renewed	Height <b>8</b>	Width <b>8</b>	Pipe Joint... <b>4</b>

SPR <b>1</b>	MPR <b>N/A</b>	PO Number <b>4397-03</b>	Customer <b>GRW</b>
SPRI <b>1</b>	MPRI <b>N/A</b>	Work Order <b>4397-02</b>	Purpose <b>Pre-Rehabilitation Survey</b>
QSR <b>1100</b>	QMR <b>N/A</b>		
OPR <b>1</b>	Surveyed By <b>Barry Rogers</b>	Direction <b>Downstream</b>	Date <b>20150629</b>
OPRI <b>1</b>	Certificate Number <b>U-1012-16405</b>	Pre-Cleaning <b>Jetting</b>	Time <b>14:49</b>
	Date Cleaned <b>20150629</b>	End Time <b>15:14</b>	Weather <b>Dry</b>
			Additional Info

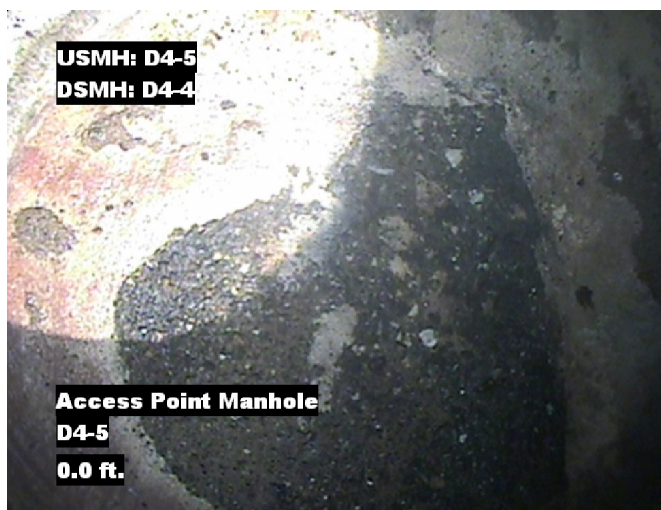
Distance: 0.0 ft. Grade: 0  
Condition: Access Point Manhole  
Remarks: D4-5

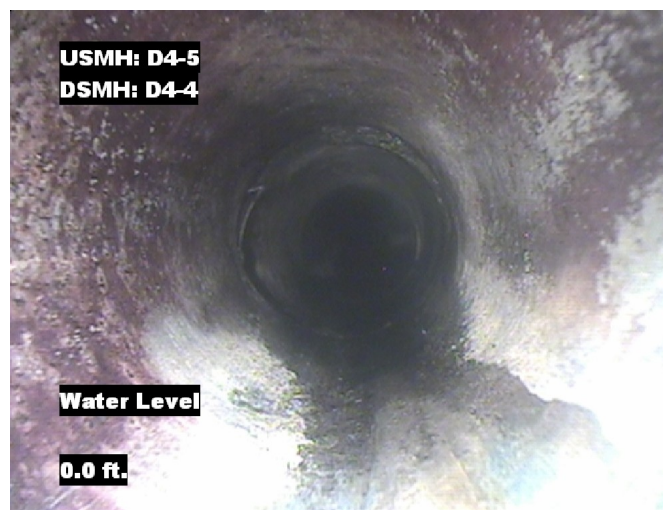
Distance: 0.0 ft. Grade: 0  
Condition: Water Level  
Remarks: N/A

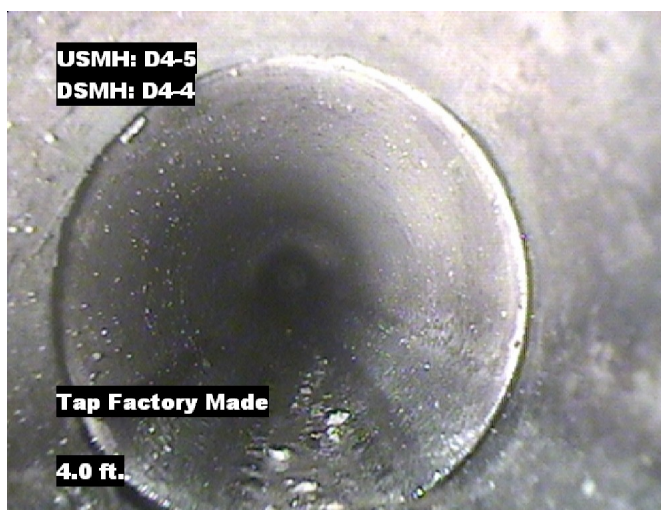
Distance: 4.0 ft. Grade: 0  
Condition: Tap Factory Made  
Remarks: N/A

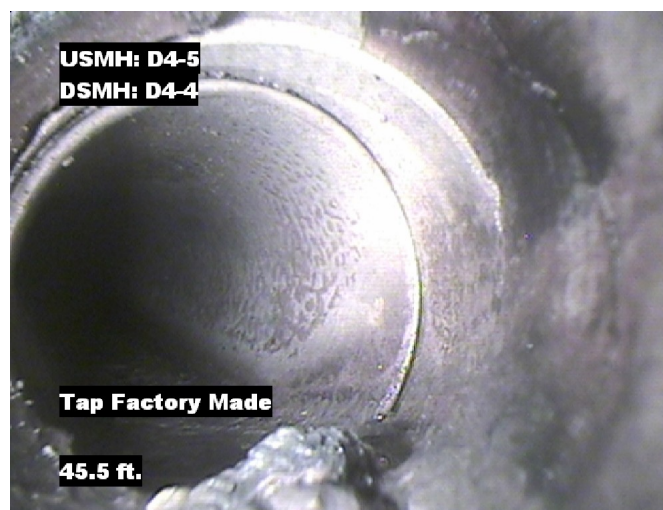
Distance: 45.5 ft. Grade: 0  
Condition: Tap Factory Made  
Remarks: N/A

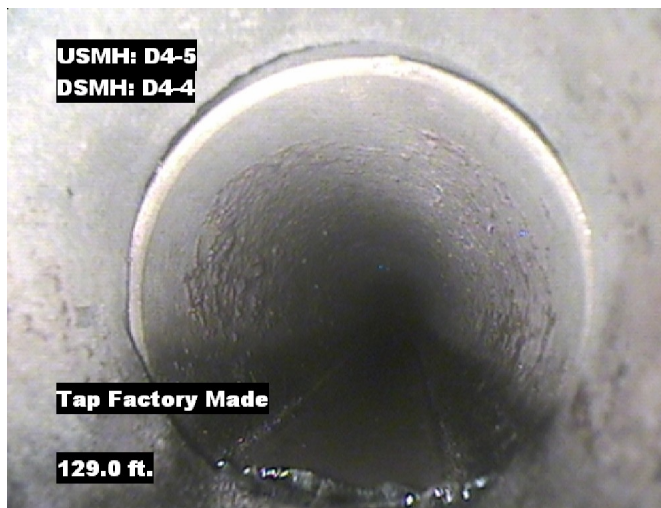
Distance: 129.0 ft. Grade: 0  
Condition: Tap Factory Made  
Remarks: N/A

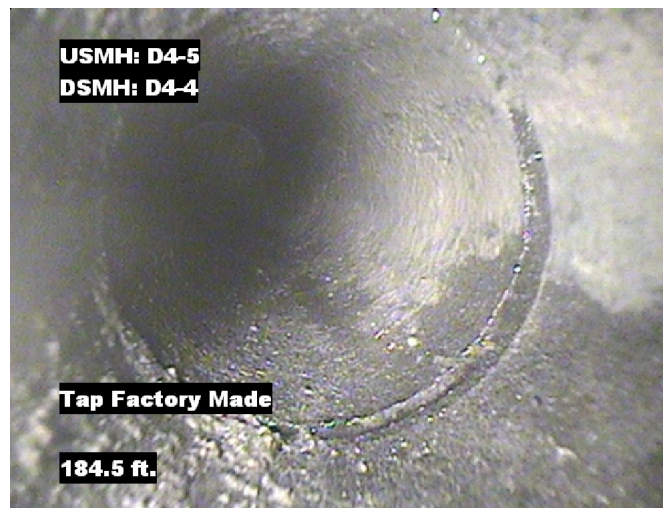
Distance: 184.5 ft. Grade: 0  
Condition: Tap Factory Made  
Remarks: N/A

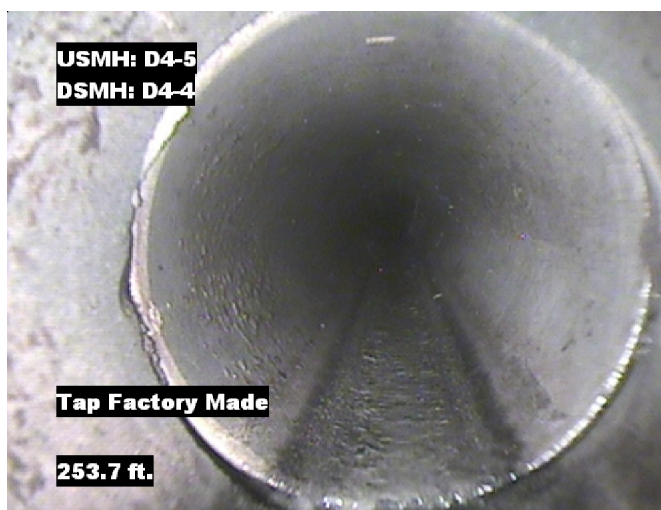
Distance: 253.7 ft. Grade: 0  
Condition: Tap Factory Made  
Remarks: N/A

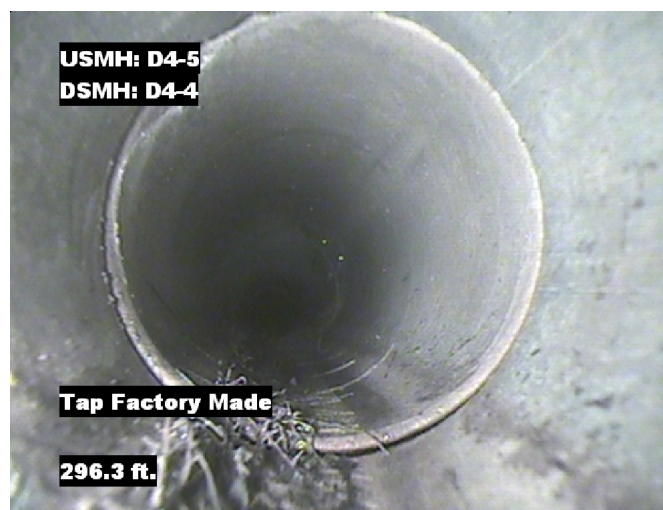
Distance: 296.3 ft. Grade: 0  
Condition: Tap Factory Made  
Remarks: N/A

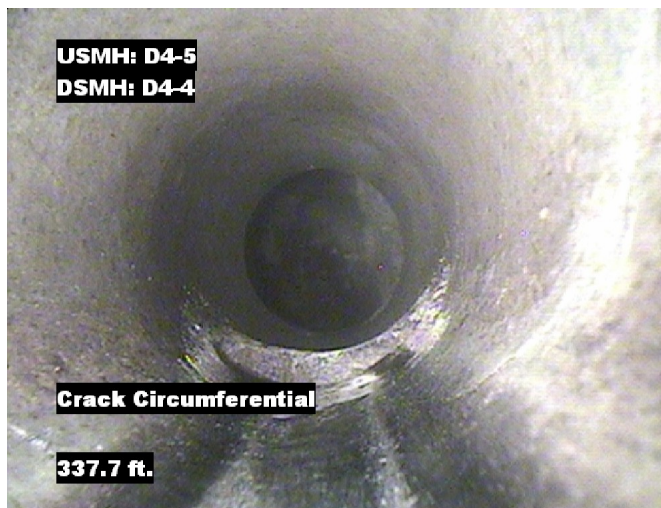
Distance: 337.7 ft. Grade: 1  
Condition: Crack Circumferential  
Remarks: N/A

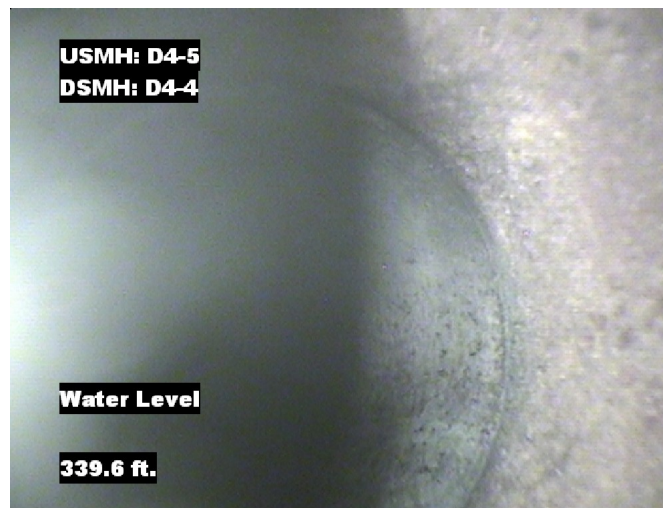
Distance: 339.6 ft. Grade: 0  
Condition: Water Level  
Remarks: N/A

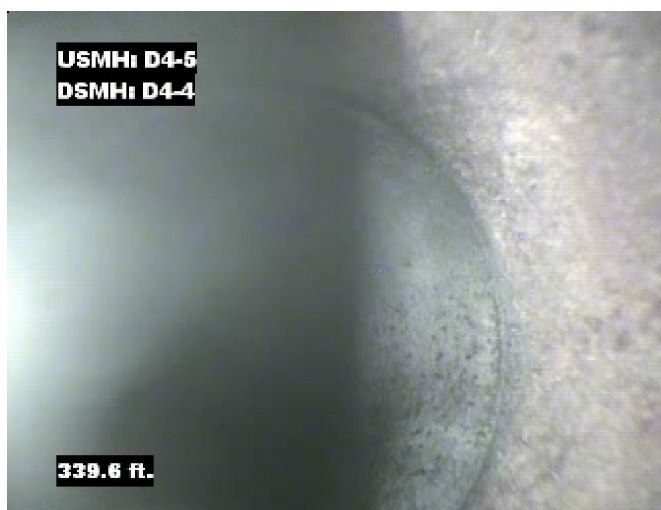
Distance: 339.7 ft. Grade: 0  
Condition: Tap Factory Made  
Remarks: drop line

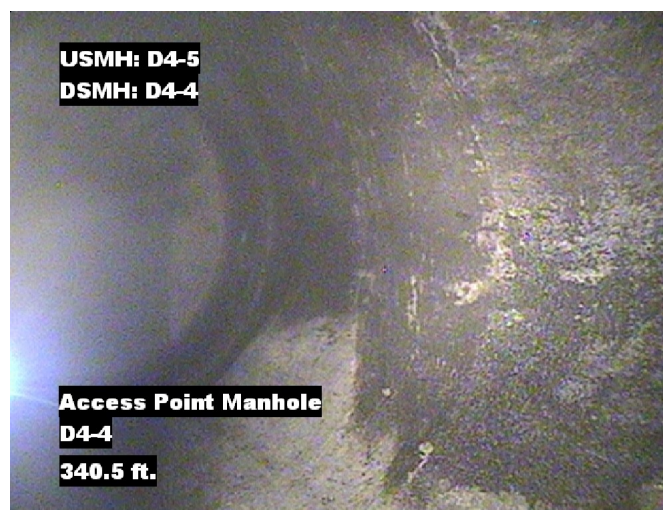
Distance: 340.5 ft. Grade: 0  
Condition: Access Point Manhole  
Remarks: D4-4
