Defect Listing

Pipe Segment Refere... D5-1_D5-1A	City Oliver Springs	Street Forest Ave	Material Concrete Pipe (non-...	Location C... Light High...	Sewer Use Sanitary
Upstream MH D5-1	Total Length 232.3	Year Laid	Shape Circular	Location Details	
DS Manhole D5-1A	Length surveyed 232.3	Year Renewed	Height 8	Width 8	Pipe Joint... 4

SPR N/A	MPR N/A	PO Number 4397-03		Customer GRW	
SPRI N/A	MPRI N/A	Work Order 4397-02		Purpose Pre-Rehabilitation Survey	
QSR N/A	QMR N/A				
OPR N/A	Surveyed By Barry Rogers	Direction Downstream	Date 20150629	Media label	
OPRI N/A	Certificate Number U-1012-16405	Pre-Cleaning Jetting	Time 13:18	Weather Dry	
Date Cleaned 20150629			End Time 13:31	Additional Info

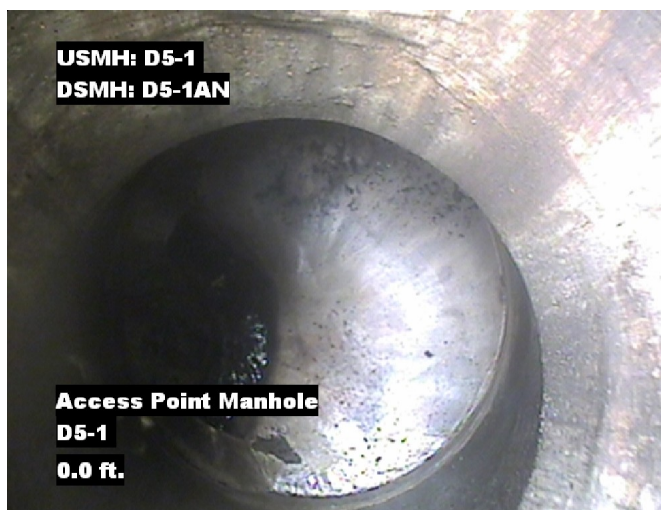
Distance: 0.0 ft. Grade: 0
Condition: Access Point Manhole
Remarks: D5-1

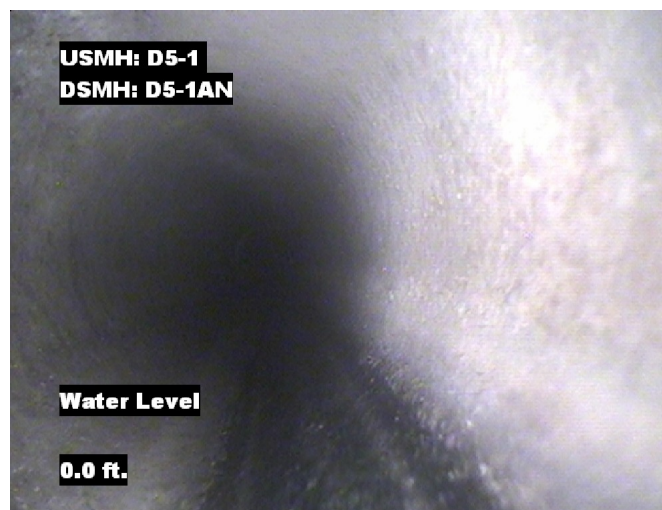
Distance: 0.0 ft. Grade: 0
Condition: Water Level
Remarks: N/A

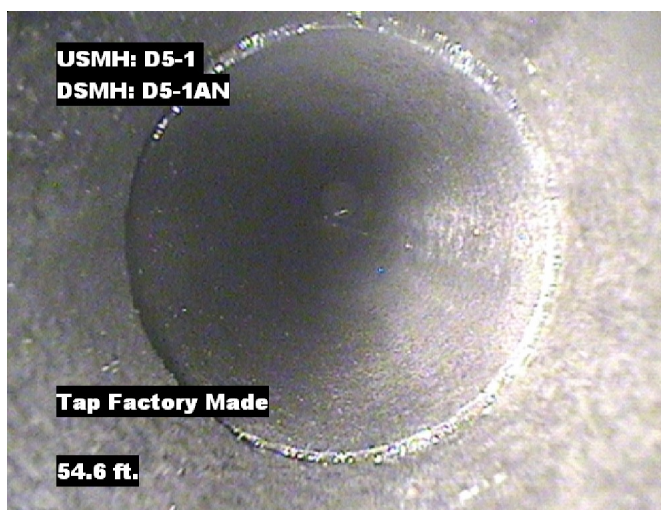
Distance: 54.6 ft. Grade: 0
Condition: Tap Factory Made
Remarks: N/A

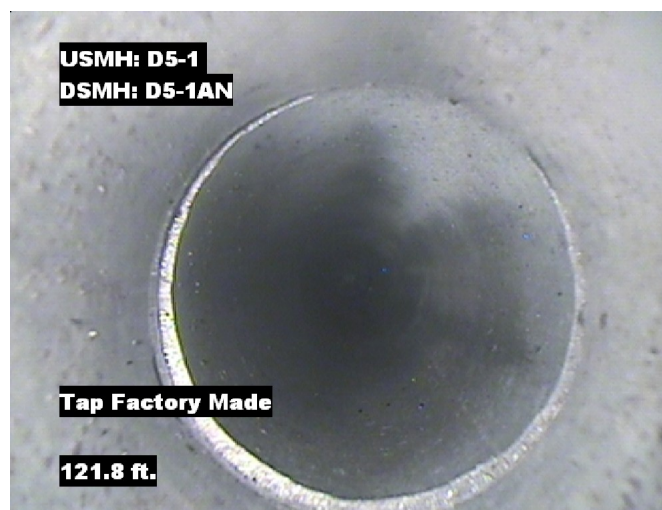
Distance: 121.8 ft. Grade: 0
Condition: Tap Factory Made
Remarks: N/A

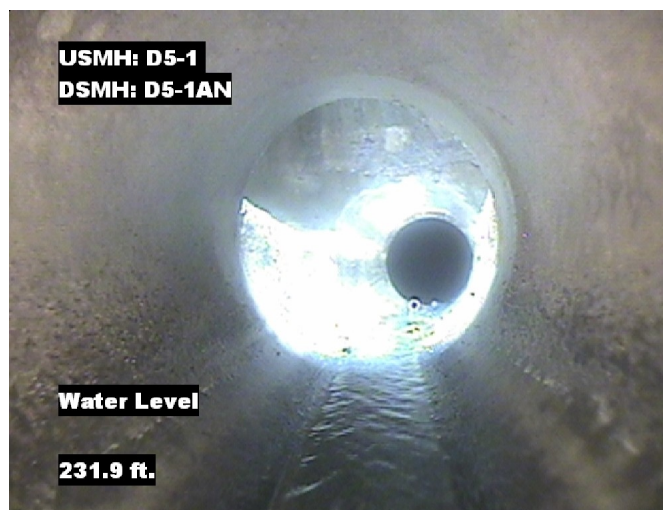
Distance: 231.9 ft. Grade: 0
Condition: Water Level
Remarks: N/A

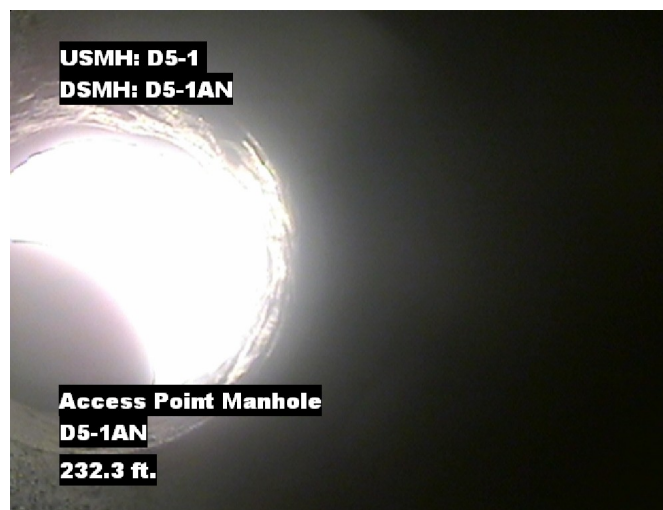
Distance: 232.3 ft. Grade: 0
Condition: Access Point Manhole
Remarks: D5-1A
