Defect Listing

Pipe Segment Refere... D5-1A_D4-4	City Oliver Springs	Street Forest Ave	Material Concrete Pipe (non-...	Location C... Light High...	Sewer Use Sanitary
Upstream MH D5-1A	Total Length 198.2	Year Laid	Shape Circular	Location Details	
DS Manhole D4-4	Length surveyed 198.2	Year Renewed	Height 8	Width 8	Pipe Joint... 4

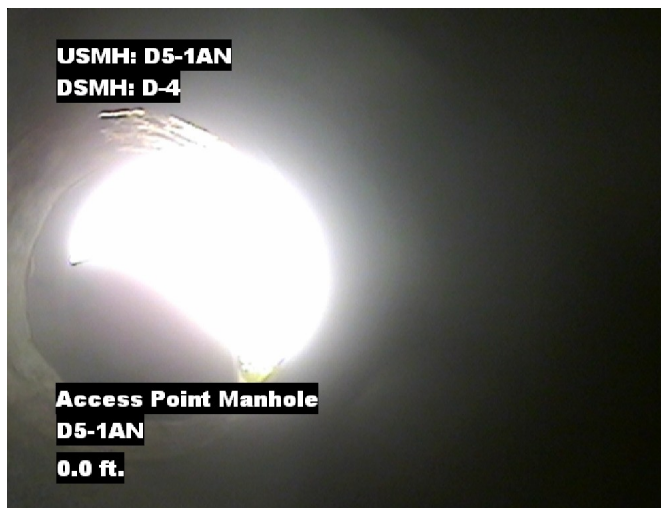
Distance: 0.0 ft. Grade: 0
Condition: Access Point Manhole
Remarks: D5-1A

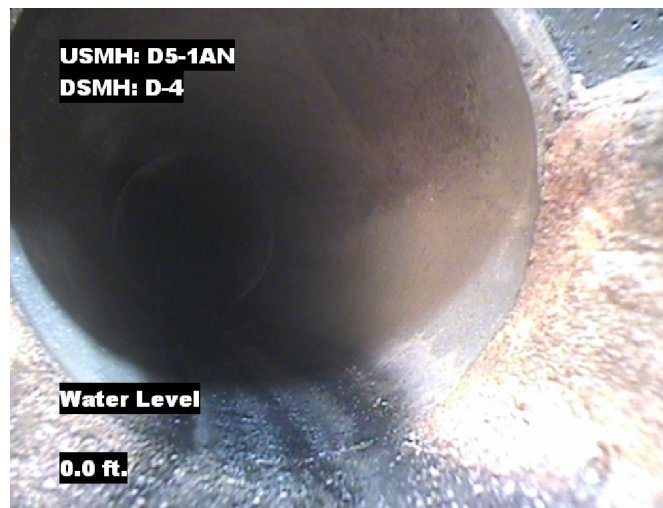
Distance: 0.0 ft. Grade: 0
Condition: Water Level
Remarks: N/A

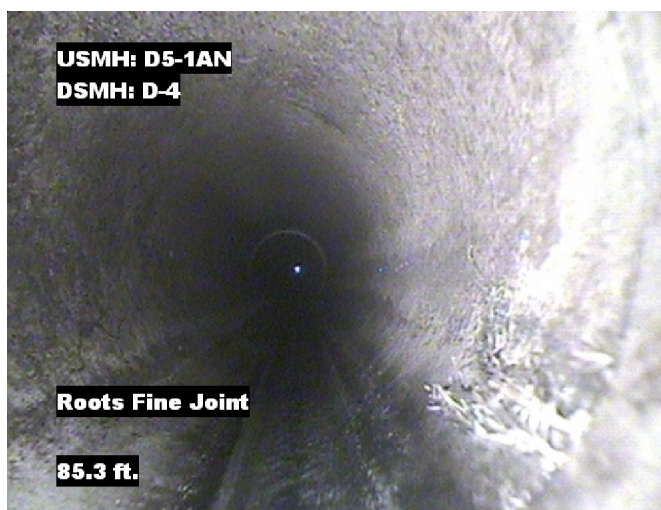
Distance: 85.3 ft. Grade: 1
Condition: Roots Fine Joint
Remarks: N/A

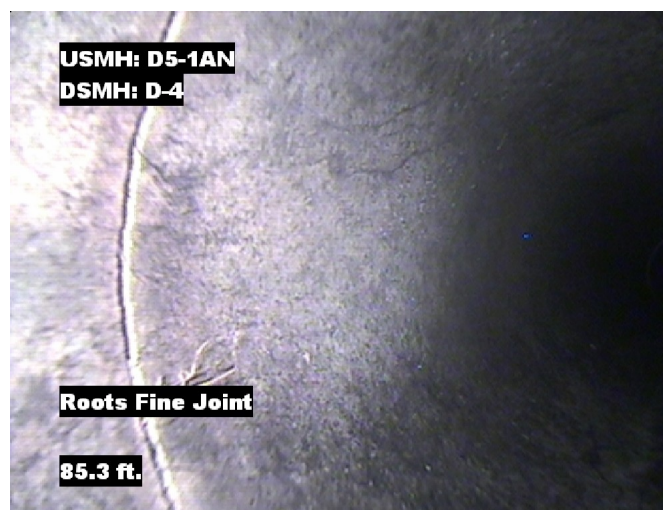
Distance: 85.3 ft. Grade: 1
Condition: Roots Fine Joint
Remarks: N/A

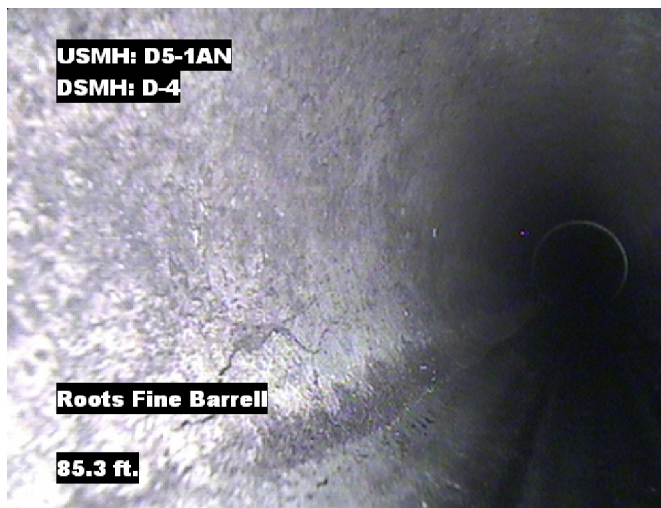
Distance: 85.3 ft. Grade: 2
Condition: Roots Fine Barrell
Remarks: N/A

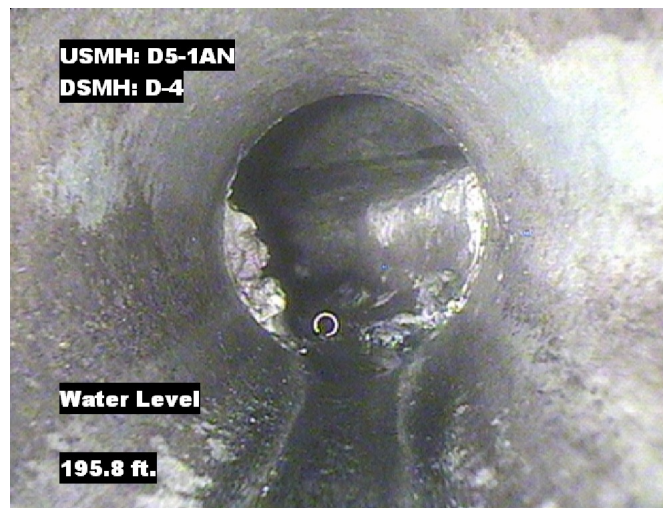
Distance: 195.7 ft. Grade: 0
Condition: Water Level
Remarks: N/A

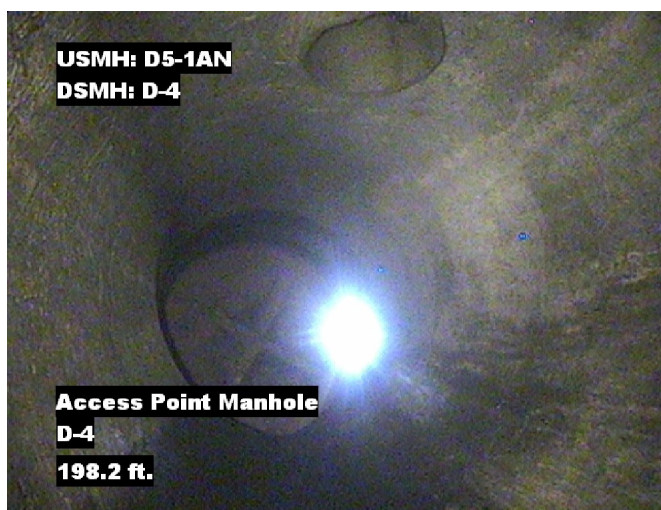
Distance: 198.2 ft. Grade: 0
Condition: Access Point Manhole
Remarks: D4-4
