## Defect Listing

Pipe Segment Refere...	City	Street	Material	Location C...	Sewer Use
D5-2 D5-1	Oliver Springs	Forest AVE	Concrete Pipe (non-...	Light High...	Sanitary
Upstream MH	Total Length	Year Laid	Shape	Location Details	
D5-2	304.6		Circular		
DS Manhole	Length surveyed	Year Renewed	Height	Width	Pipe Joint...
D5-1	304.6		8	8	4

SPR	26	MPR	9	PO Number	Customer
SPRI	2.9	MPRI	4.5	4397-03	GRW
QSR	5141	QMR	5141	Work Order	Purpose
				4397-02	Pre-Rehabilitation Survey
OPR		Surveyed By	Direction	Date	Media label
35		Barry Rogers	Downstream	20150629	
OPRI		Certificate Number	Pre-Cleaning	Time	Weather
3.2		U-1012-16405	Jetting	11:09	Dry
		Date Cleaned		End Time	Additional Info
		20150629		11:42

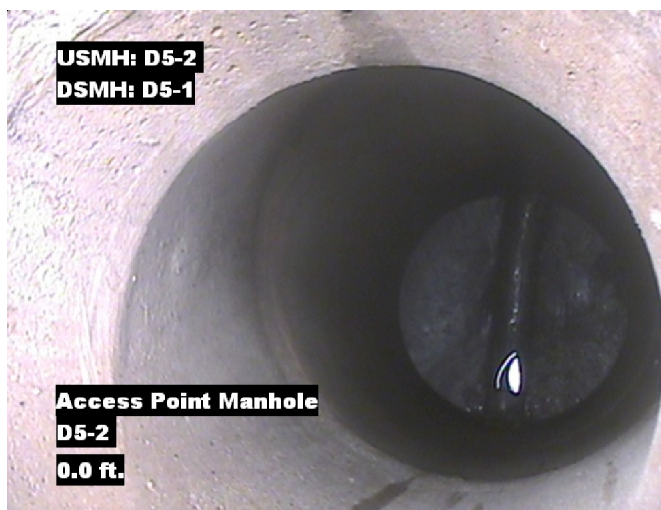
Distance: 0.0 ft. Grade: 0  
Condition: Access Point Manhole  
Remarks: D5-2

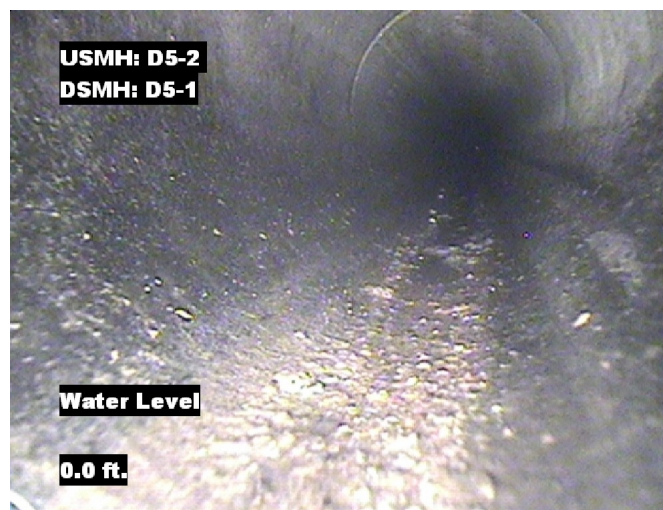
Distance: 0.0 ft. Grade: 0  
Condition: Water Level  
Remarks: N/A

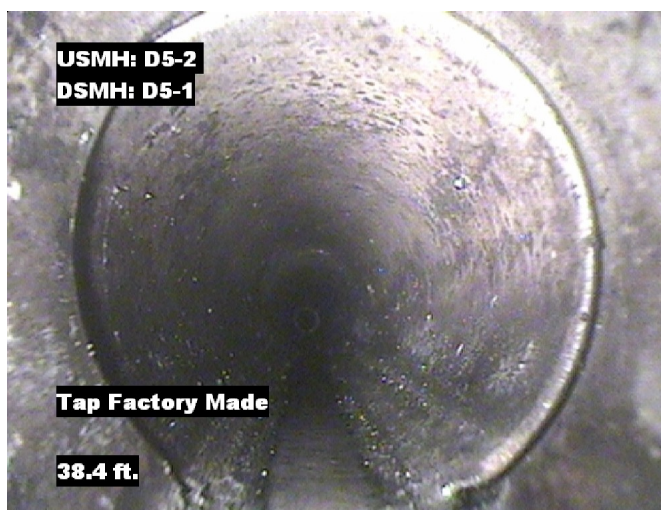
Distance: 38.4 ft. Grade: 0  
Condition: Tap Factory Made  
Remarks: N/A

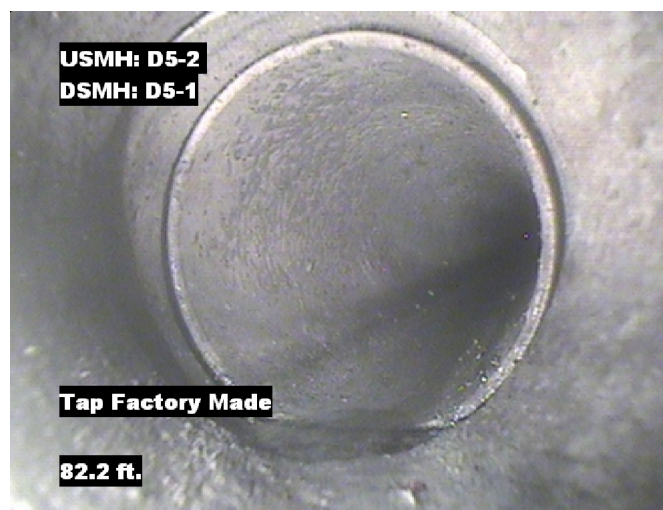
Distance: 82.2 ft. Grade: 0  
Condition: Tap Factory Made  
Remarks: N/A

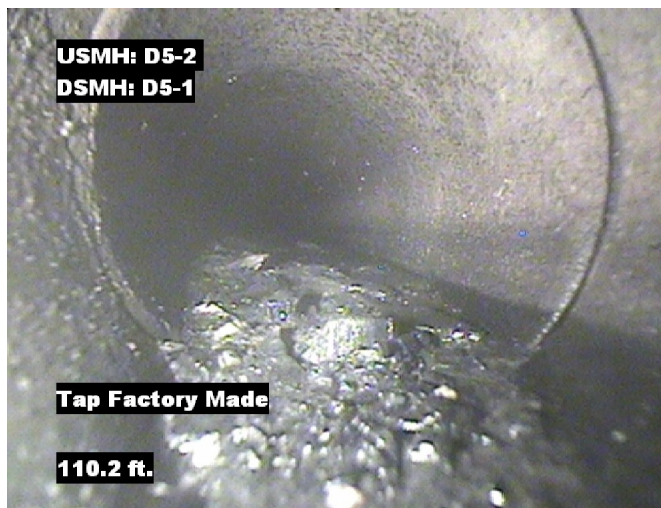
Distance: 110.2 ft. Grade: 0  
Condition: Tap Factory Made  
Remarks: N/A

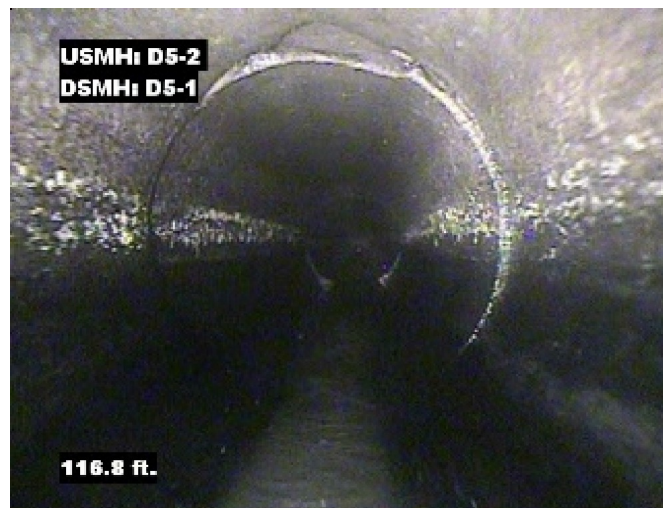
110.2 ft.	Tap Factory Made		6		0	<input type="checkbox"/>	9		
117.0 ft.	Fracture Circumferential					<input checked="" type="checkbox"/>	11	1	2
131.3 ft.	Hole				0	<input type="checkbox"/>	12		3

Distance: 117.0 ft. Grade: 2  
Condition: Fracture Circumferential  
Remarks: N/A

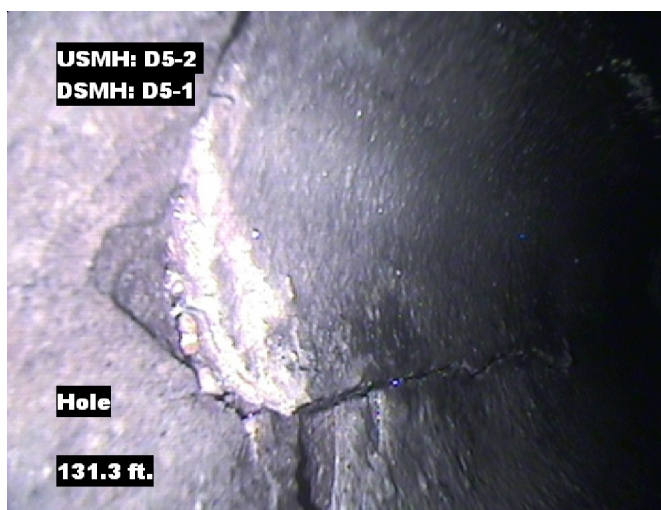
Distance: 131.3 ft. Grade: 3  
Condition: Hole  
Remarks: N/A

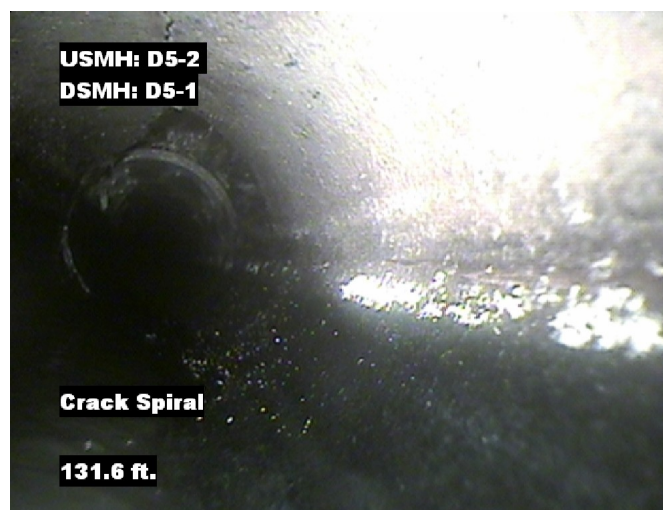
Distance: 131.6 ft. Grade: 2  
Condition: Crack Spiral  
Remarks: N/A

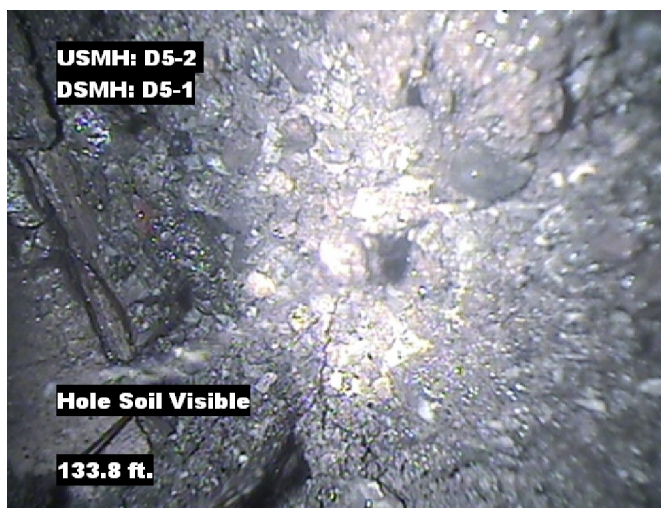
Distance: 133.8 ft. Grade: 5  
Condition: Hole Soil Visible  
Remarks: N/A

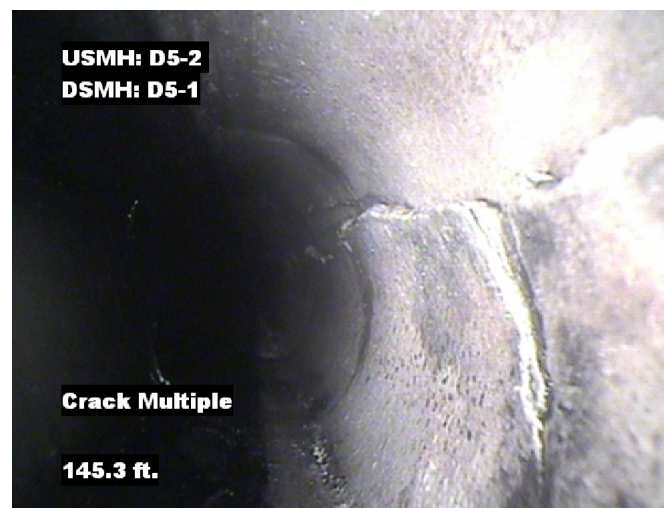
Distance: 145.3 ft. Grade: 3  
Condition: Crack Multiple  
Remarks: N/A

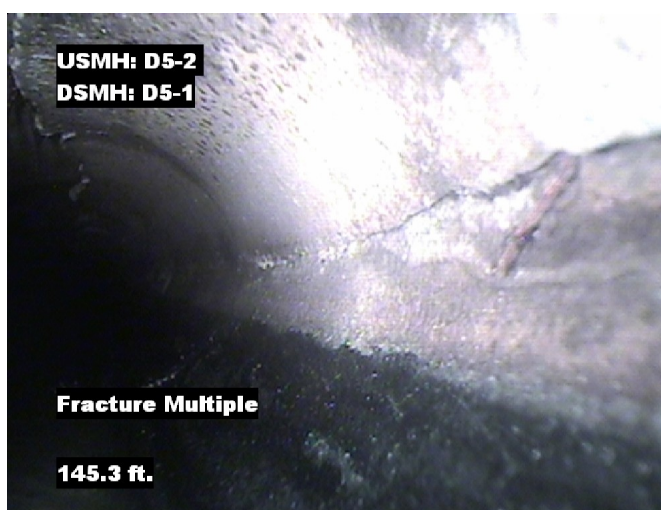
Distance: 145.3 ft. Grade: 4  
Condition: Fracture Multiple  
Remarks: N/A

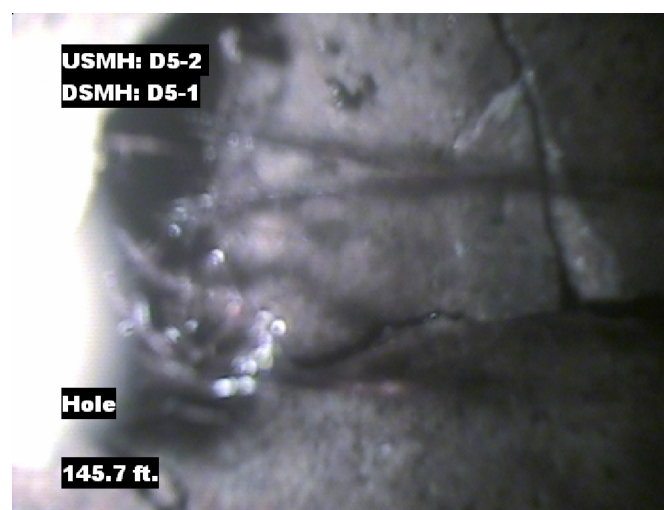
Distance: 145.7 ft. Grade: 3  
Condition: Hole  
Remarks: N/A

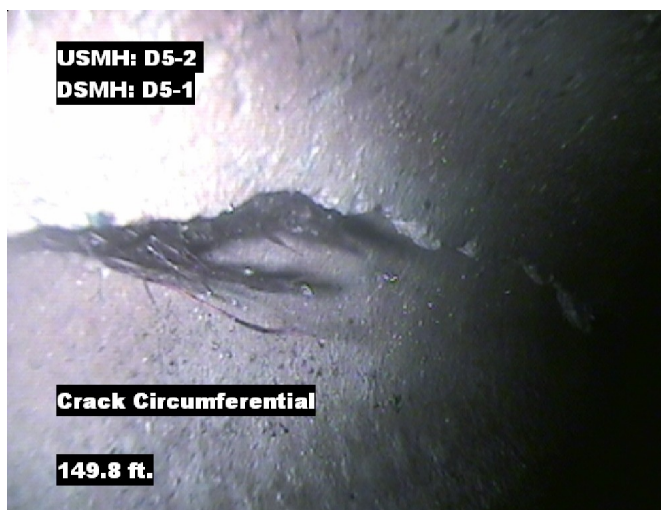
Distance: 149.8 ft. Grade: 1  
Condition: Crack Circumferential  
Remarks: N/A

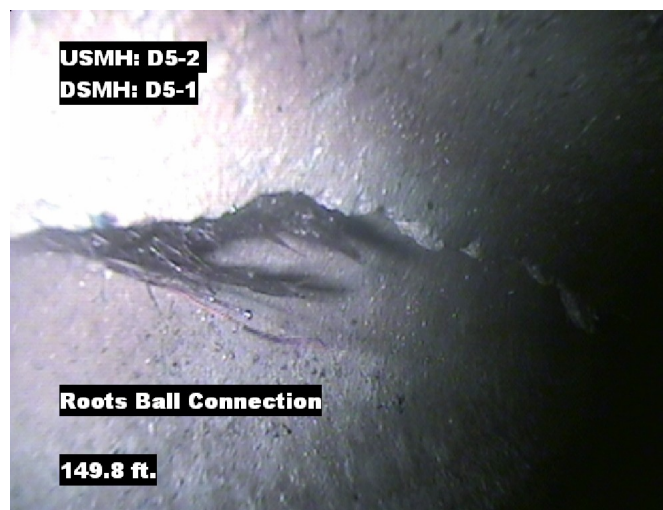
Distance: 149.8 ft. Grade: 4  
Condition: Roots Ball Connection  
Remarks: N/A

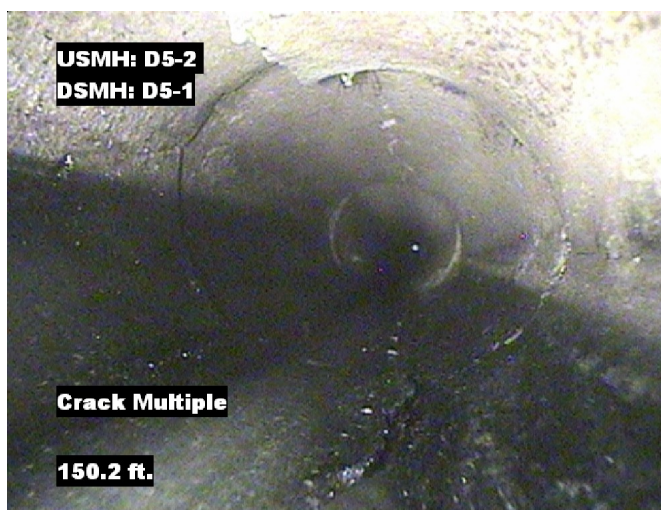
Distance: 150.2 ft. Grade: 3  
Condition: Crack Multiple  
Remarks: N/A

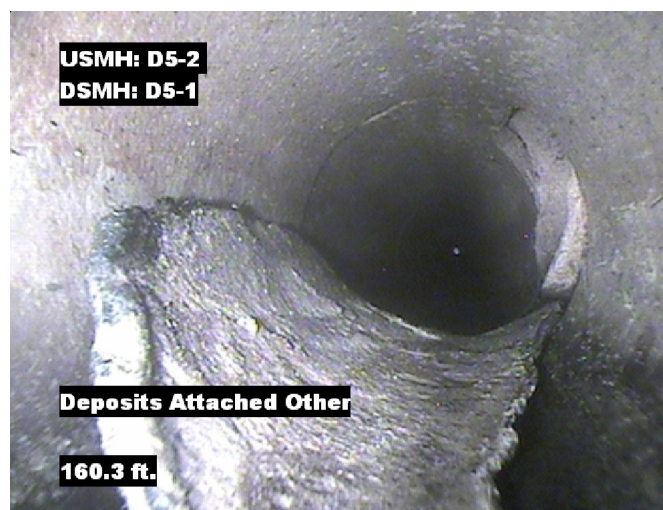
Distance: 160.3 ft. Grade: 5  
Condition: Deposits Attached Other  
Remarks: N/A

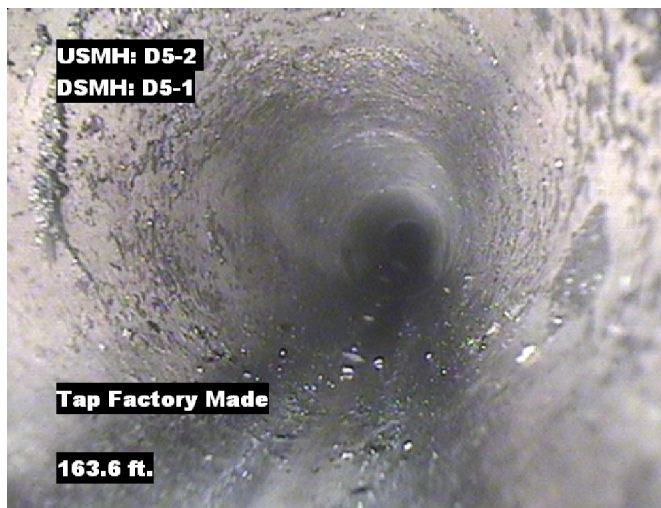
Distance: 163.6 ft. Grade: 0  
Condition: Tap Factory Made  
Remarks: N/A

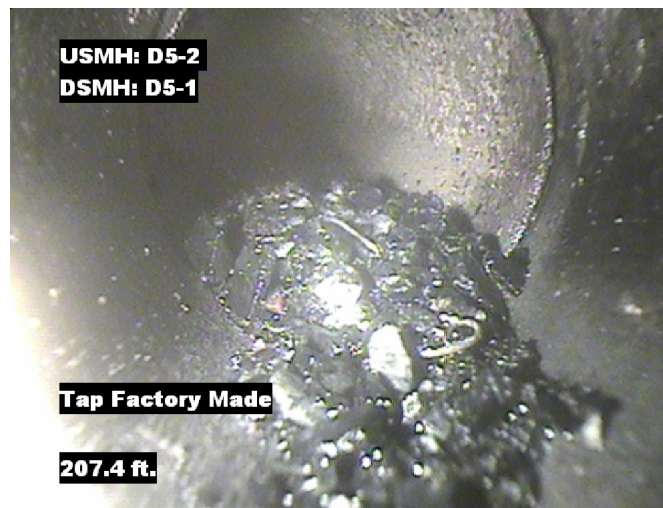
Distance: 207.4 ft. Grade: 0  
Condition: Tap Factory Made  
Remarks: N/A

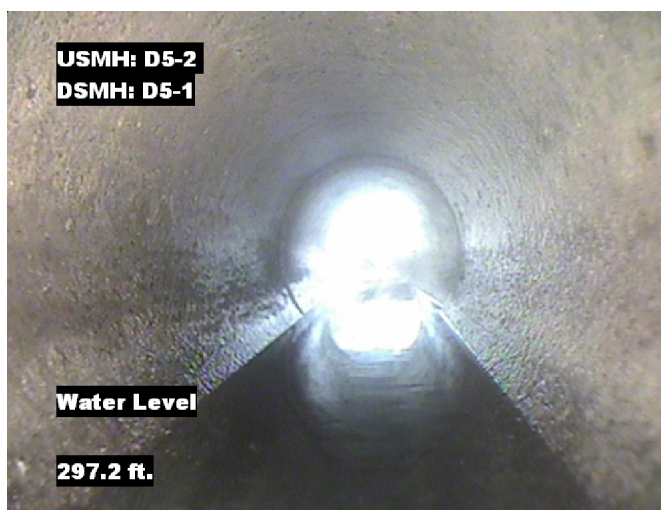
Distance: 297.2 ft. Grade: 0  
Condition: Water Level  
Remarks: N/A

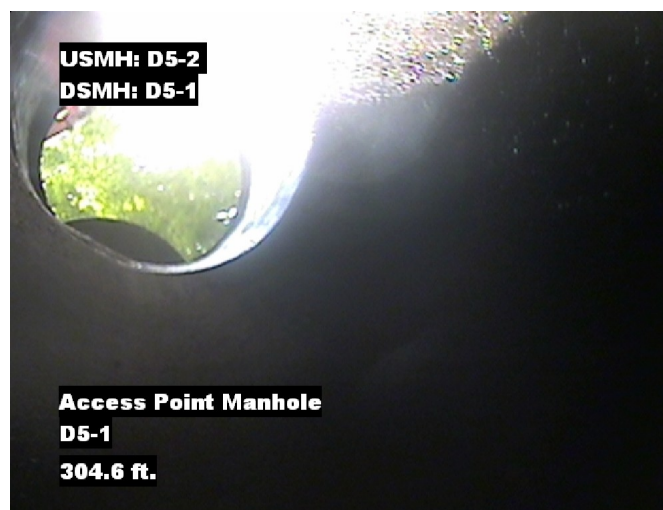
Distance: 304.6 ft. Grade: 0  
Condition: Access Point Manhole  
Remarks: D5-1
