## Defect Listing

Pipe Segment Refere... <b>D6-1_D-15</b>	City <b>Oliver Springs</b>	Street <b>Midway DR</b>	Material <b>Fibreglass Reinf...</b>	Location C... <b>Yard</b>	Sewer Use <b>Sanitary</b>
Upstream MH <b>D6-1</b>	Total Length <b>52.4</b>	Year Laid	Shape <b>Circular</b>	Location Details	
DS Manhole <b>D-15</b>	Length surveyed <b>52.4</b>	Year Renewed	Height <b>8</b>	Width <b>8</b>	Pipe Joint... <b>N/A</b>

SPR <b>N/A</b>	MPR <b>N/A</b>	PO Number <b>4397-03</b>		Customer <b>GRW</b>	
SPRI <b>N/A</b>	MPRI <b>N/A</b>	Work Order <b>4397-02</b>		Purpose <b>Pre-Rehabilitation Survey</b>	
QSR <b>N/A</b>	QMR <b>N/A</b>				
OPR <b>N/A</b>	Surveyed By <b>Barry Rogers</b>	Direction <b>Downstream</b>	Date <b>20150707</b>	Media label	
OPRI <b>N/A</b>	Certificate Number <b>U-1012-16405</b>	Pre-Cleaning <b>Jetting</b>	Time <b>07:27</b>	Weather <b>Dry</b>	
Date Cleaned <b>20150707</b>			End Time <b>07:34</b>	Additional Info

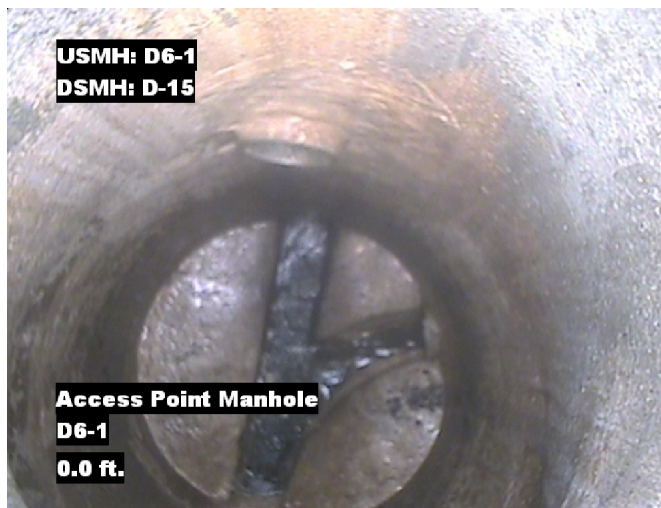
Distance: 0.0 ft. Grade: 0  
Condition: Access Point Manhole  
Remarks: D6-1

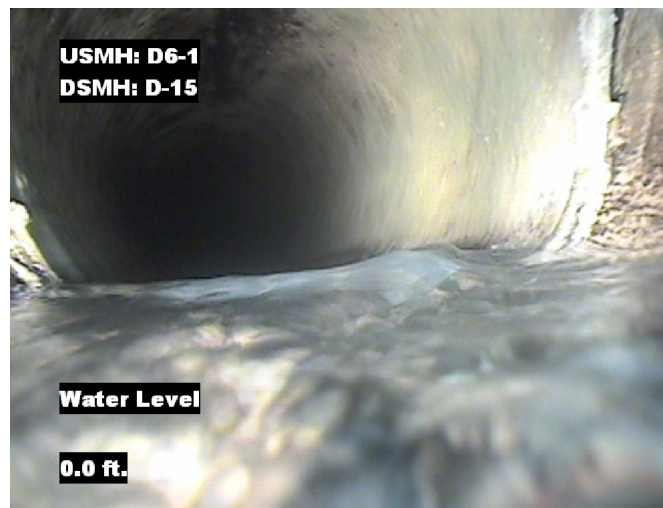
Distance: 0.0 ft. Grade: 0  
Condition: Water Level  
Remarks: N/A

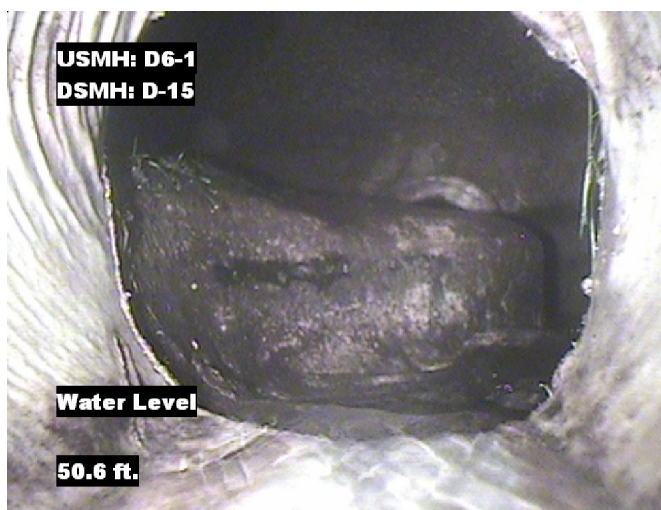
Distance: 50.6 ft. Grade: 0  
Condition: Water Level  
Remarks: N/A

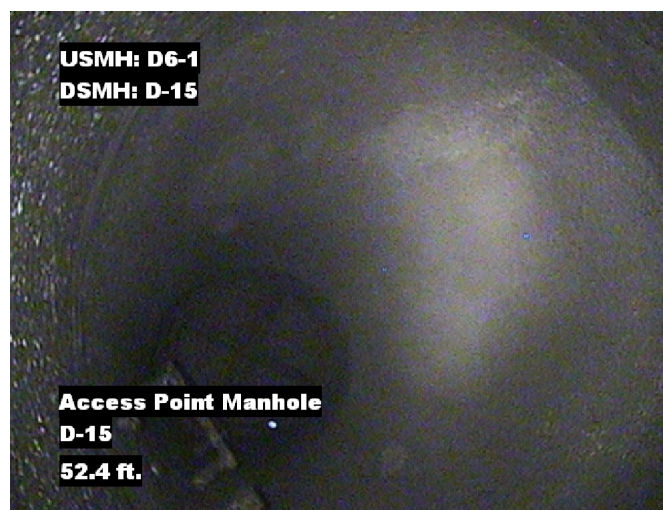
Distance: 52.4 ft. Grade: 0  
Condition: Access Point Manhole  
Remarks: D-15
