Defect Listing

Pipe Segment Refere... D6-2_D6-1	City Oliver Springs	Street Dale St	Material Concrete Pipe (non-...	Location C... Yard	Sewer Use Sanitary
Upstream MH D6-2	Total Length 296.9	Year Laid	Shape Circular	Location Details	
DS Manhole D6-1	Length surveyed 296.9	Year Renewed	Height 8	Width 8	Pipe Joint... 4

SPR 2	MPR 9	PO Number 4397-03	Customer GRW
SPRI 2	MPRI 3	Work Order 4397-02	Purpose Pre-Rehabilitation Survey
QSR 2100	QMR 4131		
OPR 11	Surveyed By Barry Rogers	Direction Downstream	Date 20150707
OPRI 2.8	Certificate Number U-1012-16405	Pre-Cleaning Jetting	Time 12:29
	Date Cleaned 20150707	End Time 12:52	Weather Dry
			Media label
			Additional Info

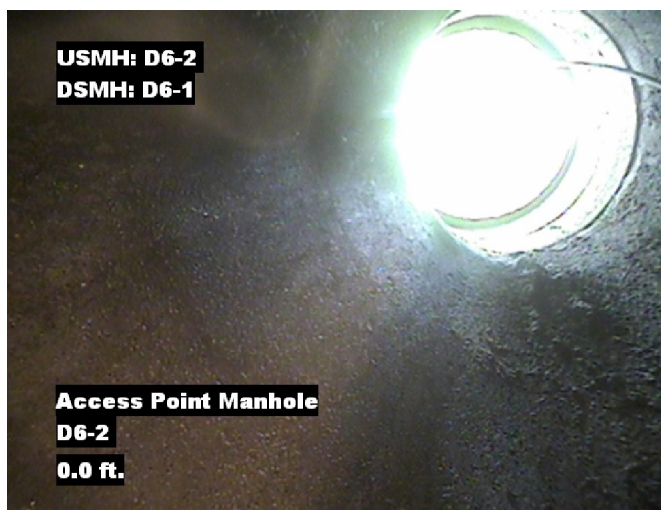
Distance: 0.0 ft. Grade: 0
Condition: Access Point Manhole
Remarks: D6-2

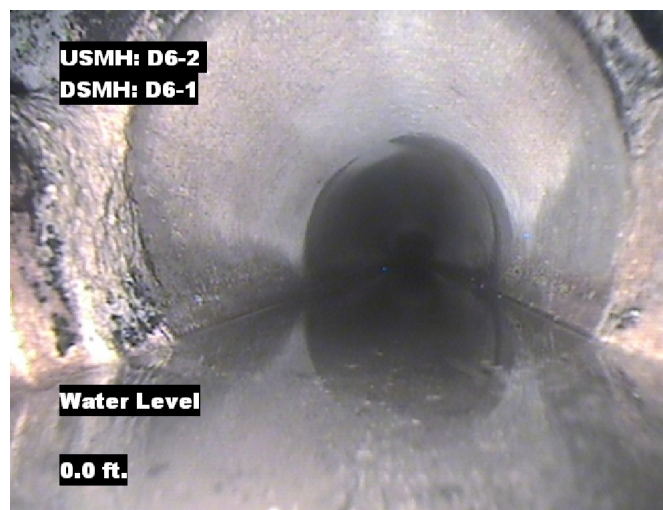
Distance: 0.0 ft. Grade: 0
Condition: Water Level
Remarks: N/A

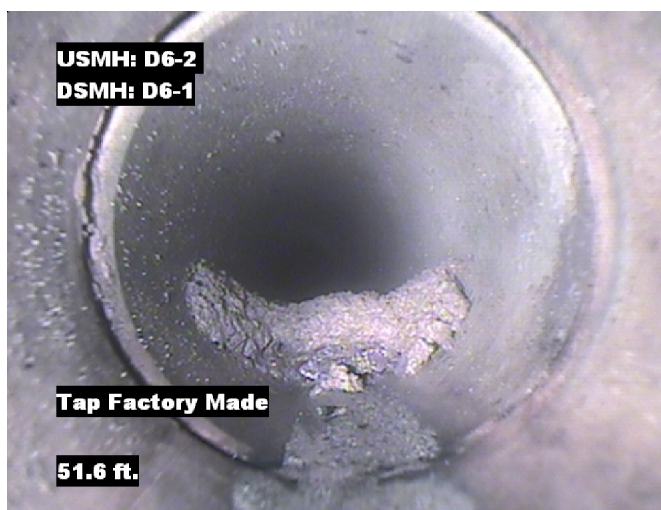
Distance: 51.6 ft. Grade: 0
Condition: Tap Factory Made
Remarks: N/A

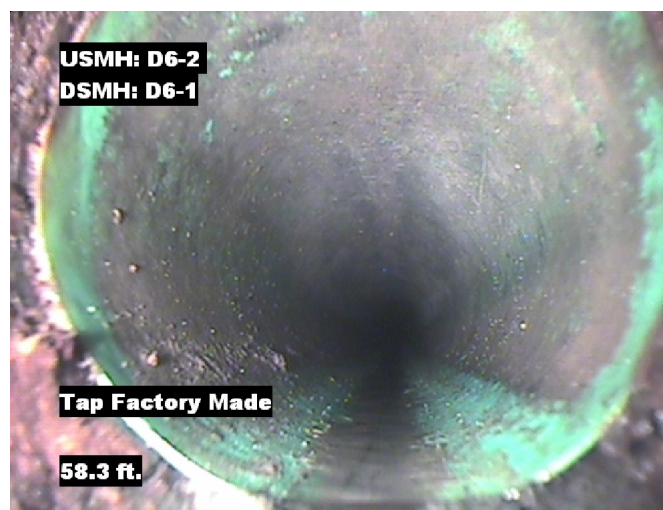
Distance: 58.3 ft. Grade: 0
Condition: Tap Factory Made
Remarks: N/A

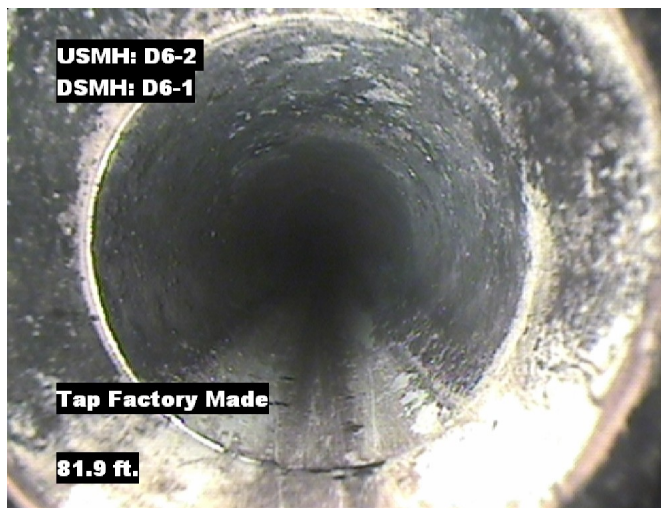
Distance: 81.9 ft. Grade: 0
Condition: Tap Factory Made
Remarks: N/A

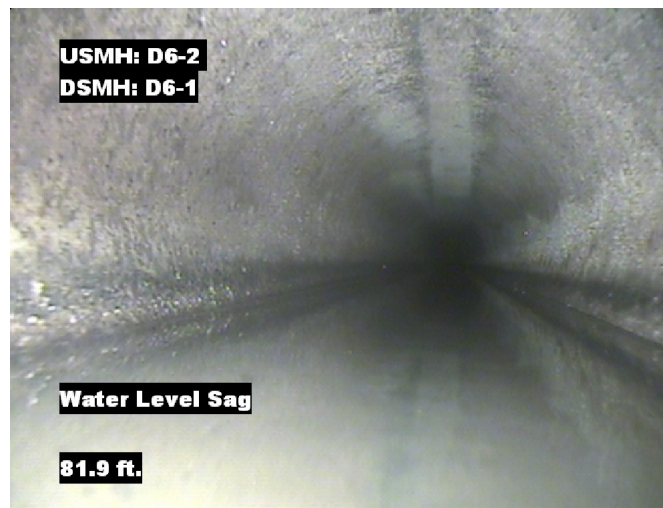
Distance: 81.9 ft. Grade: 2
Condition: Water Level Sag
Remarks: N/A

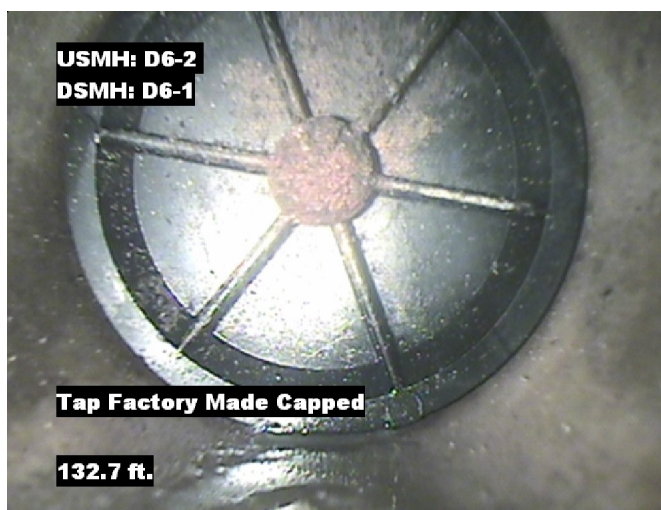
Distance: 132.7 ft. Grade: 0
Condition: Tap Factory Made Capped
Remarks: N/A

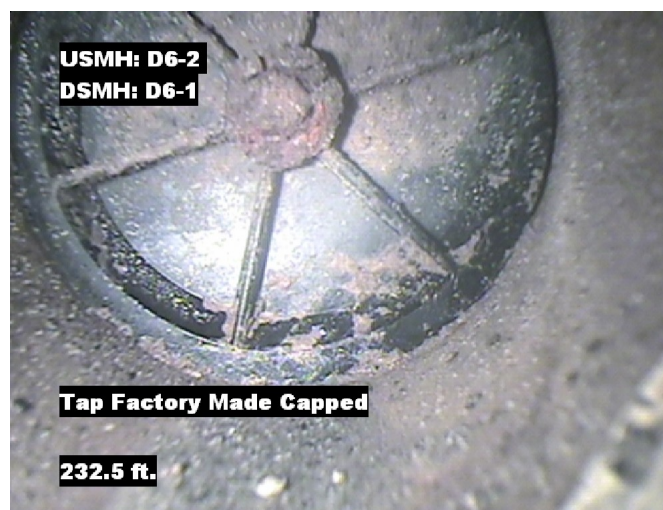
Distance: 232.5 ft. Grade: 0
Condition: Tap Factory Made Capped
Remarks: N/A

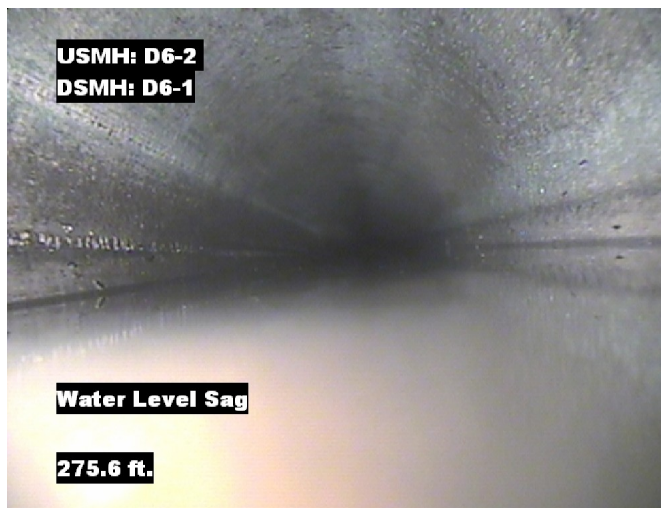
Distance: 275.6 ft. Grade: 3
Condition: Water Level Sag
Remarks: N/A

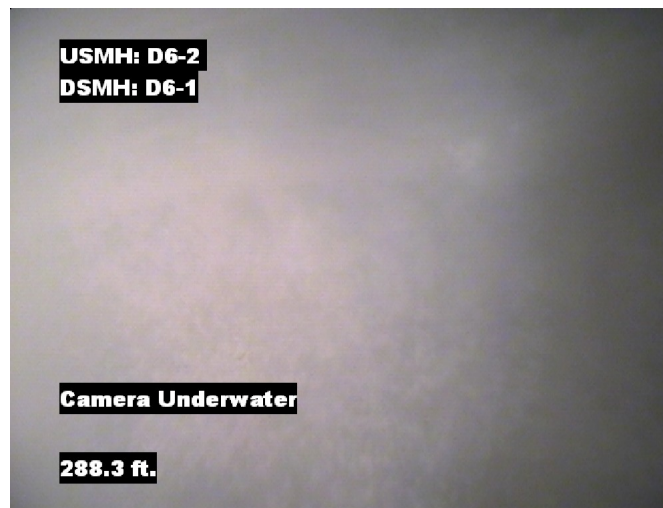
Distance: 288.3 ft. Grade: 4
Condition: Camera Underwater
Remarks: N/A

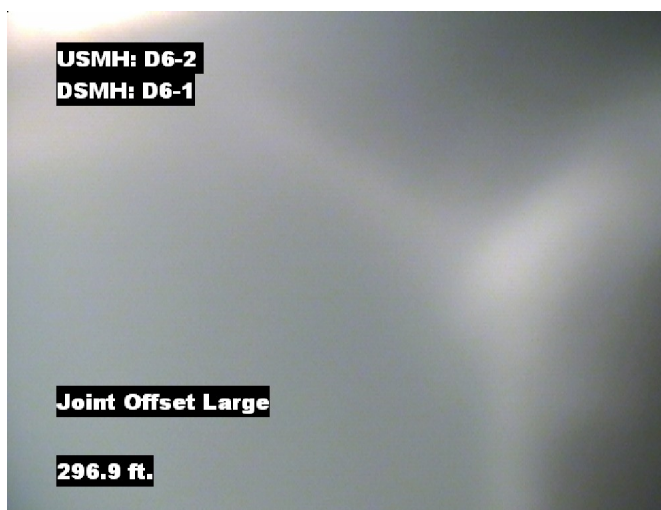
Distance: 296.9 ft. Grade: 2
Condition: Joint Offset Large
Remarks: N/A

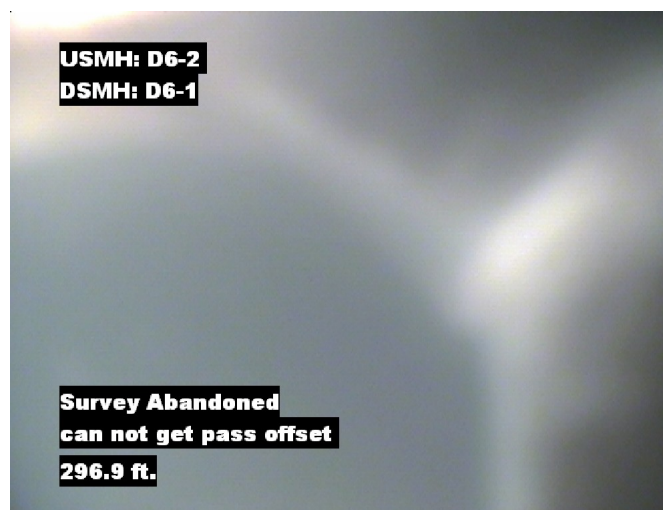
Distance: 296.9 ft. Grade: 0
Condition: Survey Abandoned
Remarks: can not get pass offset
