Defect Listing

Pipe Segment Refere... D6-3_D6-2	City Oliver Springs	Street Dale St	Material Concrete Pipe (non-...	Location C... Yard	Sewer Use Sanitary
Upstream MH D6-3	Total Length 288.2	Year Laid	Shape Circular	Location Details	
DS Manhole D6-2	Length surveyed 288.2	Year Renewed	Height 8	Width 8	Pipe Joint... 4

SPR N/A	MPR 5	PO Number 4397-03	Customer GRW
SPRI N/A	MPRI 5	Work Order 4397-02	Purpose Pre-Rehabilitation Survey
QSR N/A	QMR 5100		
OPR 5	Surveyed By Barry Rogers	Direction Downstream	Date 20150706
OPRI 5	Certificate Number U-1012-16405	Pre-Cleaning Jetting	Time 13:07
	Date Cleaned 20150706	End Time 13:20	Weather Dry
			Additional Info

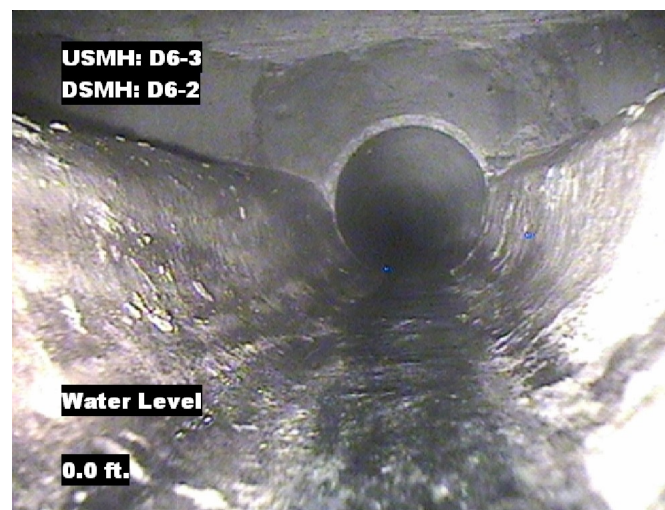
Distance: 0.0 ft. Grade: 0
Condition: Water Level
Remarks: N/A

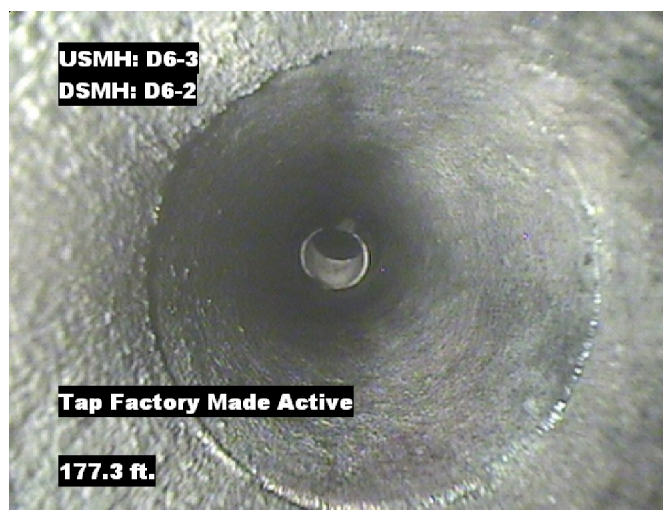
Distance: 177.3 ft. Grade: 0
Condition: Tap Factory Made Active
Remarks: N/A

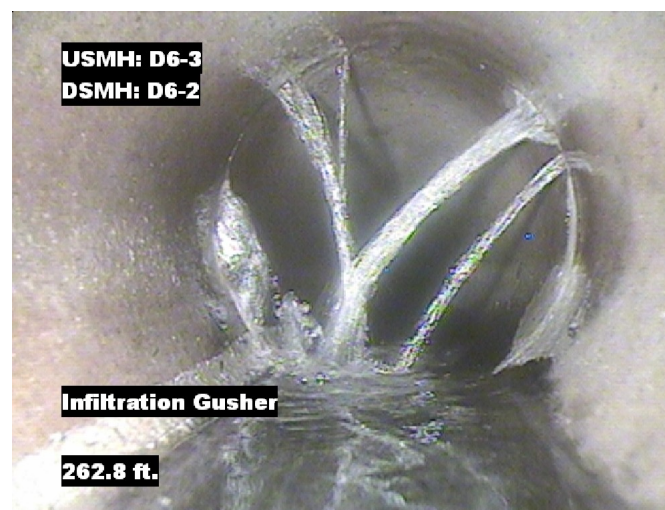
Distance: 262.8 ft. Grade: 5
Condition: Infiltration Gusher
Remarks: N/A

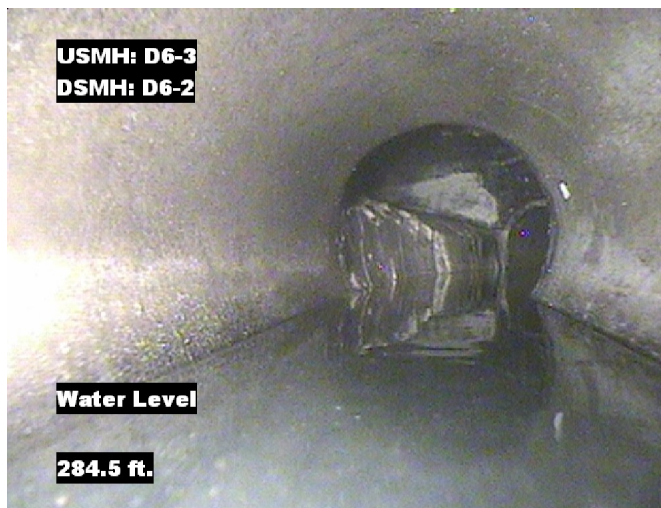
Distance: 284.5 ft. Grade: 0
Condition: Water Level
Remarks: N/A
