Defect Listing

Pipe Segment Refere		City		Street	Mat	erial	Location C	Sewer Use	
D6-4_	_D6-3	Oliver	Springs	Dale St	Concrete P	Concrete Pipe (non		Sanitary	
Upstre	Upstream MH Tota		Length	Year Laid	Sha	Shape		n Details	
De	6-4	21	3.6		Circ	ular			
DS Ma	anhole	Length s	surveyed	Year Renewed	Height	Width	Pipe Joint		
De	6-3	213.6			8	8	4		
SPR	N/A	MPR	4	PO Number			Customer		
0001	-	MDDI		4397-03			GRW		
SPRI	N/A	MPRI	4	Work Order		Purpose			
QSR	N/A	QMR	4100	4397-02		Pre-Rehabilitation Survey			
O	PR	Surve	yed By	Direction	Date Media I		a label		
4	1	Barry_Rogers		Downstream	2015	20150706			
OF	PRI	Certificate Number		Pre-Cleaning	Time		Weather		
4		U-1012-16405		Jetting	12:49		Dry		
	•	Date C	Cleaned		End	End Time		Additional Info	
		2015	60706		13:	:02

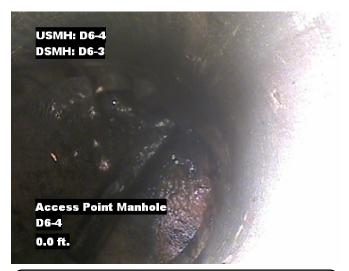
Distance: 0.0 ft. Grade: 0

Condition: Access Point Manhole

Remarks: D6-4

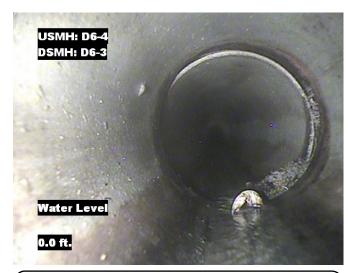
Distance: 0.0 ft. Grade: (

Condition: Water Level

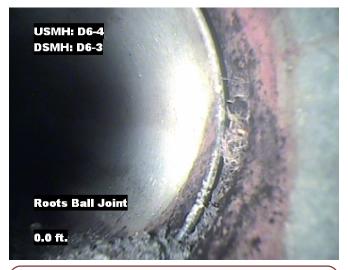
Distance: 4.0 ft. Grade: 4

Condition: Roots Ball Joint

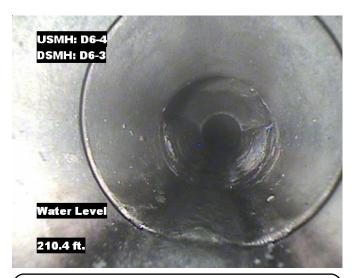
Distance: 210.4 ft. Grade: 0

Condition: Water Level

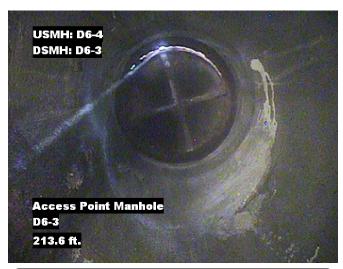
Distance: 213.6 ft. Grade: 0

Condition: Access Point Manhole

Remarks: D6-3
