Defect Listing

Pipe Segment Refere...	City	Street	Material	Location C...	Sewer Use
D6-5_D6-4	Oliver Springs	Dale St	Concrete Pipe (non-...	Light High...	Sanitary
Upstream MH	Total Length	Year Laid	Shape	Location Details	
D6-5	373.9		Circular		
DS Manhole	Length surveyed	Year Renewed	Height	Width	Pipe Joint...
D6-4	373.9		8	8	4

SPR	5	MPR	N/A	PO Number	Customer
SPRI	2.5	MPRI	N/A	4397-03	GRW
QSR	4111	QMR	N/A	Work Order	Purpose
				4397-02	Pre-Rehabilitation Survey
OPR		Surveyed By	Direction	Date	Media label
5		Barry Rogers	Downstream	20150706	
OPRI		Certificate Number	Pre-Cleaning	Time	Weather
2.5		U-1012-16405	Jetting	09:58	Dry
Date Cleaned				End Time	Additional Info
20150706				10:21

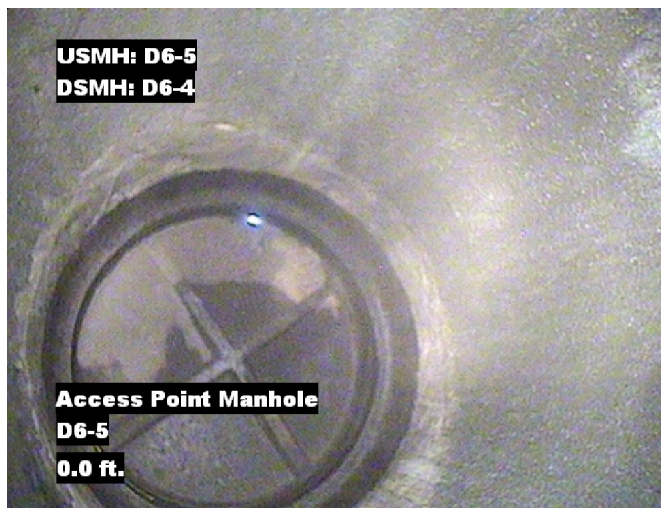
Distance: 0.0 ft. Grade: 0
Condition: Access Point Manhole
Remarks: D6-5

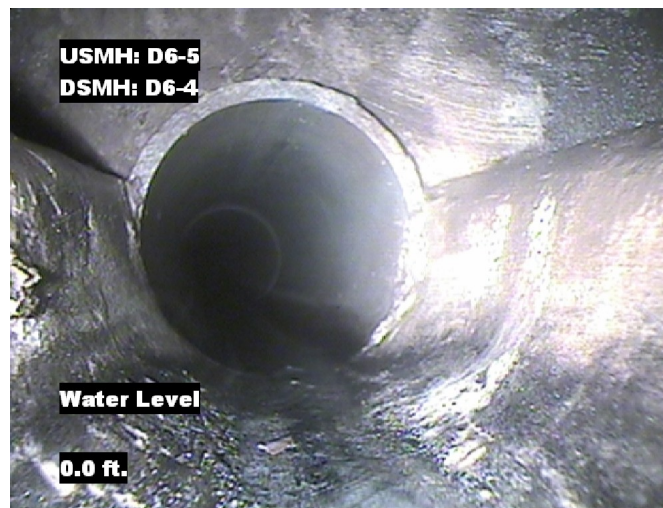
Distance: 0.0 ft. Grade: 0
Condition: Water Level
Remarks: N/A

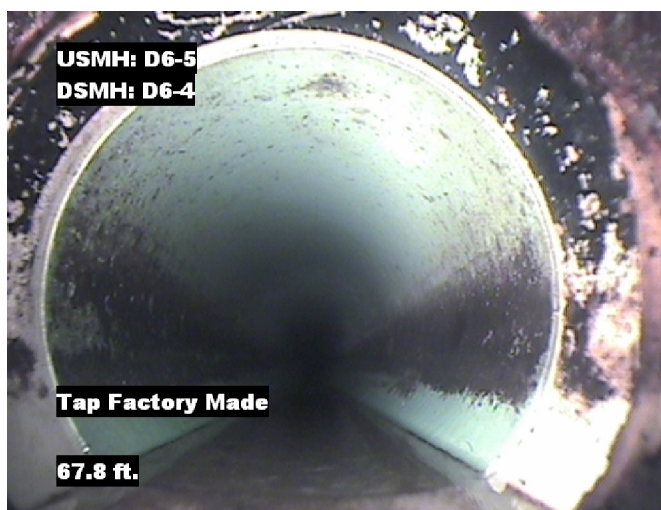
Distance: 67.8 ft. Grade: 0
Condition: Tap Factory Made
Remarks: N/A

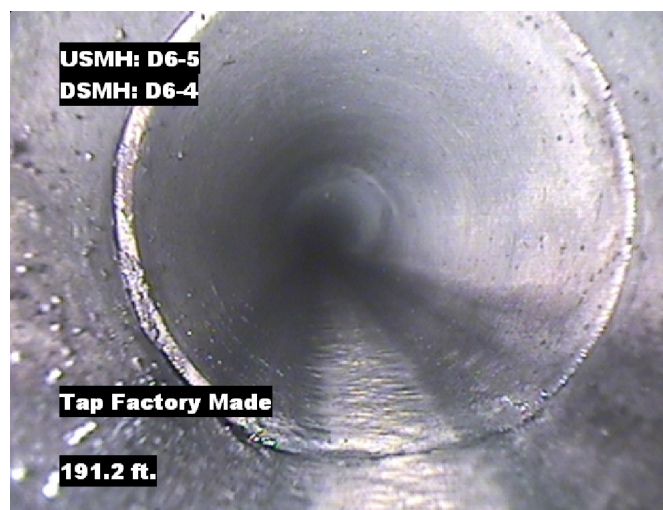
Distance: 191.2 ft. Grade: 0
Condition: Tap Factory Made
Remarks: N/A

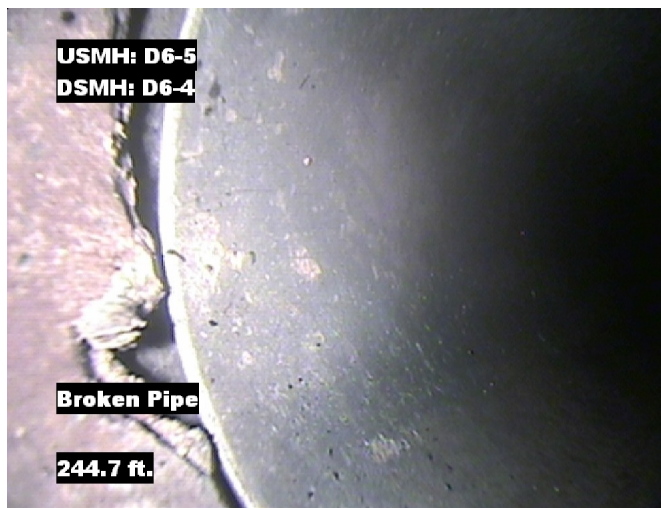
Distance: 244.7 ft. Grade: 4
Condition: Broken Pipe
Remarks: N/A

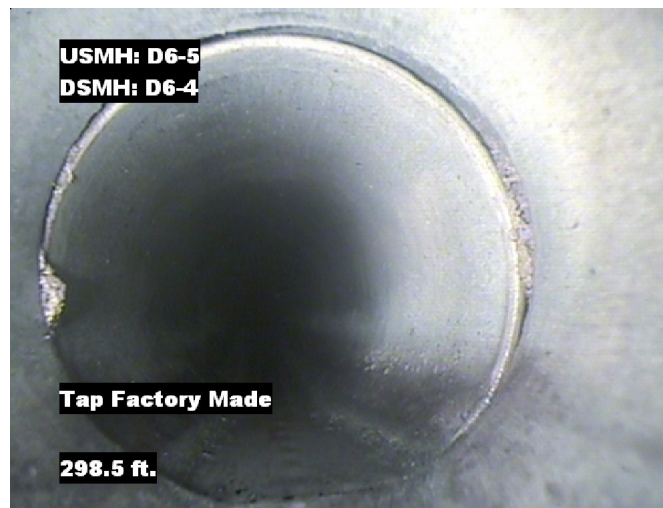
Distance: 298.5 ft. Grade: 0
Condition: Tap Factory Made
Remarks: N/A

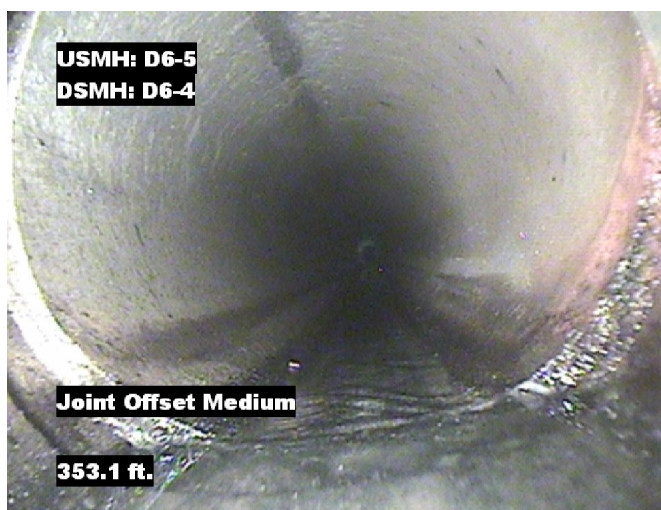
Distance: 353.1 ft. Grade: 1
Condition: Joint Offset Medium
Remarks: N/A

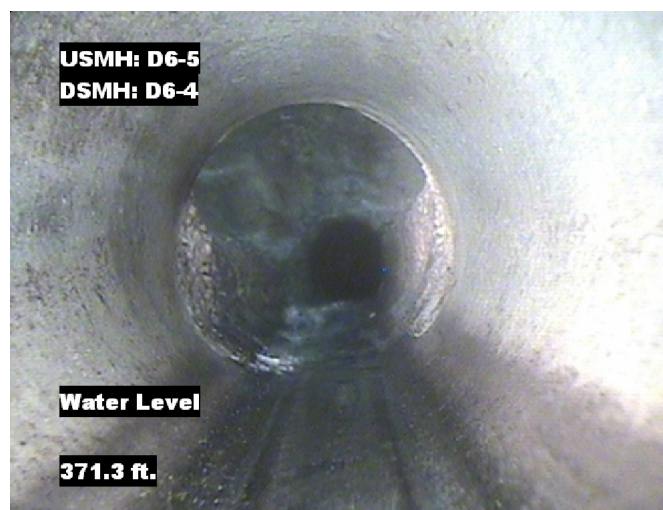
Distance: 371.3 ft. Grade: 0
Condition: Water Level
Remarks: N/A

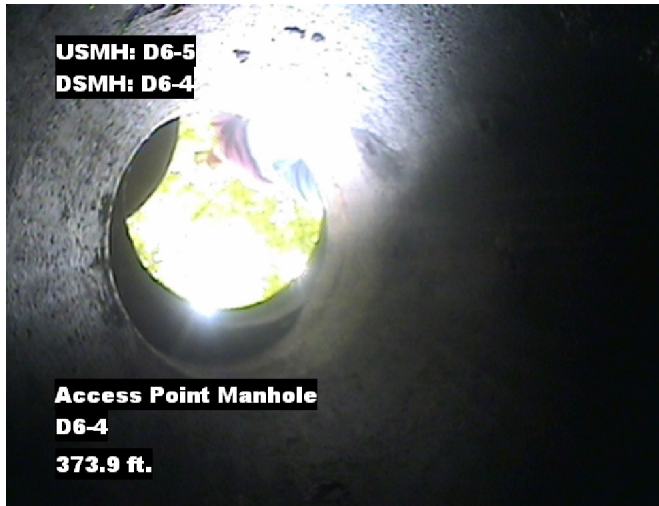
Distance: 373.9 ft. Grade: 0
Condition: Access Point Manhole
Remarks: D6-4
