Defect Listing

Pipe Segment Refere...	City	Street	Material	Location C...	Sewer Use
D6-6_D6-5	Oliver Springs	Dale st	Concrete Pipe (non-...	Light High...	Sanitary
Upstream MH	Total Length	Year Laid	Shape	Location Details	
D6-6	194.1		Circular		
DS Manhole	Length surveyed	Year Renewed	Height	Width	Pipe Joint...
D6-5	194.1		8	8	4

SPR	N/A	MPR	2	PO Number	Customer
SPRI	N/A	MPRI	2	4397-03	GRW
QSR	N/A	QMR	2100	Work Order	Purpose
				4397-02	Pre-Rehabilitation Survey
OPR	Surveyed By	Direction	Date	Media label	
2	Barry Rogers	Downstream	20150706		
OPRI	Certificate Number	Pre-Cleaning	Time	Weather	
2	U-1012-16405	Jetting	09:40	Dry	
Date Cleaned			End Time	Additional Info	
20150706			09:53

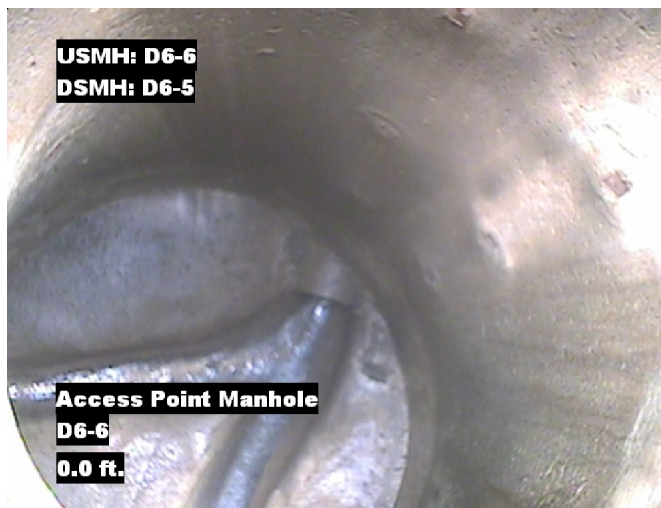
Distance: 0.0 ft. Grade: 0
Condition: Access Point Manhole
Remarks: D6-6

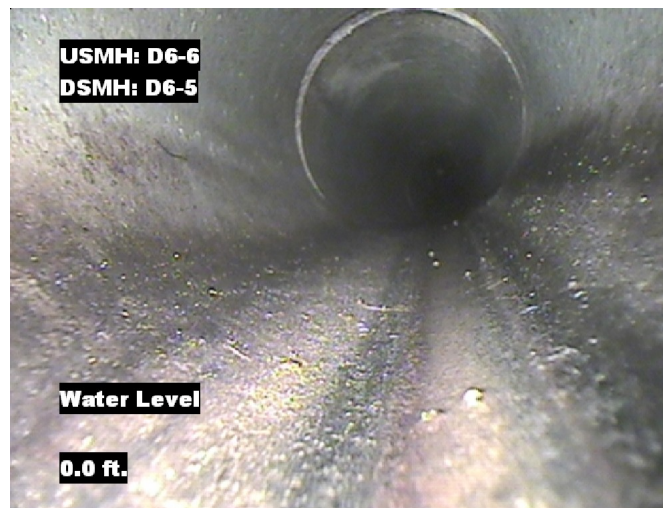
Distance: 0.0 ft. Grade: 0
Condition: Water Level
Remarks: N/A

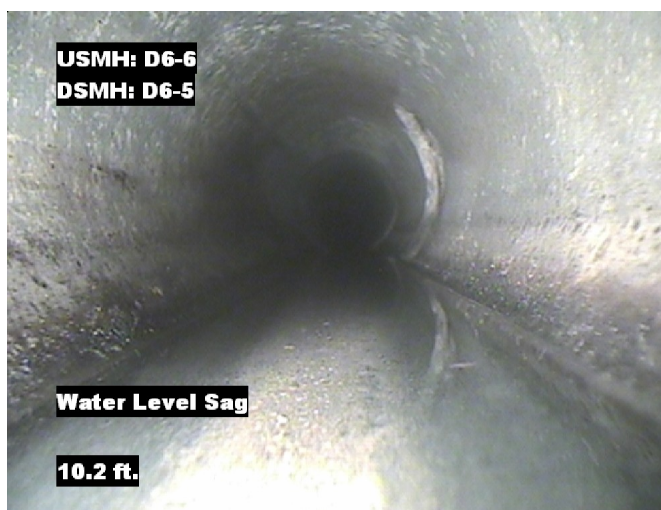
Distance: 10.2 ft. Grade: 2
Condition: Water Level Sag
Remarks: N/A

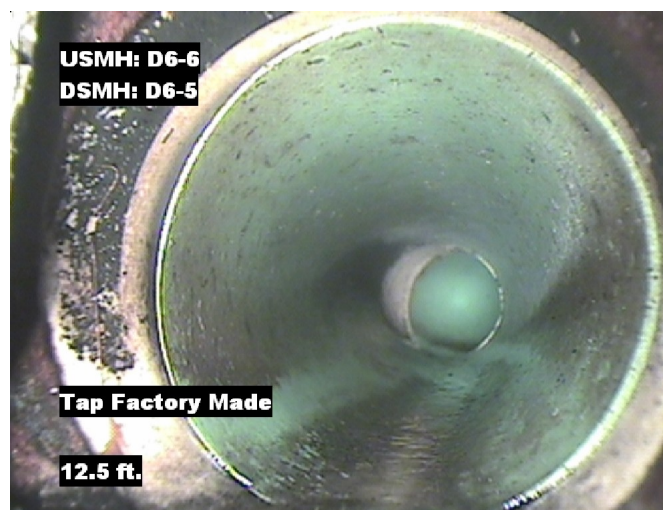
Distance: 12.5 ft. Grade: 0
Condition: Tap Factory Made
Remarks: N/A

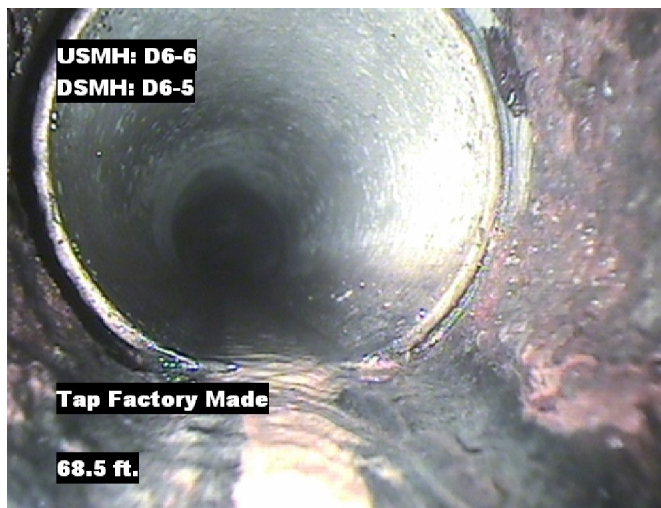
Distance: 68.5 ft. Grade: 0
Condition: Tap Factory Made
Remarks: N/A

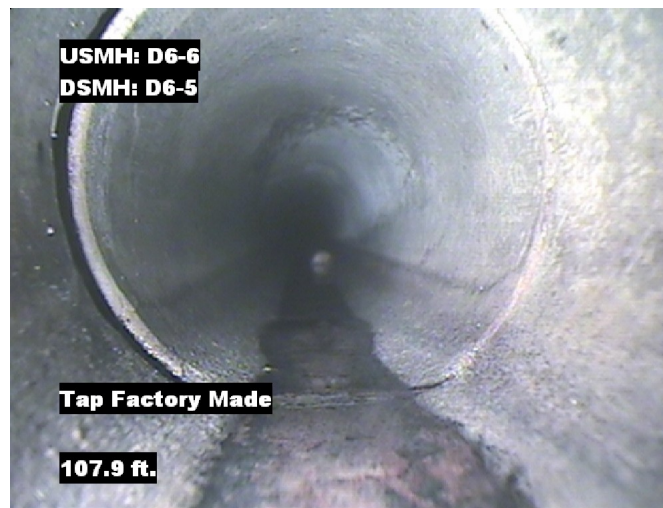
Distance: 107.9 ft. Grade: 0
Condition: Tap Factory Made
Remarks: N/A

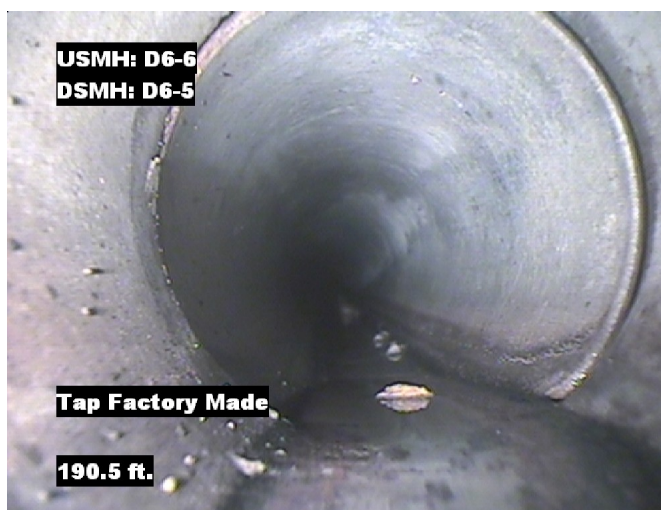
Distance: 190.5 ft. Grade: 0
Condition: Tap Factory Made
Remarks: N/A

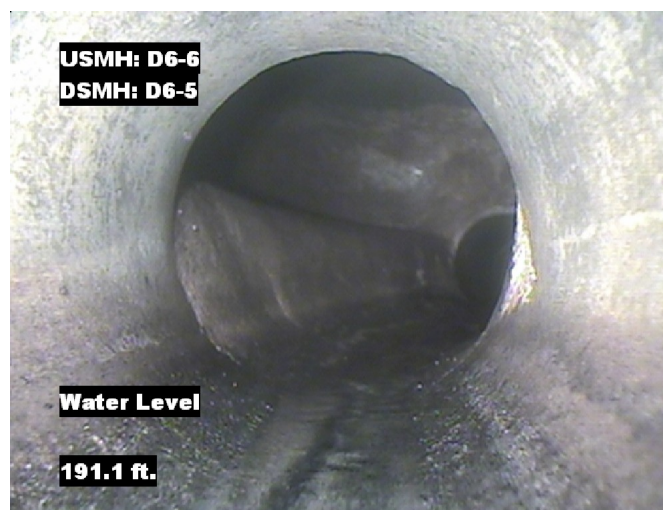
Distance: 191.1 ft. Grade: 0
Condition: Water Level
Remarks: N/A

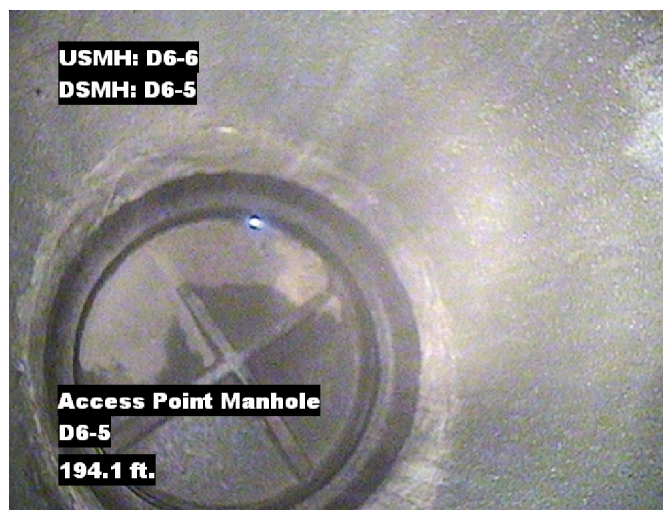
Distance: 194.1 ft. Grade: 0
Condition: Access Point Manhole
Remarks: D6-5
