## Defect Listing

Pipe Segment Refere... <b>D7-1_D6-4</b>	City <b>Oliver Springs</b>	Street <b>Dale St</b>	Material <b>Concrete Pipe (non-...</b>	Location C... <b>Light High...</b>	Sewer Use <b>Sanitary</b>
Upstream MH <b>D7-1</b>	Total Length <b>224.2</b>	Year Laid	Shape <b>Circular</b>	Location Details	
DS Manhole <b>D6-4</b>	Length surveyed <b>224.2</b>	Year Renewed	Height <b>8</b>	Width <b>8</b>	Pipe Joint... <b>4</b>

SPR <b>N/A</b>	MPR <b>N/A</b>	PO Number <b>4397-03</b>		Customer <b>GRW</b>	
SPRI <b>N/A</b>	MPRI <b>N/A</b>	Work Order <b>4397-02</b>		Purpose <b>Pre-Rehabilitation Survey</b>	
QSR <b>N/A</b>	QMR <b>N/A</b>				
OPR <b>N/A</b>	Surveyed By <b>Barry Rogers</b>	Direction <b>Downstream</b>	Date <b>20150706</b>	Media label	
OPRI <b>N/A</b>	Certificate Number <b>U-1012-16405</b>	Pre-Cleaning <b>Jetting</b>	Time <b>11:00</b>	Weather <b>Dry</b>	
Date Cleaned <b>20150706</b>			End Time <b>11:13</b>	Additional Info

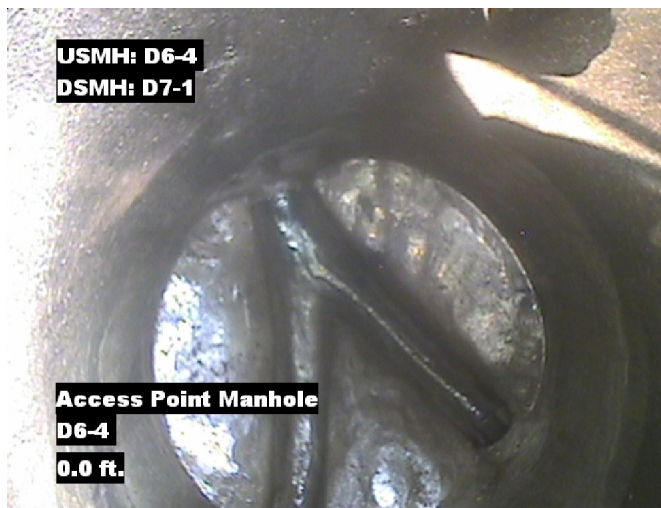
Distance: 0.0 ft. Grade: 0  
Condition: Access Point Manhole  
Remarks: D6-4

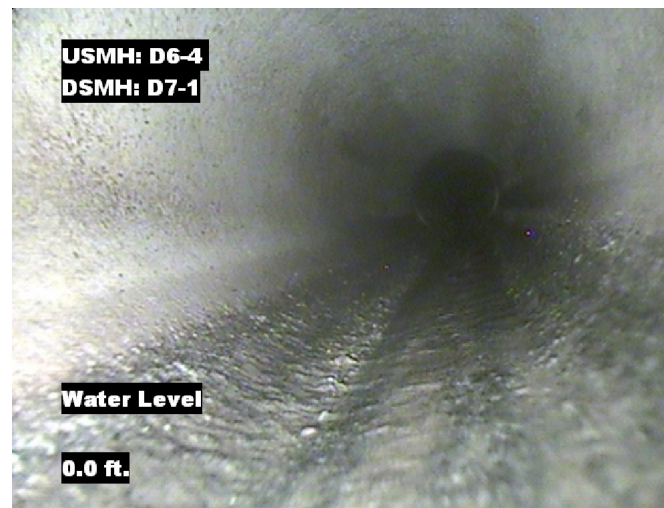
Distance: 0.0 ft. Grade: 0  
Condition: Water Level  
Remarks: N/A

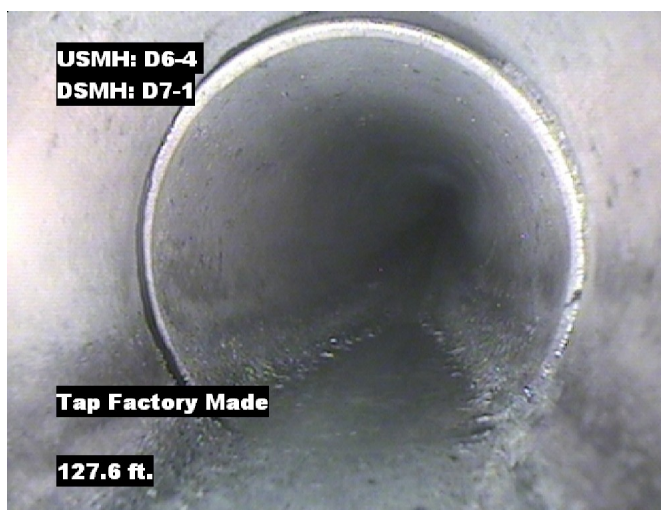
Distance: 127.6 ft. Grade: 0  
Condition: Tap Factory Made  
Remarks: N/A

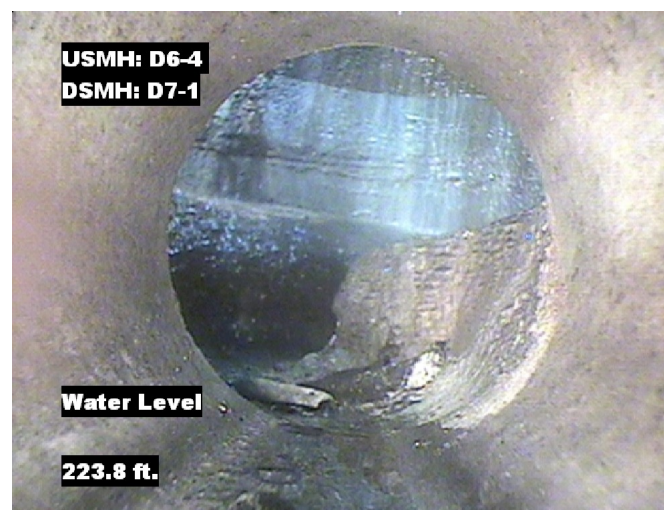
Distance: 223.8 ft. Grade: 0  
Condition: Water Level  
Remarks: N/A

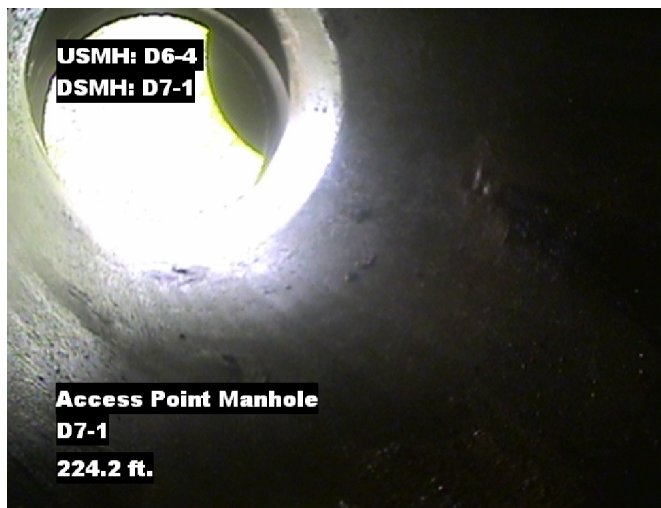
Distance: 224.2 ft. Grade: 0  
Condition: Access Point Manhole  
Remarks: D7-1
