Defect Listing

Pipe Segment Refere... D8-1_D8-1A	City Oliver Springs	Street Michelle Ln	Material Concrete Pipe (non-...	Location C... Light High...	Sewer Use Sanitary
Upstream MH D8-1	Total Length 326.1	Year Laid	Shape Circular	Location Details	
DS Manhole D8-1A	Length surveyed 326.1	Year Renewed	Height 8	Width 8	Pipe Joint... 4

SPR N/A	MPR 11	PO Number 4397-03	Customer GRW
SPRI N/A	MPRI 2.8	Work Order 4397-02	Purpose Pre-Rehabilitation Survey
QSR N/A	QMR 4131		
OPR 11	Surveyed By Barry Rogers	Direction Downstream	Date 20150706
OPRI 2.8	Certificate Number U-1012-16405	Pre-Cleaning Jetting	Time 09:06
	Date Cleaned 20150706	End Time 09:26	Weather Dry
			Additional Info correct line segmen...

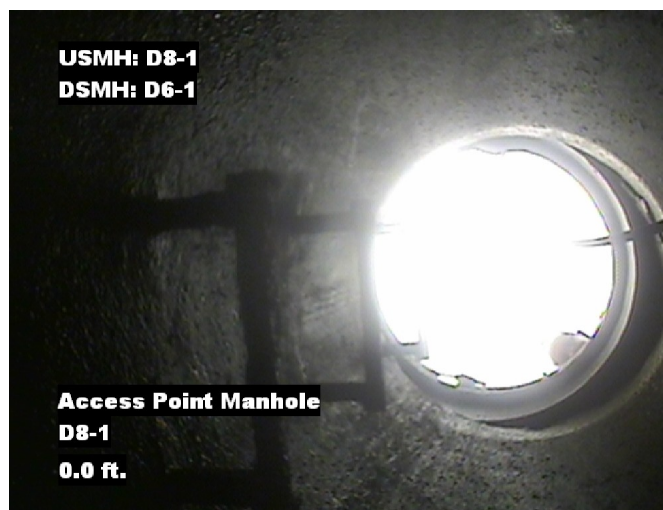
Distance: 0.0 ft. Grade: 0
Condition: Access Point Manhole
Remarks: D8-1

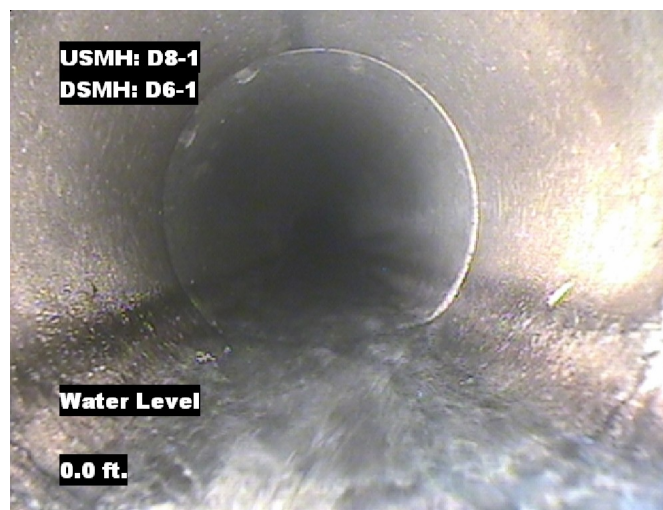
Distance: 0.0 ft. Grade: 0
Condition: Water Level
Remarks: N/A

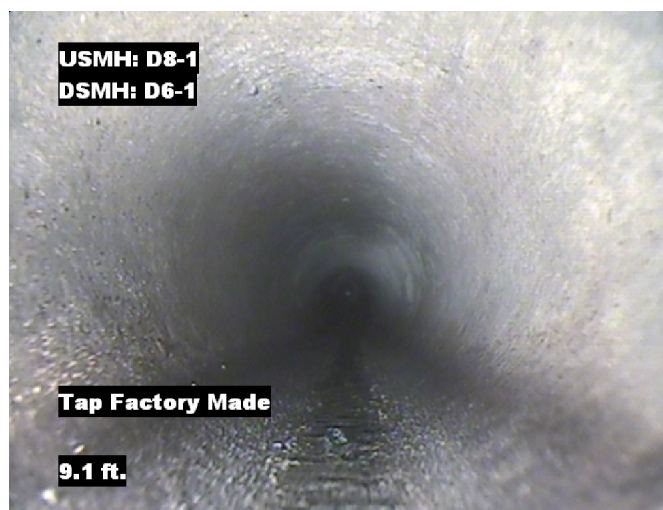
Distance: 9.1 ft. Grade: 0
Condition: Tap Factory Made
Remarks: N/A

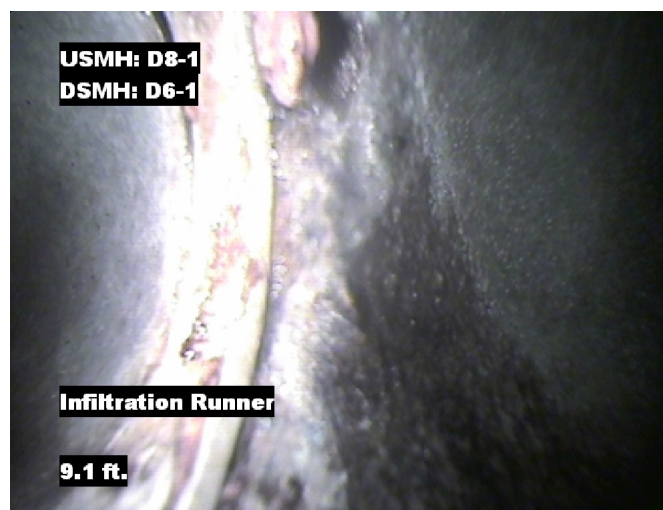
Distance: 9.1 ft. Grade: 4
Condition: Infiltration Runner
Remarks: N/A

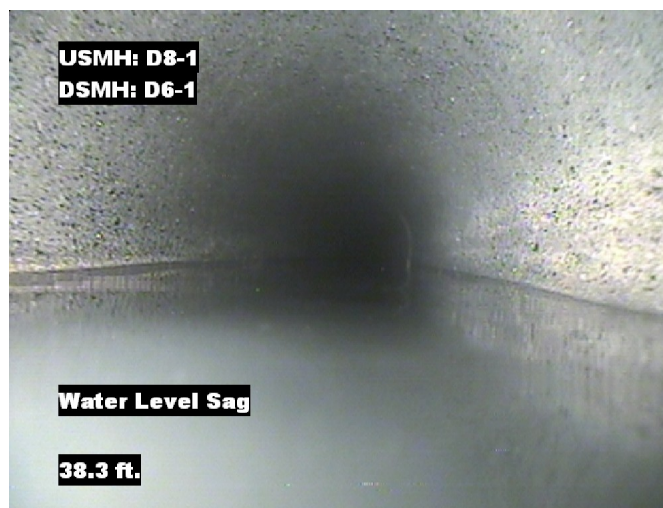
Distance: 38.3 ft. Grade: 3
Condition: Water Level Sag
Remarks: N/A

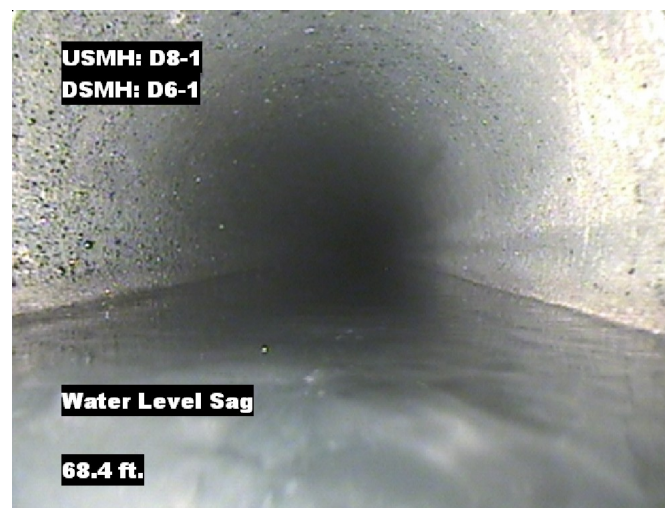
Distance: 68.4 ft. Grade: 2
Condition: Water Level Sag
Remarks: N/A

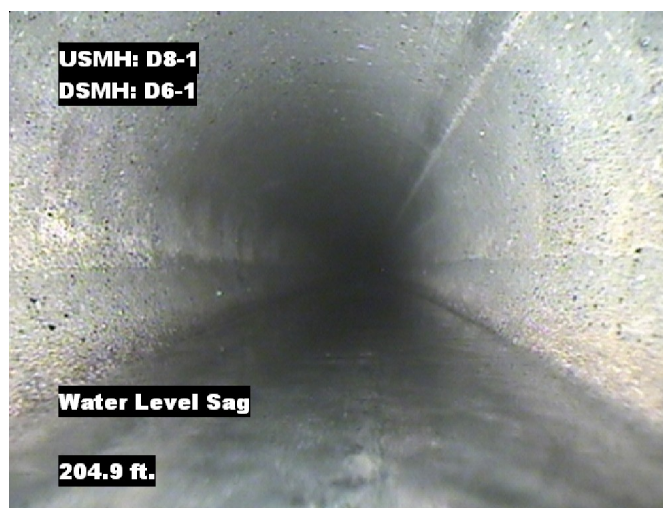
Distance: 204.9 ft. Grade: 2
Condition: Water Level Sag
Remarks: N/A

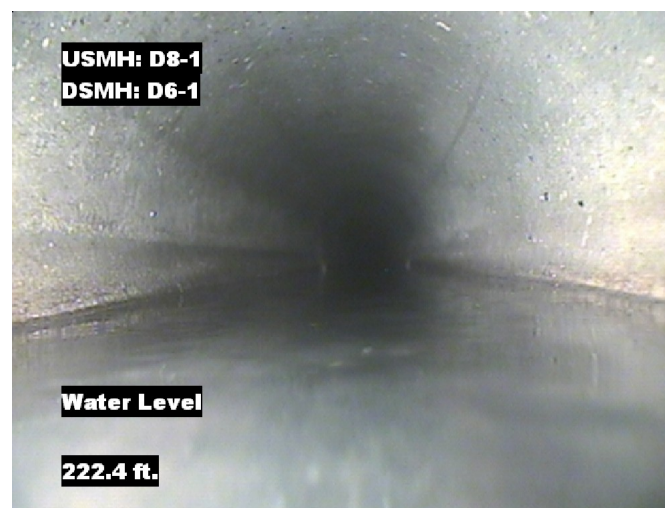
Distance: 222.4 ft. Grade: 0
Condition: Water Level
Remarks: N/A

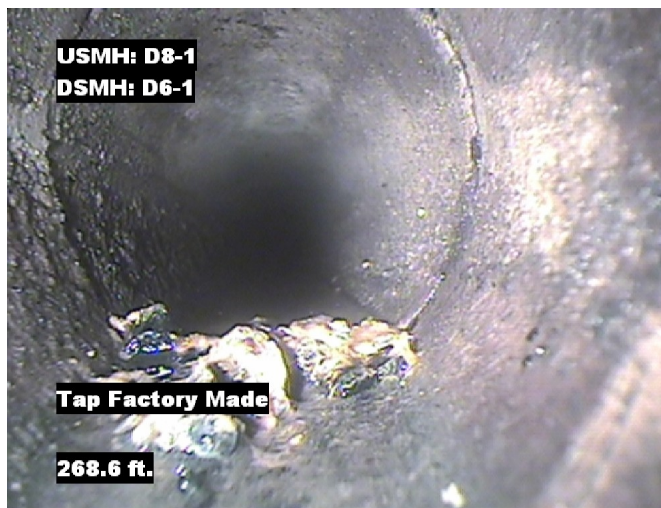
Distance: 268.6 ft. Grade: 0
Condition: Tap Factory Made
Remarks: N/A

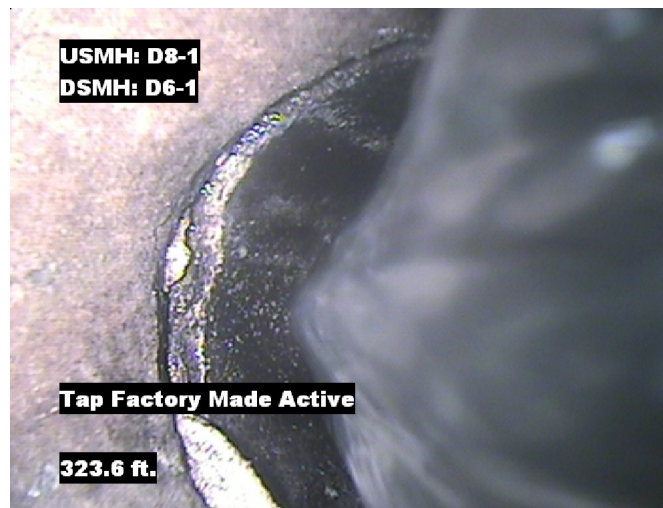
Distance: 323.6 ft. Grade: 0
Condition: Tap Factory Made Active
Remarks: N/A

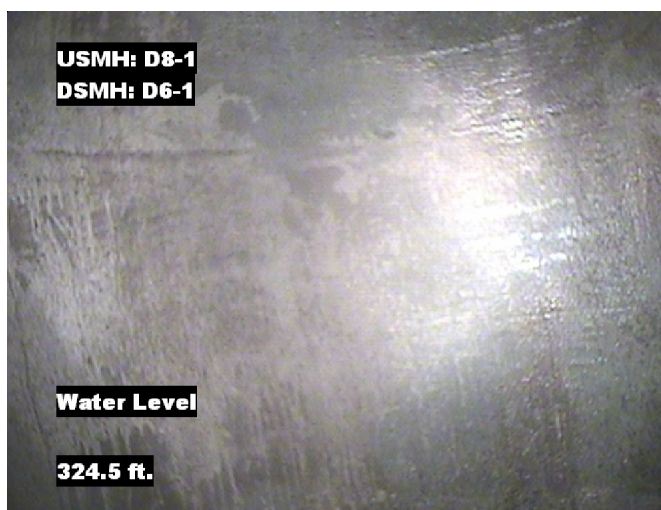
Distance: 324.5 ft. Grade: 0
Condition: Water Level
Remarks: N/A

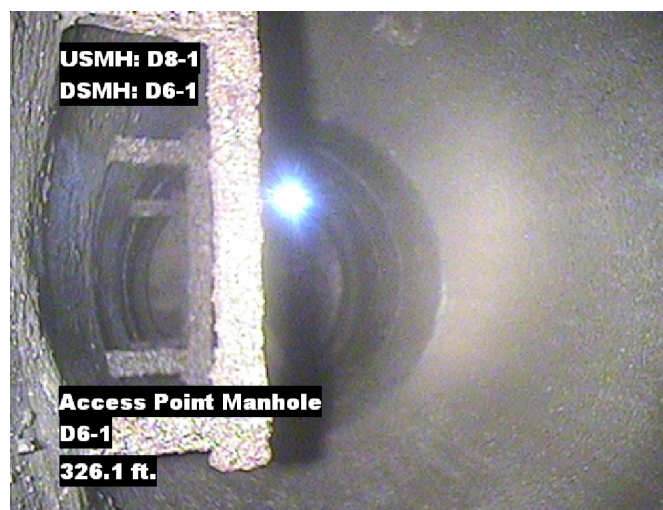
Distance: 326.1 ft. Grade: 0
Condition: Access Point Manhole
Remarks: D8-1A
