Defect Listing

| Pipe Segment Refere... D8-1A_D6-1 | City Oliver Springs | Street Michelle Ln | Material Concrete Pipe (non-... | Location C... Light High... | Sewer Use Sanitary |

| SPRI N/A | MPRI N/A | Work Order 4397-02 | Purpose Pre-Rehabilitation Survey |

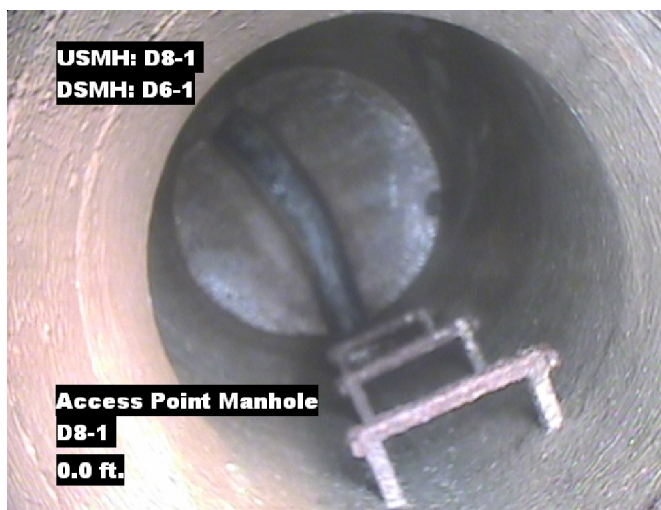
Distance: 0.0 ft. Grade: 0
Condition: Access Point Manhole
Remarks: D8-1A

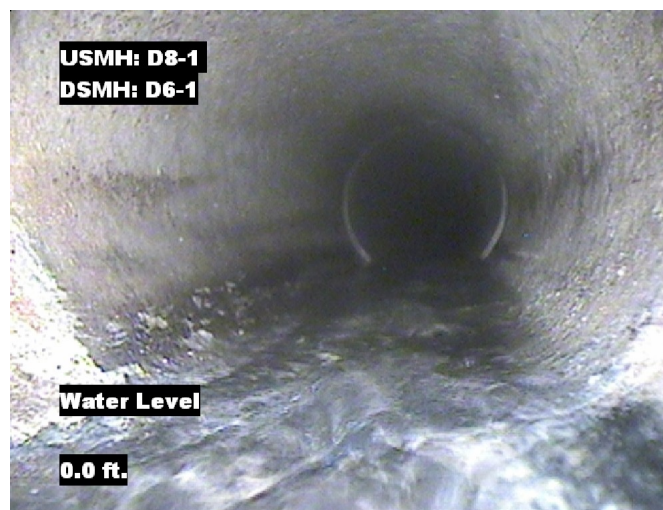
Distance: 0.0 ft. Grade: 0
Condition: Water Level
Remarks: N/A

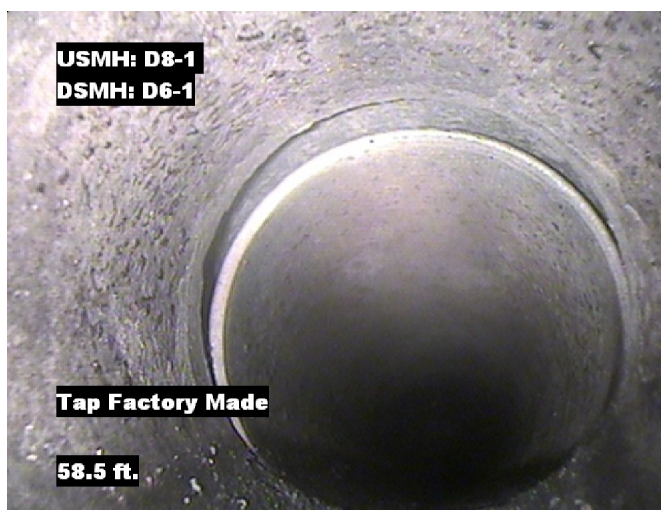
Distance: 58.5 ft. Grade: 0
Condition: Tap Factory Made
Remarks: N/A

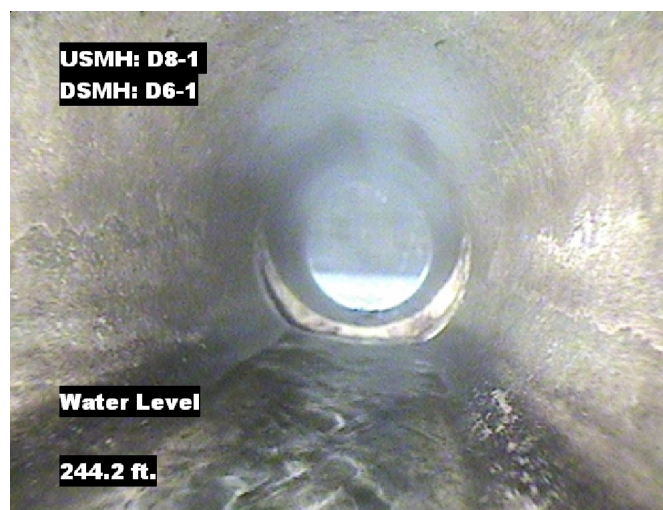
Distance: 244.1 ft. Grade: 0
Condition: Water Level
Remarks: N/A

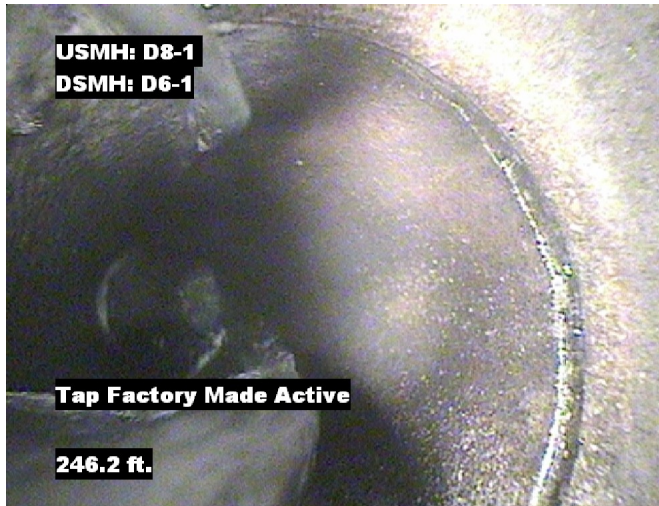
Distance: 246.2 ft. Grade: 0
Condition: Tap Factory Made Active
Remarks: N/A

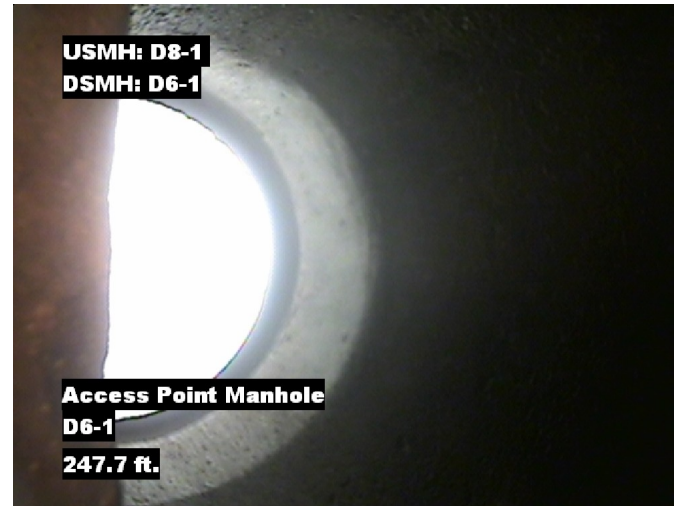
Distance: 247.7 ft. Grade: 0
Condition: Access Point Manhole
Remarks: D6-1
