## Defect Listing

Pipe Segment Refere...	City	Street	Material	Location C...	Sewer Use
<b>D8-2_D8-1</b>	<b>Oliver Springs</b>	<b>Highway#61&amp; #62</b>	<b>Concrete Pipe (non-...</b>	<b>Main Highw...</b>	<b>Sanitary</b>
Upstream MH	Total Length	Year Laid	Shape	Location Details	
<b>D8-2</b>	<b>338.7</b>		<b>Circular</b>		
DS Manhole	Length surveyed	Year Renewed	Height	Width	Pipe Joint...
<b>D8-1</b>	<b>338.7</b>		<b>8</b>	<b>8</b>	<b>4</b>

SPR	N/A	MPR	20	PO Number	Customer
SPRI	N/A	MPRI	2.9	<b>4397-03</b>	<b>GRW</b>
QSR	N/A	QMR	5141	Work Order	Purpose
				<b>4397-02</b>	<b>Pre-Rehabilitation Survey</b>
OPR	Surveyed By	Direction	Date	Media label	
<b>20</b>	<b>Barry Rogers</b>	<b>Downstream</b>	<b>20150706</b>		
OPRI	Certificate Number	Pre-Cleaning	Time	Weather	
<b>2.9</b>	<b>U-1012-16405</b>	<b>Jetting</b>	<b>08:15</b>	<b>Dry</b>	
Date Cleaned			End Time	Additional Info	
<b>20150706</b>			<b>08:37</b>

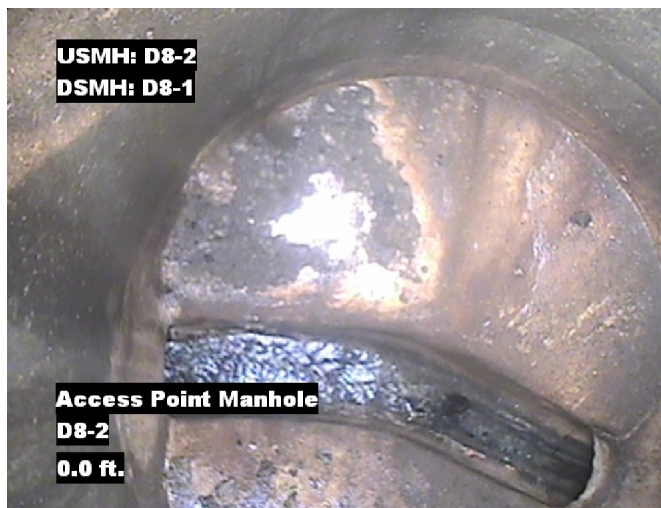
Distance: 0.0 ft. Grade: 0  
Condition: Access Point Manhole  
Remarks: D8-2

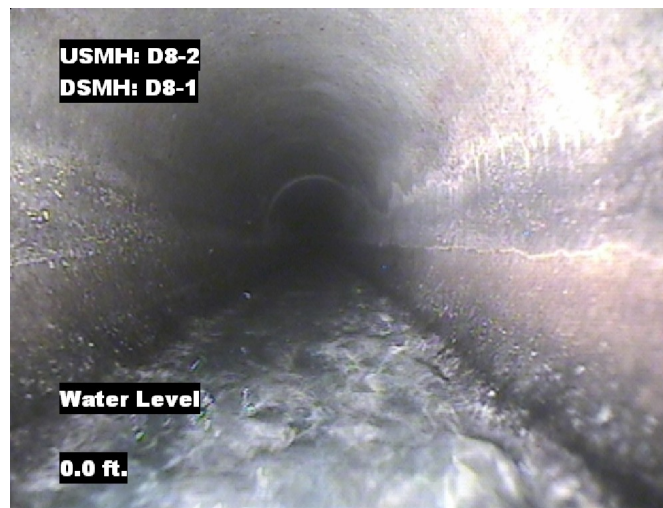
Distance: 0.0 ft. Grade: 0  
Condition: Water Level  
Remarks: N/A

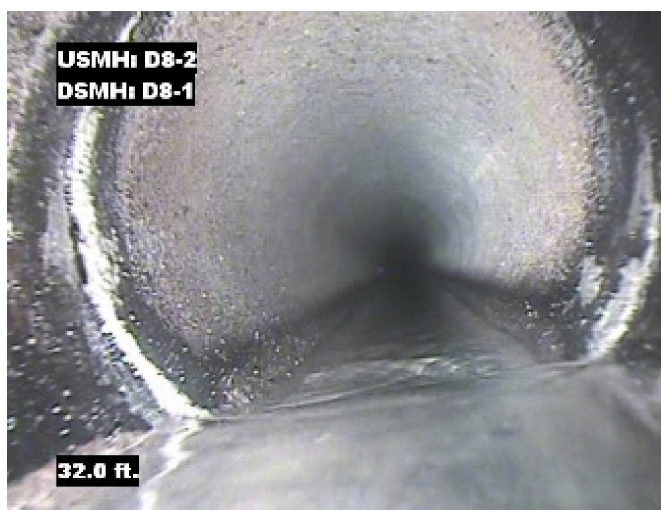
Distance: 32.1 ft. Grade: 3  
Condition: Infiltration Dripper  
Remarks: N/A

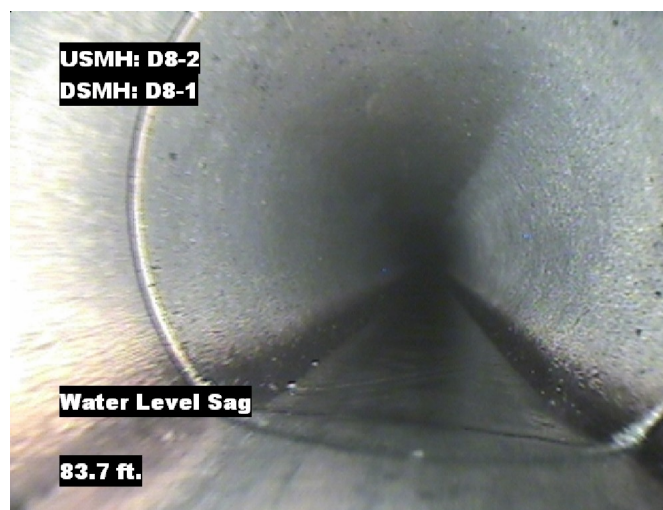
Distance: 83.6 ft. Grade: 2  
Condition: Water Level Sag  
Remarks: N/A

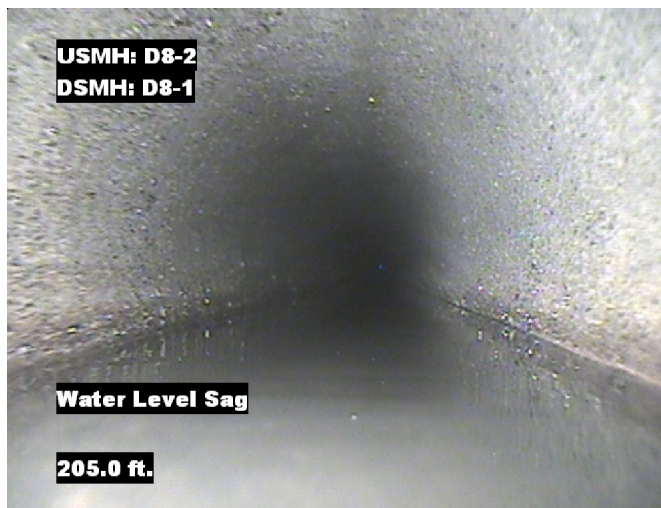
Distance: 204.9 ft. Grade: 2  
Condition: Water Level Sag  
Remarks: N/A

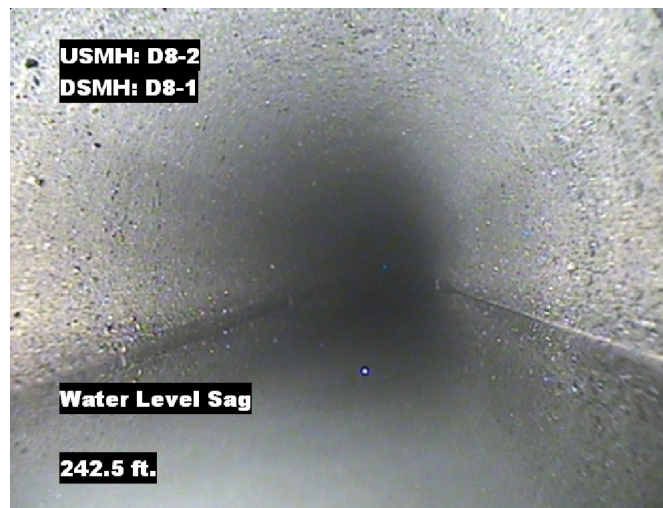
Distance: 242.5 ft. Grade: 2  
Condition: Water Level Sag  
Remarks: N/A

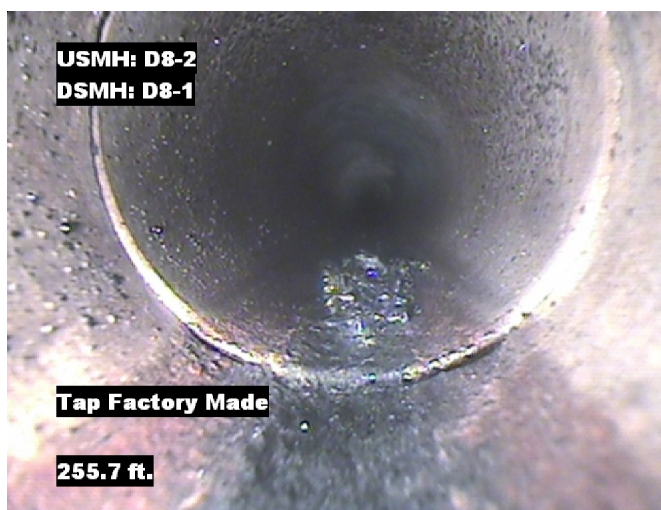
Distance: 255.7 ft. Grade: 0  
Condition: Tap Factory Made  
Remarks: N/A

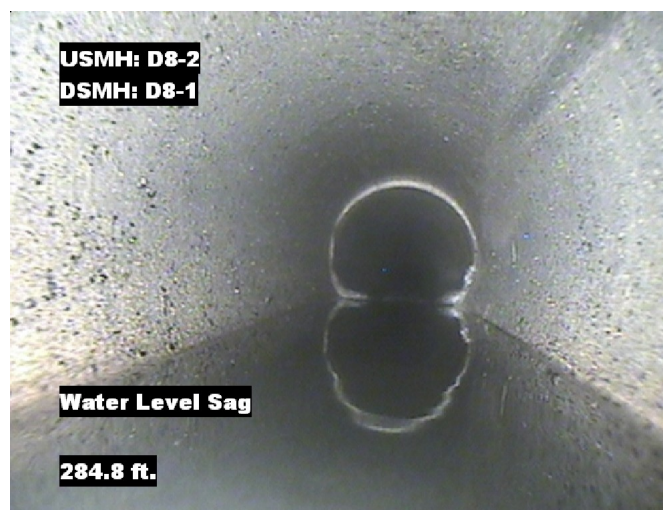
Distance: 284.8 ft. Grade: 2  
Condition: Water Level Sag  
Remarks: N/A

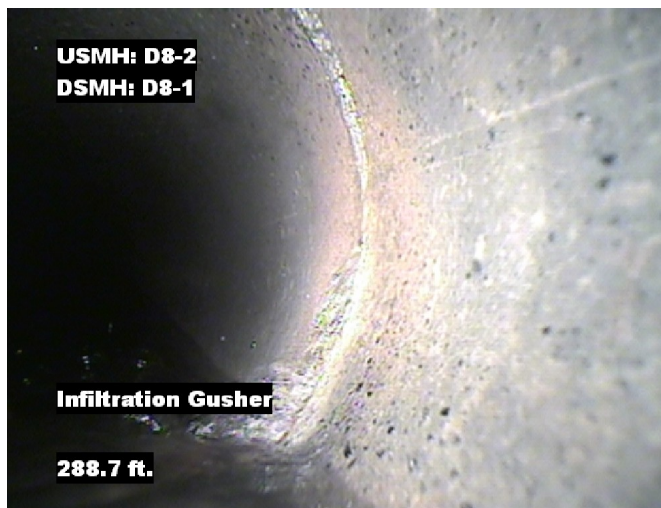
Distance: 288.7 ft. Grade: 5  
Condition: Infiltration Gusher  
Remarks: N/A

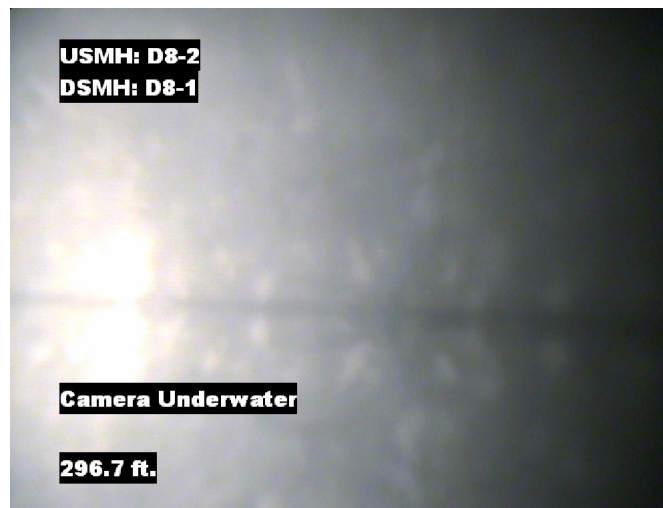
Distance: 296.7 ft. Grade: 4  
Condition: Camera Underwater  
Remarks: N/A

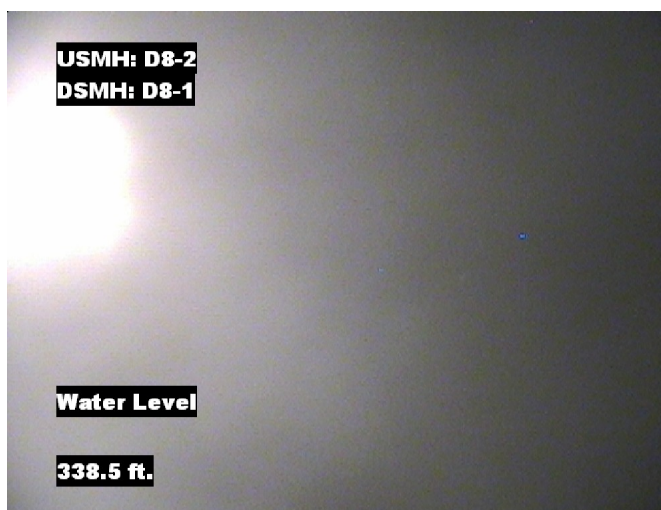
Distance: 338.5 ft. Grade: 0  
Condition: Water Level  
Remarks: N/A

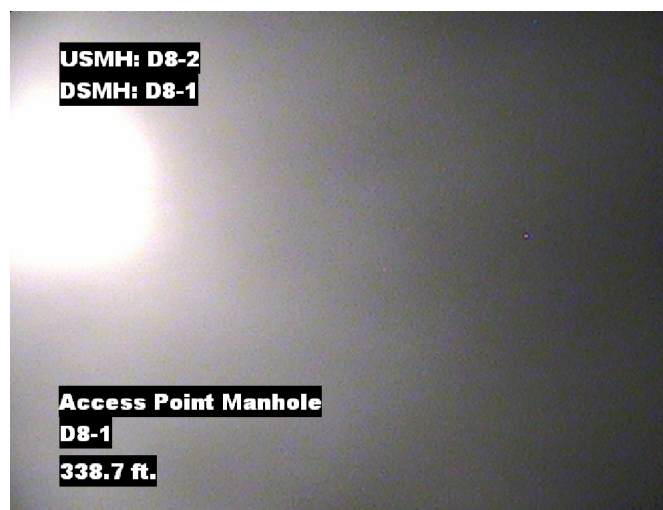
Distance: 338.7 ft. Grade: 0  
Condition: Access Point Manhole  
Remarks: D8-1
