Defect Listing

Pipe Segment Refere... D8-3_D8-2	City Oliver Springs	Street Highway #61 & #62	Material Concrete Pipe (non-...	Location C... Main Highw...	Sewer Use Sanitary
Upstream MH D8-3	Total Length 302.8	Year Laid	Shape Circular	Location Details	
DS Manhole D8-2	Length surveyed 302.8	Year Renewed	Height 8	Width 8	Pipe Joint... 4

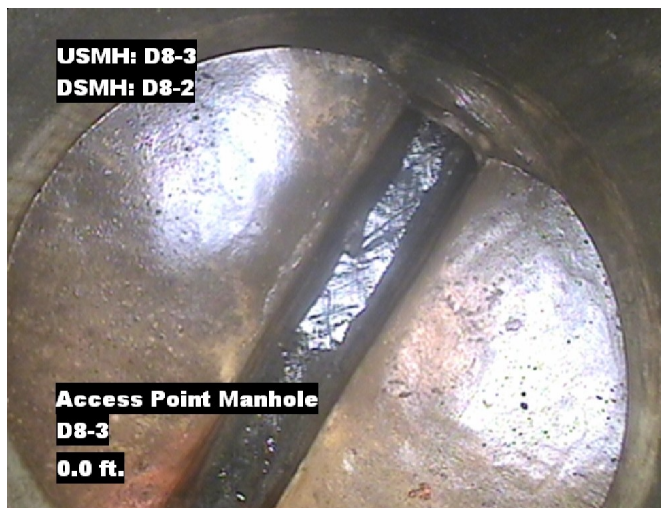
Distance: 0.0 ft. Grade: 0
Condition: Access Point Manhole
Remarks: D8-3

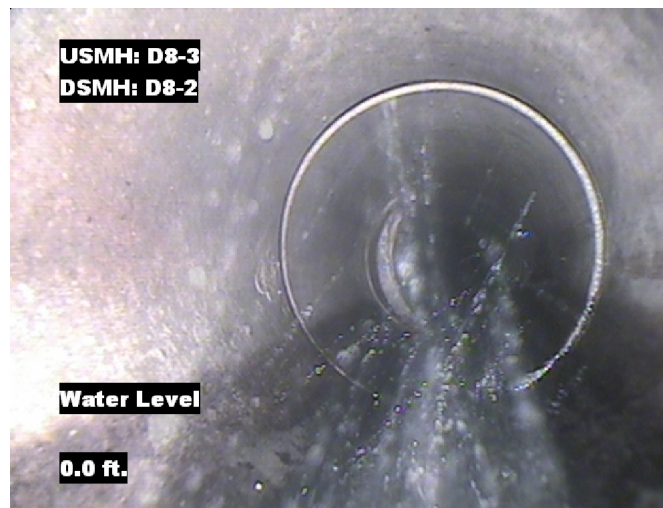
Distance: 0.0 ft. Grade: 0
Condition: Water Level
Remarks: N/A

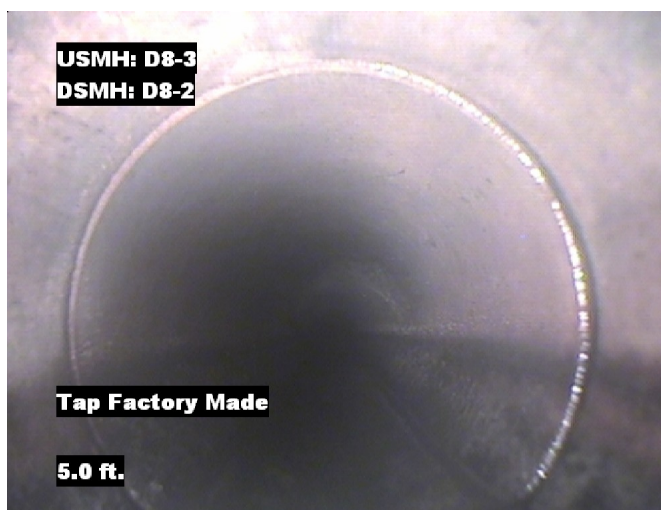
Distance: 5.0 ft. Grade: 0
Condition: Tap Factory Made
Remarks: N/A

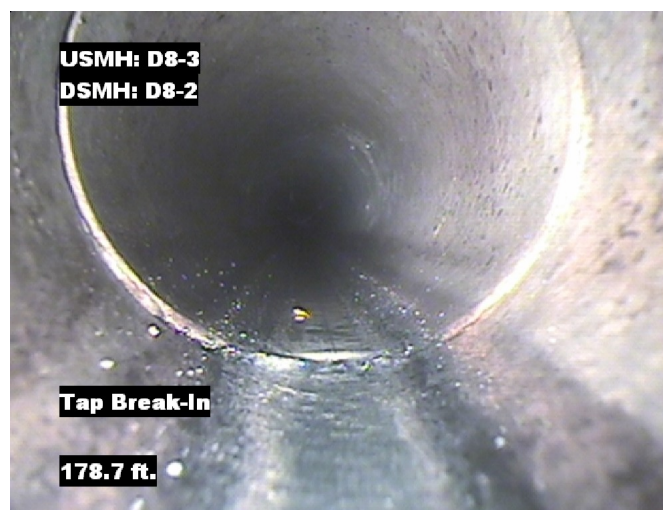
Distance: 178.7 ft. Grade: 0
Condition: Tap Break-In
Remarks: N/A

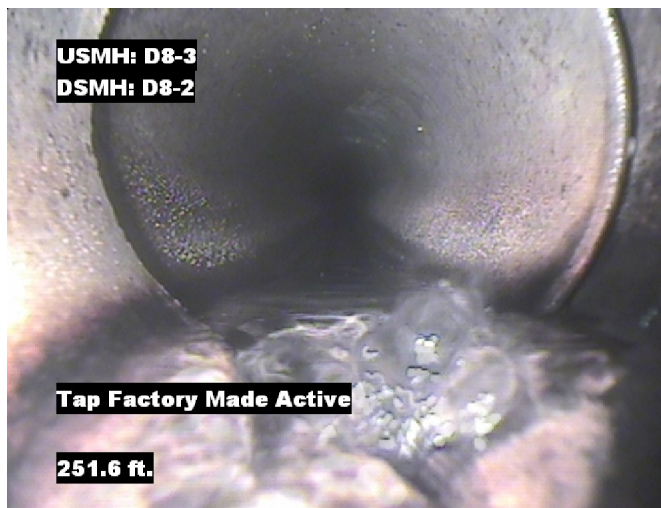
Distance: 251.6 ft. Grade: 0
Condition: Tap Factory Made Active
Remarks: N/A

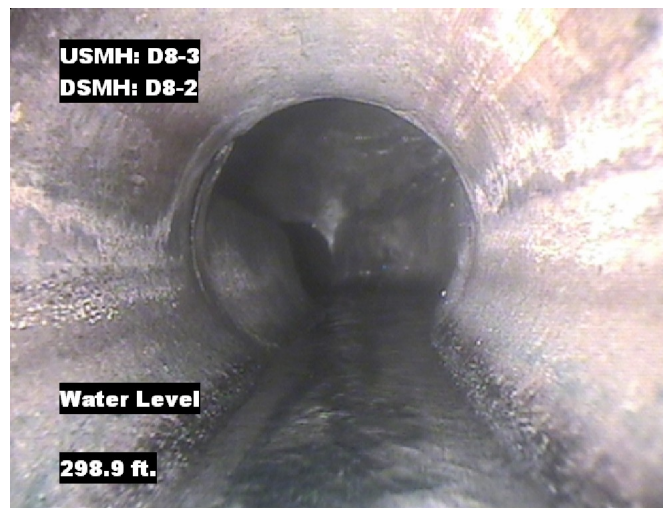
Distance: 298.8 ft. Grade: 0
Condition: Water Level
Remarks: N/A

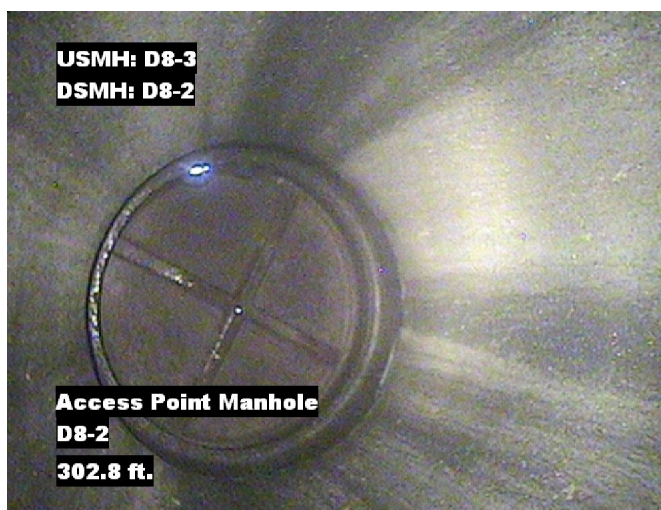
Distance: 302.8 ft. Grade: 0
Condition: Access Point Manhole
Remarks: D8-2
