Defect Listing

Pipe Segment Refere... D8-4_D8-3	City Oliver Springs	Street Highway #61 &# 62	Material Concrete Pipe (non-...	Location C... Main Highw...	Sewer Use Sanitary
Upstream MH D8-4	Total Length 289.1	Year Laid	Shape Circular	Location Details	
DS Manhole D8-3	Length surveyed 289.1	Year Renewed	Height 8	Width 8	Pipe Joint... 4

SPR N/A	MPR N/A	PO Number 4397-03		Customer GRW	
SPRI N/A	MPRI N/A	Work Order 4397-02		Purpose Pre-Rehabilitation Survey	
QSR N/A	QMR N/A				
OPR N/A	Surveyed By Barry Rogers	Direction Downstream	Date 20150706	Media label	
OPRI N/A	Certificate Number U-1012-16405	Pre-Cleaning Jetting	Time 07:01	Weather Dry	
Date Cleaned 20150706			End Time 07:16	Additional Info

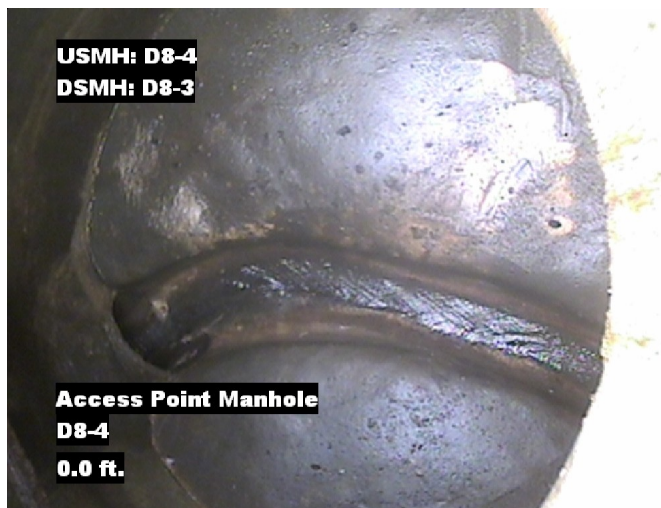
Distance: 0.0 ft. Grade: 0
Condition: Access Point Manhole
Remarks: D8-4

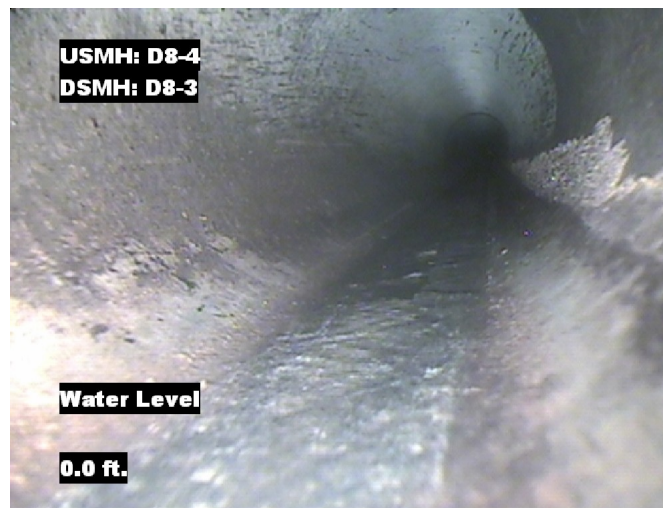
Distance: 0.0 ft. Grade: 0
Condition: Water Level
Remarks: N/A

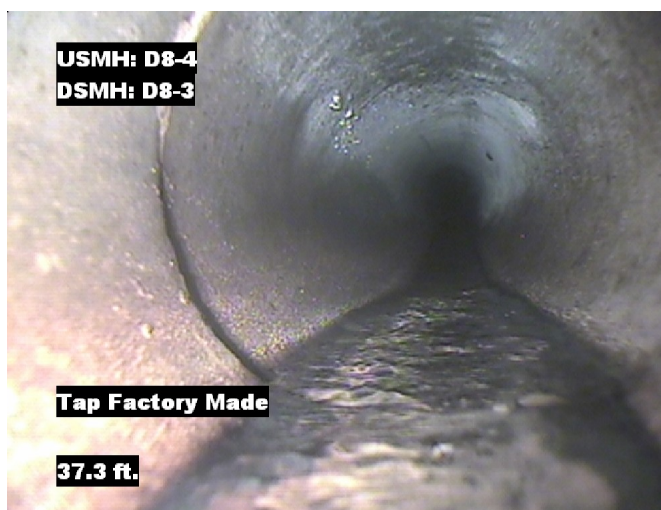
Distance: 37.3 ft. Grade: 0
Condition: Tap Factory Made
Remarks: N/A

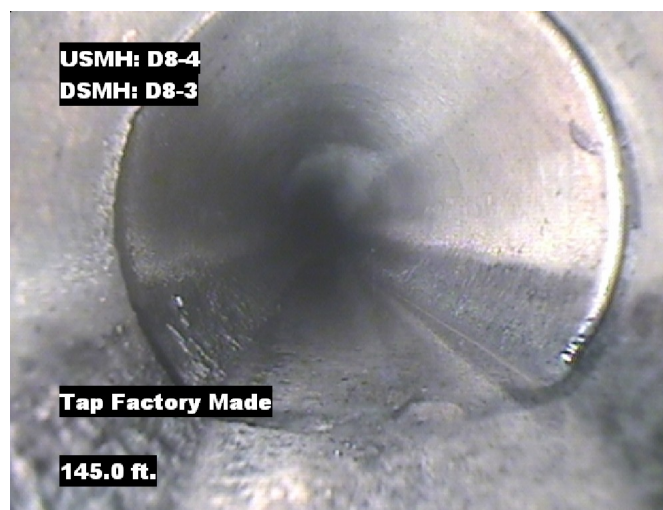
Distance: 145.0 ft. Grade: 0
Condition: Tap Factory Made
Remarks: N/A

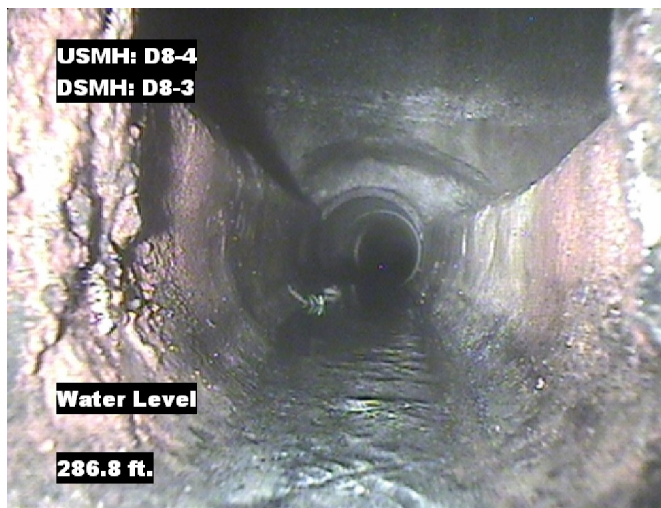
Distance: 286.8 ft. Grade: 0
Condition: Water Level
Remarks: N/A

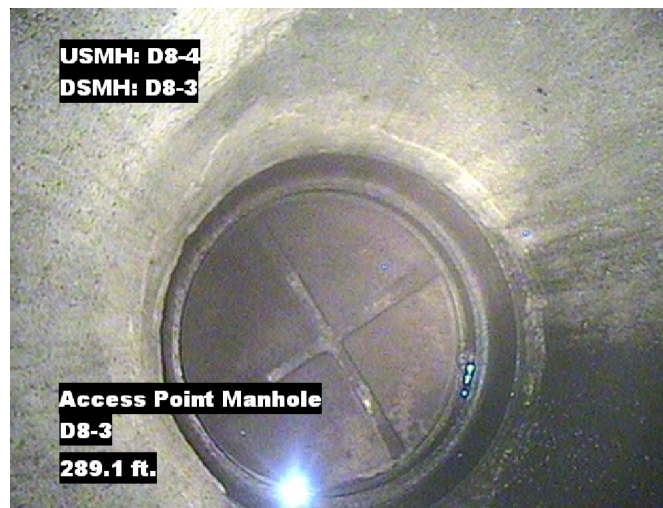
Distance: 289.1 ft. Grade: 0
Condition: Access Point Manhole
Remarks: D8-3
