Defect Listing

Pipe Segment Refere... D9-1_D-16	City Oliver Springs	Street Midway Dr	Material Fibreglass Reinforc...	Location C... Light High...	Sewer Use Sanitary
Upstream MH D9-1	Total Length 354.4	Year Laid	Shape Circular	Location Details	
DS Manhole D-16	Length surveyed 354.4	Year Renewed	Height 10	Width 10	Pipe Joint... N/A

SPR N/A	MPR 8	PO Number 4397-03	Customer GRW
SPRI N/A	MPRI 2	Work Order 4397-02	Purpose Pre-Rehabilitation Survey
QSR N/A	QMR 2400		
OPR 8	Surveyed By Barry Rogers	Direction Downstream	Date 20150703
OPRI 2	Certificate Number U-1012-16405	Pre-Cleaning Jetting	Time 07:50
	Date Cleaned 20150703	End Time 08:13	Weather Damp
			Media label
			Additional Info

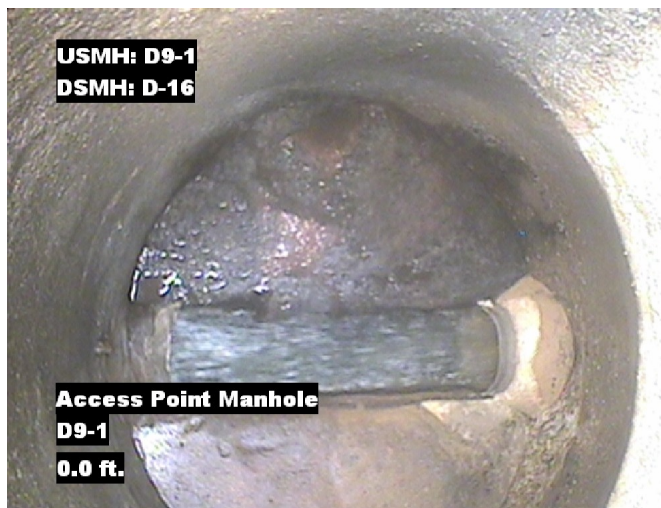
Distance: 0.0 ft. Grade: 0
Condition: Access Point Manhole
Remarks: D9-1

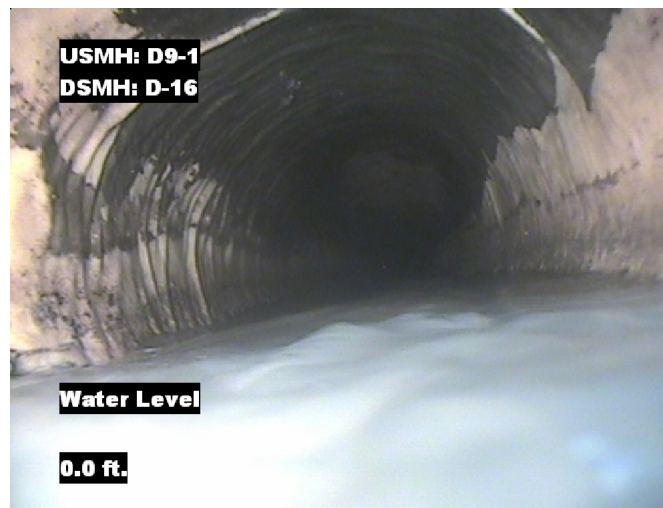
Distance: 0.0 ft. Grade: 0
Condition: Water Level
Remarks: N/A

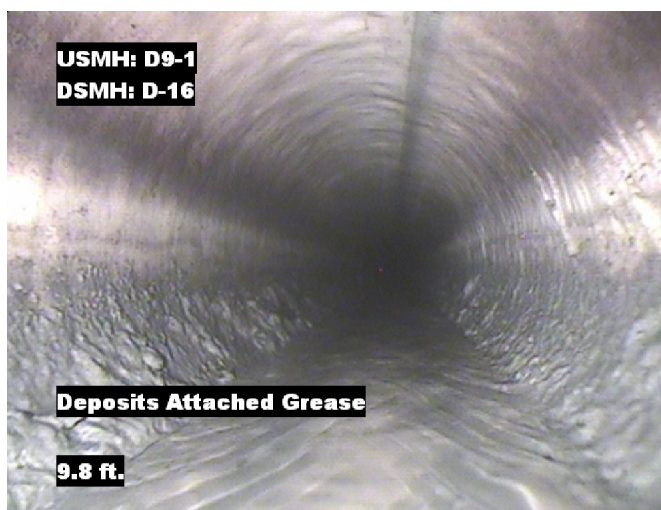
Distance: 9.8 ft. Grade: 2
Condition: Deposits Attached Grease
Remarks: N/A

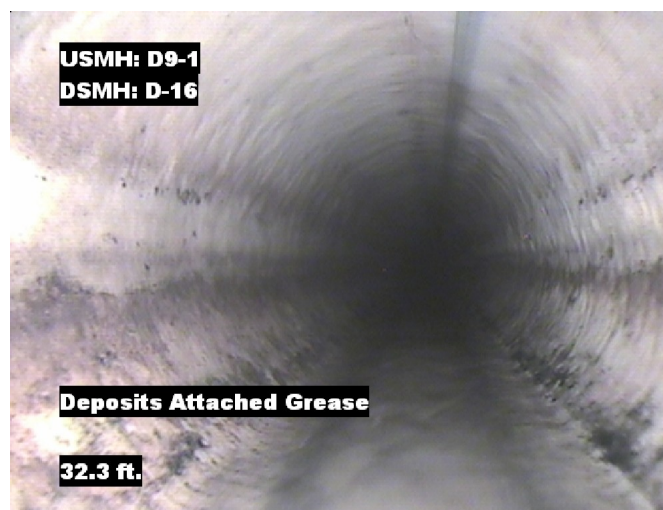
Distance: 32.3 ft. Grade: 2
Condition: Deposits Attached Grease
Remarks: N/A

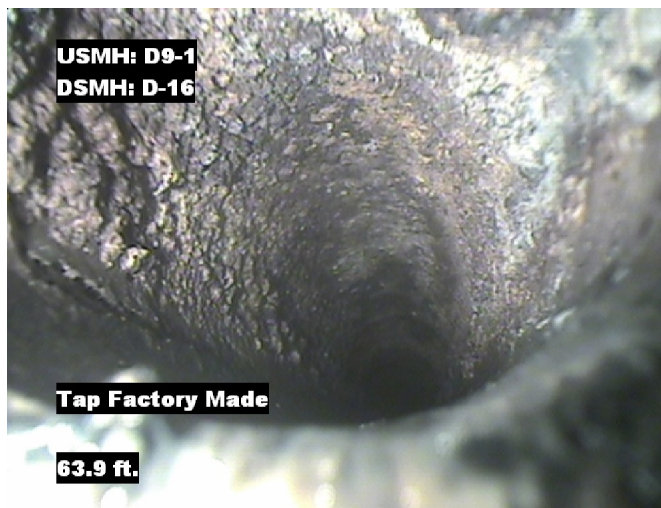
Distance: 63.9 ft. Grade: 0
Condition: Tap Factory Made
Remarks: N/A

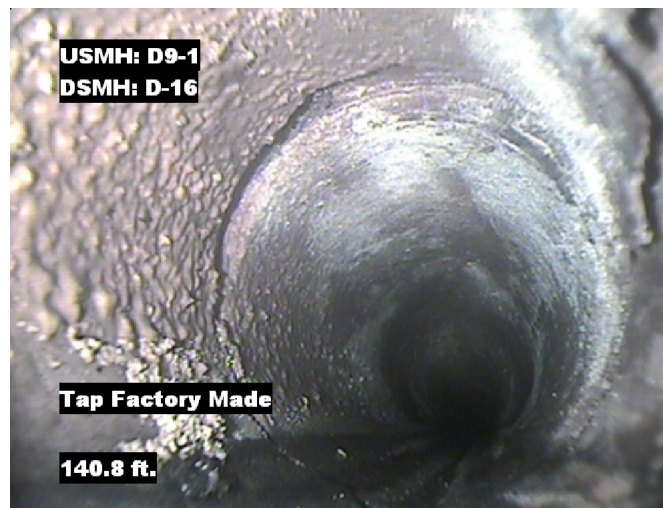
Distance: 140.8 ft. Grade: 0
Condition: Tap Factory Made
Remarks: N/A

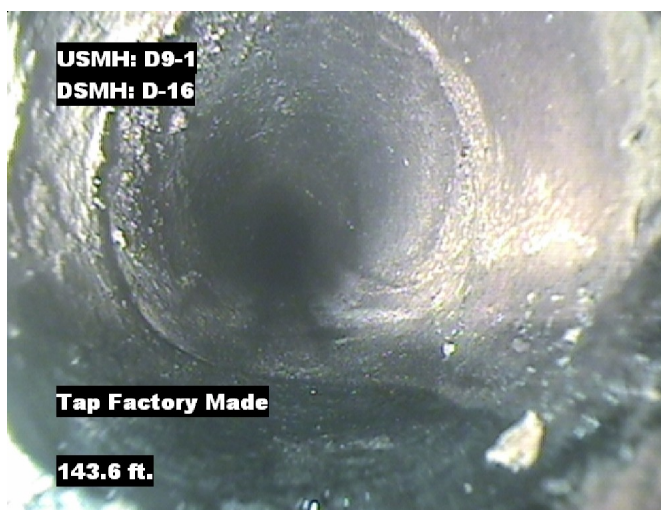
Distance: 143.6 ft. Grade: 0
Condition: Tap Factory Made
Remarks: N/A

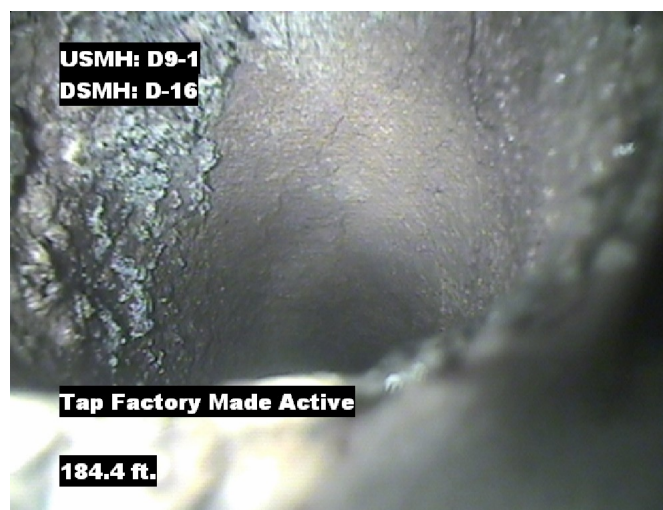
Distance: 184.4 ft. Grade: 0
Condition: Tap Factory Made Active
Remarks: N/A

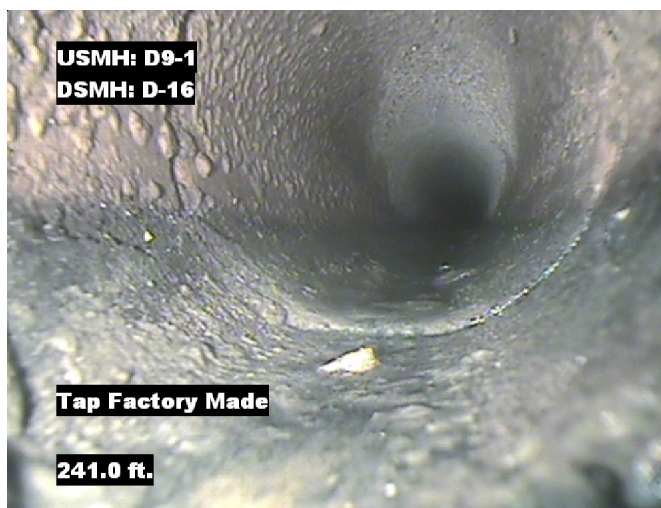
Distance: 241.0 ft. Grade: 0
Condition: Tap Factory Made
Remarks: N/A

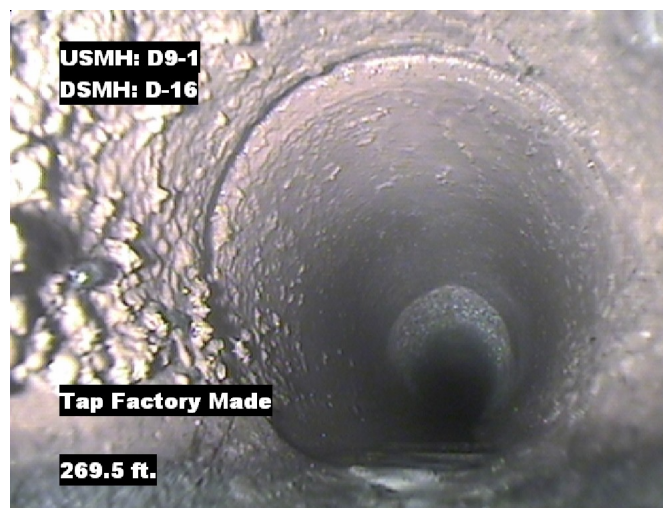
Distance: 269.5 ft. Grade: 0
Condition: Tap Factory Made
Remarks: N/A

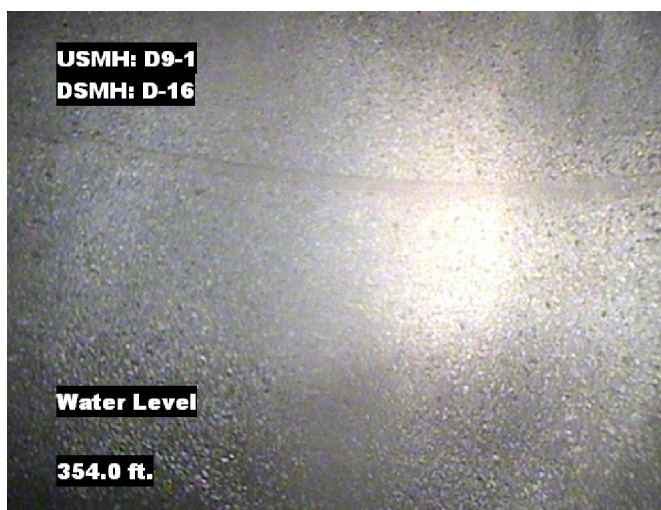
Distance: 354.0 ft. Grade: 0
Condition: Water Level
Remarks: N/A

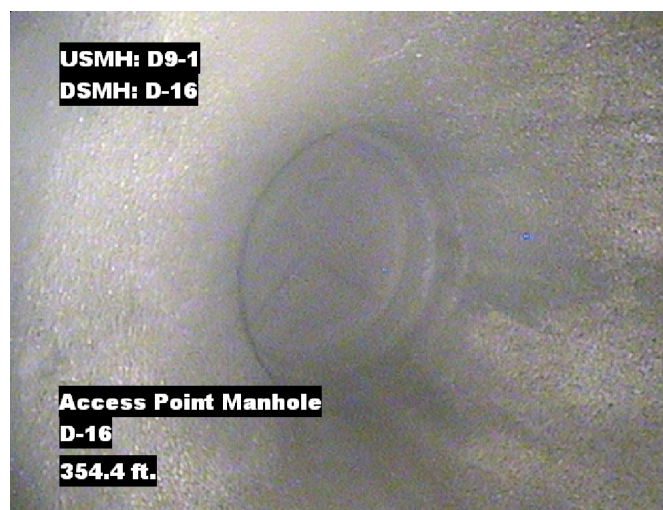
Distance: 354.4 ft. Grade: 0
Condition: Access Point Manhole
Remarks: D-16
