Defect Listing

Pipe Segment Refere... D9-2_D9-1	City Oliver Springs	Street Midway Dr	Material Fibreglass Reinforc...	Location C... Light High...	Sewer Use Sanitary
Upstream MH D9-2	Total Length 350	Year Laid	Shape Circular	Location Details	
DS Manhole D9-1	Length surveyed 350	Year Renewed	Height 10	Width 10	Pipe Joint... N/A

SPR 6	MPR N/A	PO Number 4397-03	Customer GRW
SPRI 3	MPRI N/A	Work Order 4397-02	Purpose Pre-Rehabilitation Survey
QSR 3200	QMR N/A		
OPR 6	Surveyed By Barry Rogers	Direction Downstream	Date 20150703
OPRI 3	Certificate Number U-1012-16405	Pre-Cleaning Jetting	Time 06:43
	Date Cleaned 20150703	End Time 07:19	Weather Damp
			Media label
			Additional Info

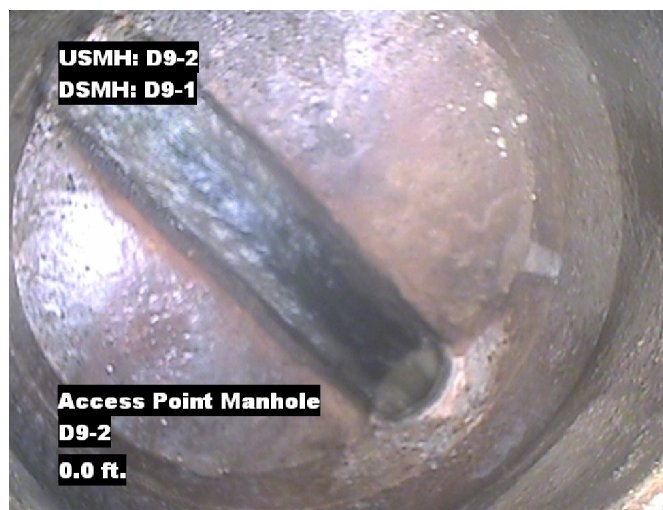
Distance: 0.0 ft. Grade: 0
Condition: Access Point Manhole
Remarks: D9-2

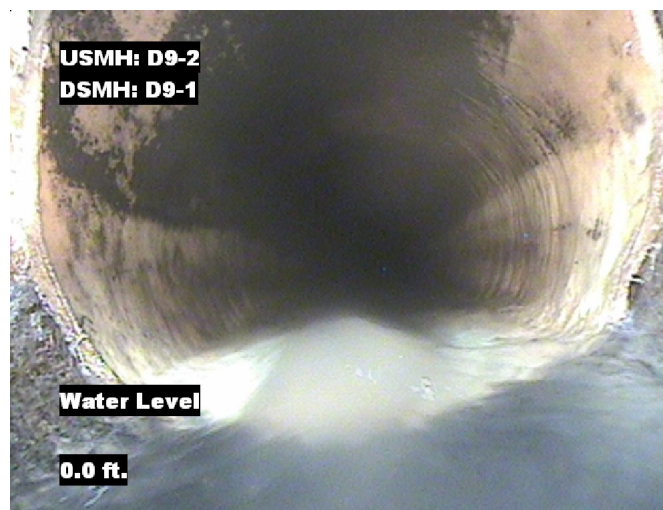
Distance: 0.0 ft. Grade: 0
Condition: Water Level
Remarks: N/A

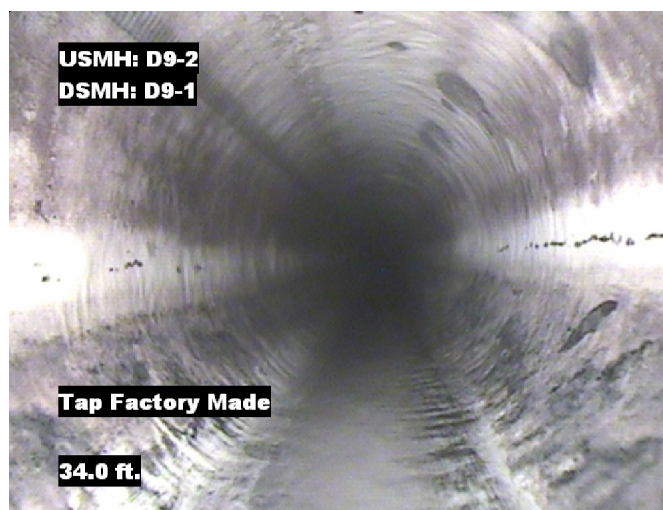
Distance: 34.0 ft. Grade: 0
Condition: Tap Factory Made
Remarks: N/A

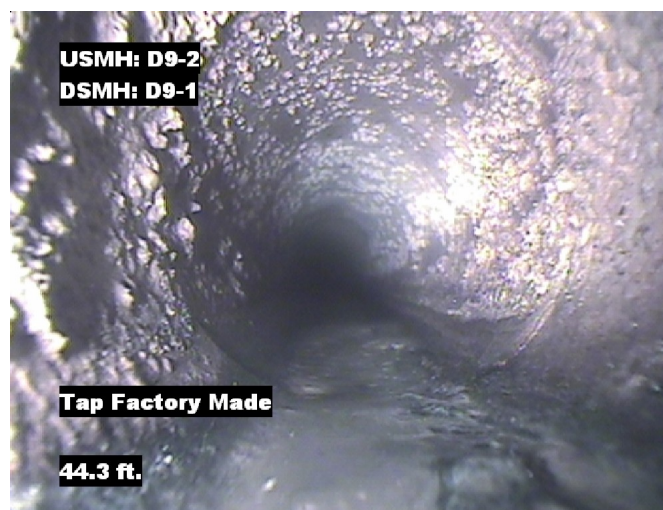
Distance: 44.3 ft. Grade: 0
Condition: Tap Factory Made
Remarks: N/A

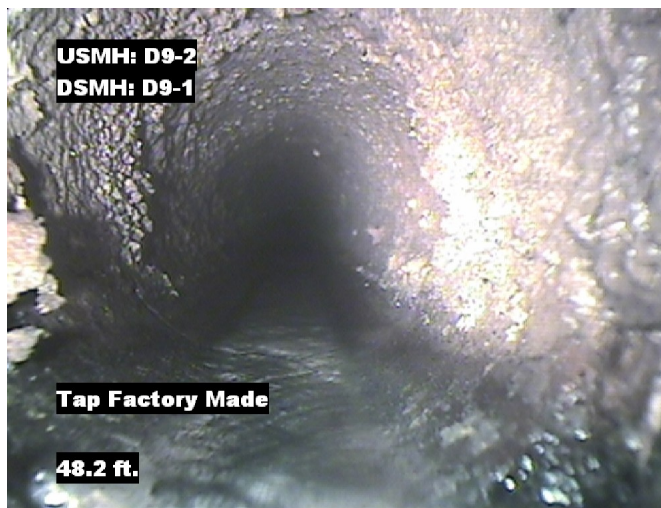
Distance: 48.2 ft. Grade: 0
Condition: Tap Factory Made
Remarks: N/A

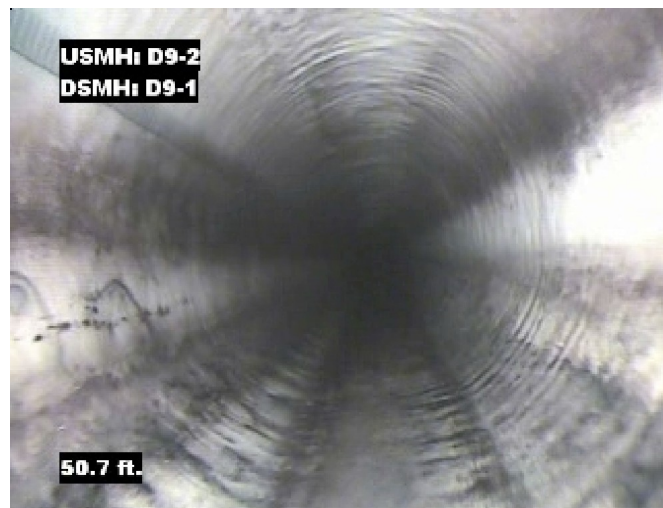
48.2 ft.	Tap Factory Made		6		0	<input type="checkbox"/>	3		
50.6 ft.	Lining Failure Wrinkled					<input type="checkbox"/>	11	1	3
Remarks: CONT. DEFECT

Distance: 50.6 ft. Grade: 3
Condition: Lining Failure Wrinkled
Remarks: CONT. DEFECT

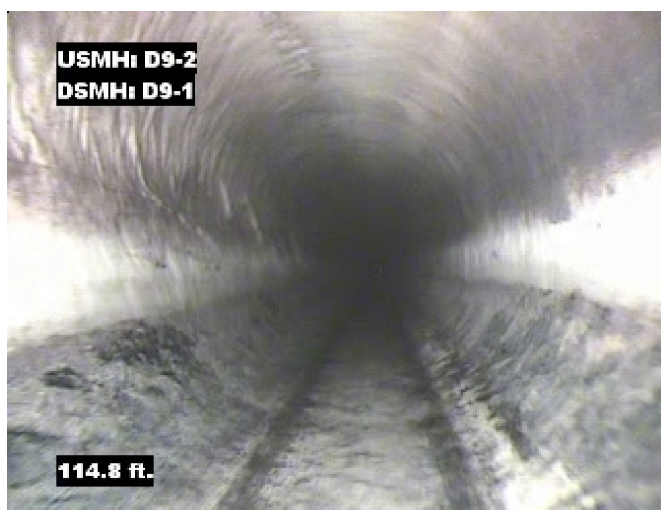
114.7 ft.	Lining Failure Wrinkled					<input type="checkbox"/>	9	11	3
193.4 ft.	Tap Factory Made		6		0	<input type="checkbox"/>	3		
214.6 ft.	Tap Factory Made		6		0	<input type="checkbox"/>	9

Distance: 114.7 ft. Grade: 3
Condition: Lining Failure Wrinkled
Remarks: N/A

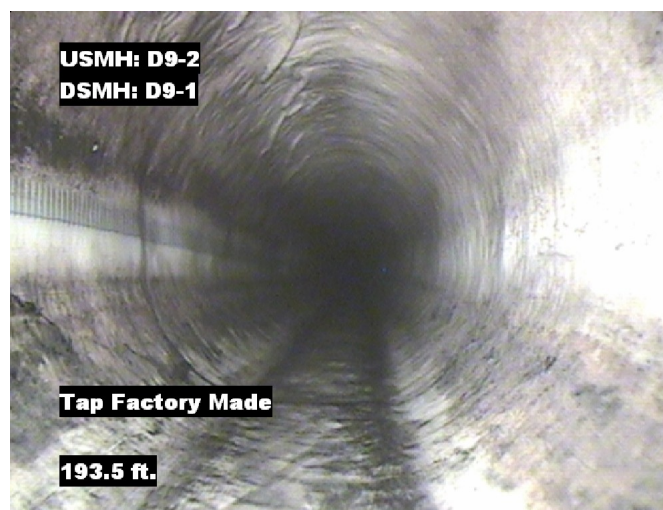
Distance: 193.4 ft. Grade: 0
Condition: Tap Factory Made
Remarks: N/A

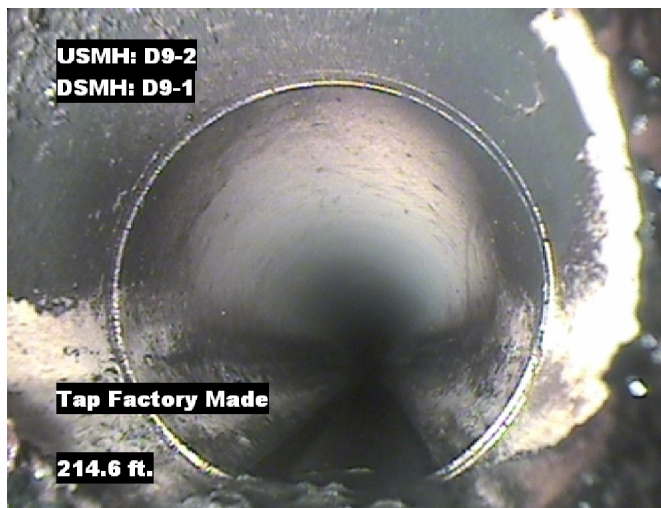
Distance: 214.6 ft. Grade: 0
Condition: Tap Factory Made
Remarks: N/A

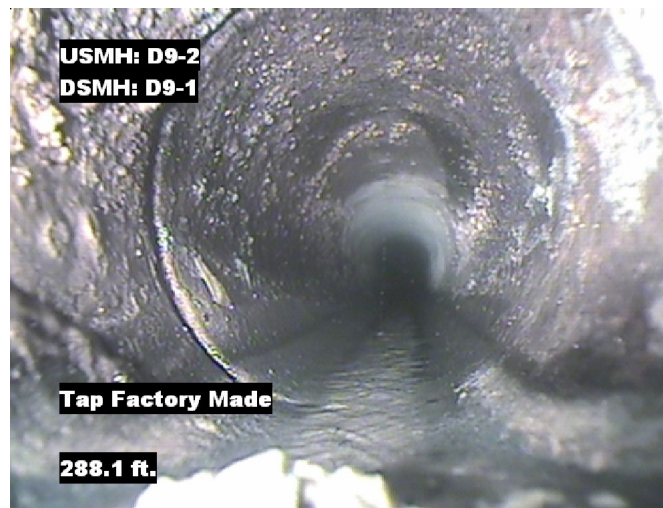
Distance: 288.1 ft. Grade: 0
Condition: Tap Factory Made
Remarks: N/A

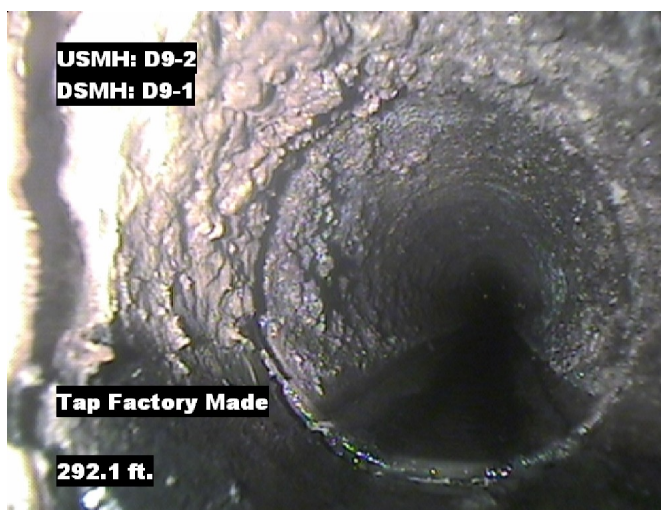
Distance: 292.1 ft. Grade: 0
Condition: Tap Factory Made
Remarks: N/A

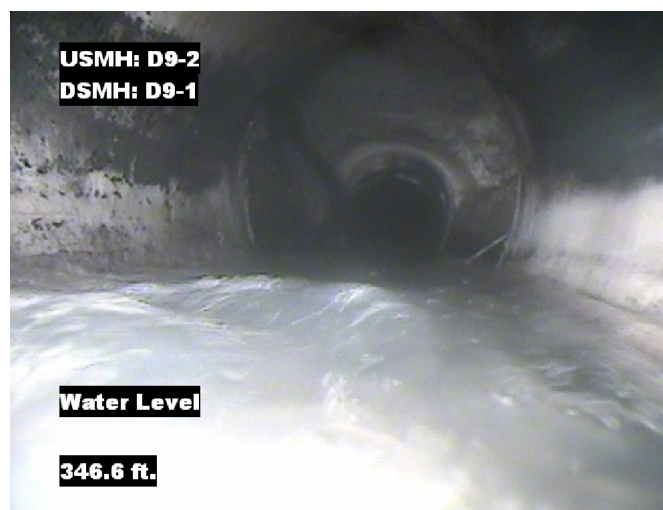
Distance: 346.6 ft. Grade: 0
Condition: Water Level
Remarks: N/A

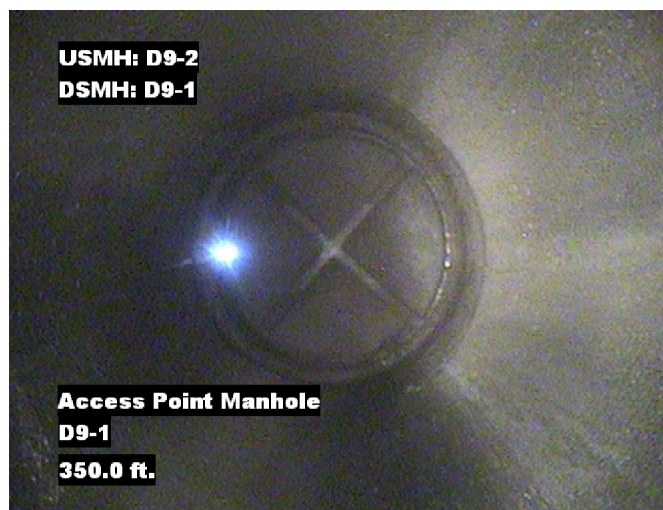
Distance: 350.0 ft. Grade: 0
Condition: Access Point Manhole
Remarks: D9-1
