## Defect Listing

Pipe Segment Refere... <b>D9-3_D9-2</b>	City <b>Oliver Springs</b>	Street <b>Midway Dr</b>	Material <b>Other</b>	Location C... <b>Light High...</b>	Sewer Use <b>Sanitary</b>
Upstream MH <b>D9-3</b>	Total Length <b>329.2</b>	Year Laid	Shape <b>Circular</b>	Location Details	
DS Manhole <b>D9-2</b>	Length surveyed <b>329.2</b>	Year Renewed	Height <b>10</b>	Width <b>10</b>	Pipe Joint... <b>N/A</b>

SPR <b>N/A</b>	MPR <b>N/A</b>	PO Number <b>4397-03</b>	Customer <b>GRW</b>
SPRI <b>N/A</b>	MPRI <b>N/A</b>	Work Order <b>4397-02</b>	Purpose <b>Pre-Rehabilitation Survey</b>
QSR <b>N/A</b>	QMR <b>N/A</b>		
OPR <b>N/A</b>	Surveyed By <b>Barry Rogers</b>	Direction <b>Downstream</b>	Date <b>20150701</b>
OPRI <b>N/A</b>	Certificate Number <b>U-1012-16405</b>	Pre-Cleaning <b>Jetting</b>	Time <b>15:07</b>
	Date Cleaned <b>20150701</b>	End Time <b>15:32</b>	Weather <b>Damp</b>
			Media label
			Additional Info

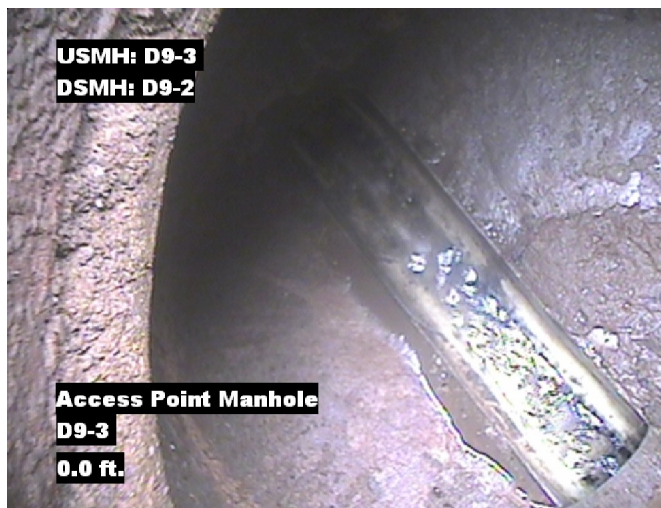
Distance: 0.0 ft. Grade: 0  
Condition: Access Point Manhole  
Remarks: D9-3

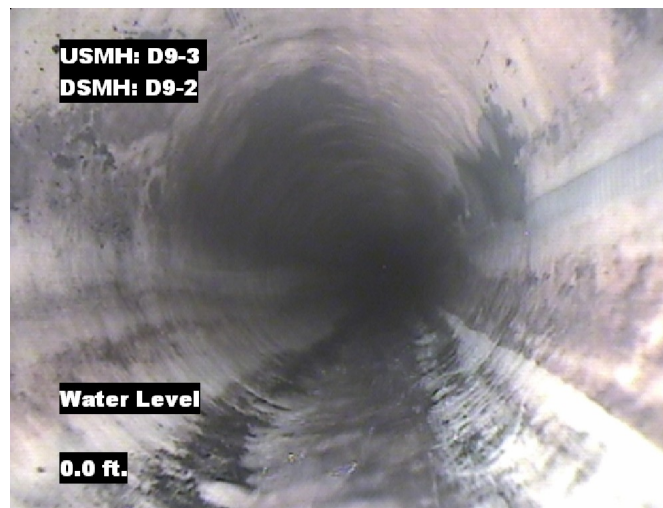
Distance: 0.0 ft. Grade: 0  
Condition: Water Level  
Remarks: N/A

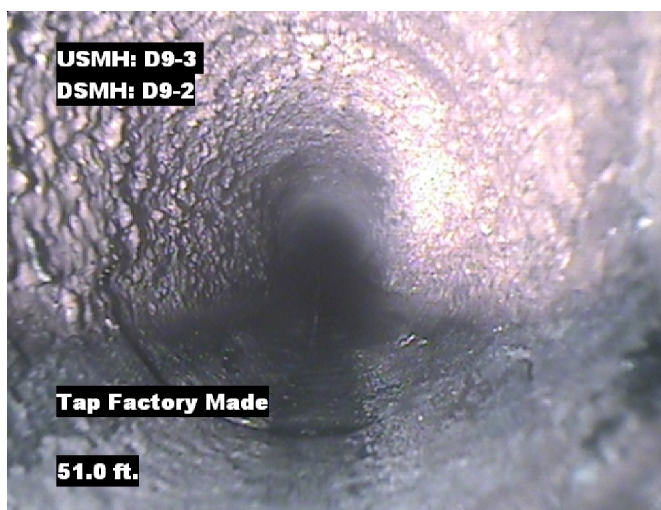
Distance: 51.0 ft. Grade: 0  
Condition: Tap Factory Made  
Remarks: N/A

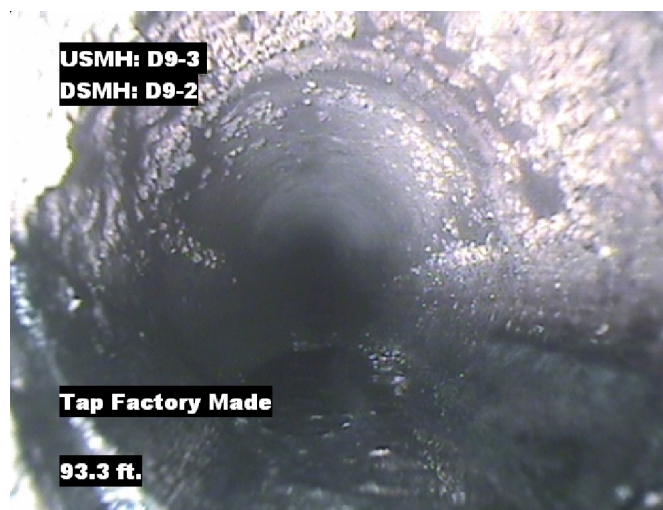
Distance: 93.3 ft. Grade: 0  
Condition: Tap Factory Made  
Remarks: N/A

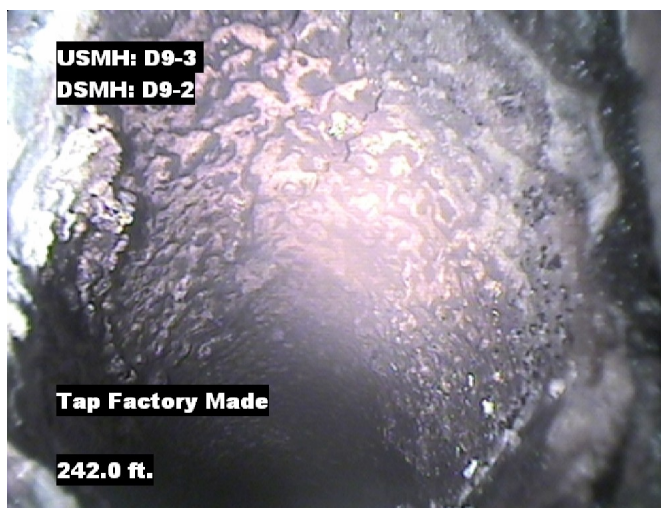
Distance: 242.0 ft. Grade: 0  
Condition: Tap Factory Made  
Remarks: N/A

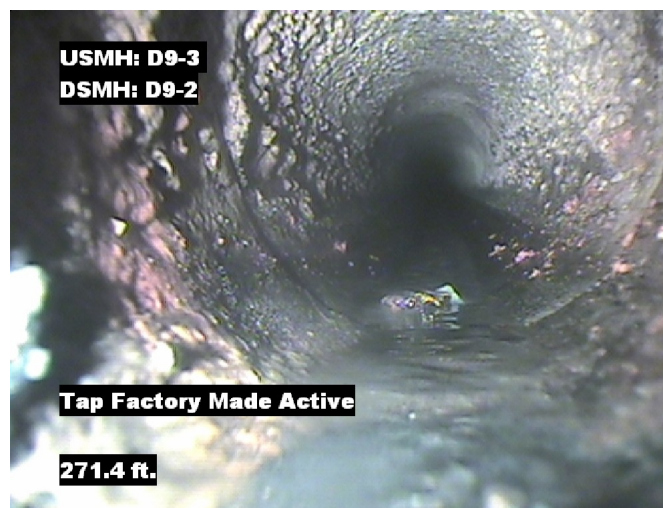
Distance: 271.4 ft. Grade: 0  
Condition: Tap Factory Made Active  
Remarks: N/A

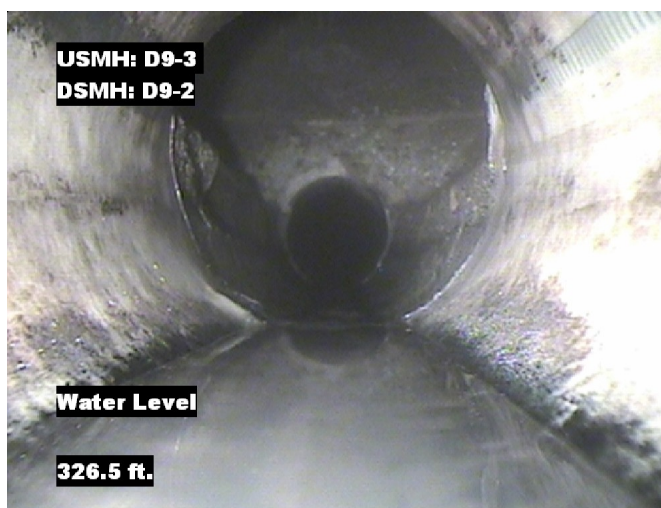
Distance: 326.5 ft. Grade: 0  
Condition: Water Level  
Remarks: N/A

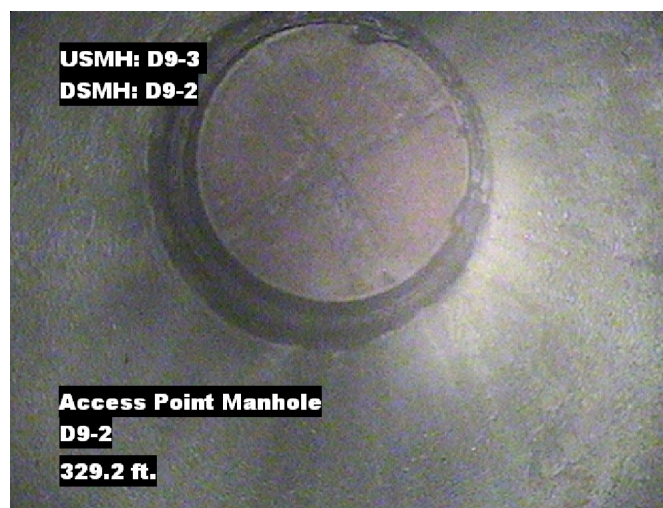
Distance: 329.2 ft. Grade: 0  
Condition: Access Point Manhole  
Remarks: D9-2
