Defect Listing

Pipe Segment Refere... D9-4_D9-3	City Oliver Springs	Street Midway Dr	Material Other	Location C... Light High...	Sewer Use Sanitary
Upstream MH D9-4	Total Length 240.2	Year Laid	Shape Circular	Location Details	
DS Manhole D9-3	Length surveyed 240.2	Year Renewed	Height 10	Width 10	Pipe Joint... N/A

SPR 3	MPR N/A	PO Number 4397-03	Customer GRW
SPRI 3	MPRI N/A	Work Order 4397-02	Purpose Pre-Rehabilitation Survey
QSR 3100	QMR N/A		
OPR 3	Surveyed By Barry Rogers	Direction Downstream	Date 20150701
OPRI 3	Certificate Number U-1012-16405	Pre-Cleaning Jetting	Time 14:41
	Date Cleaned 20150701	End Time 14:56	Weather Saturated
			Media label
			Additional Info

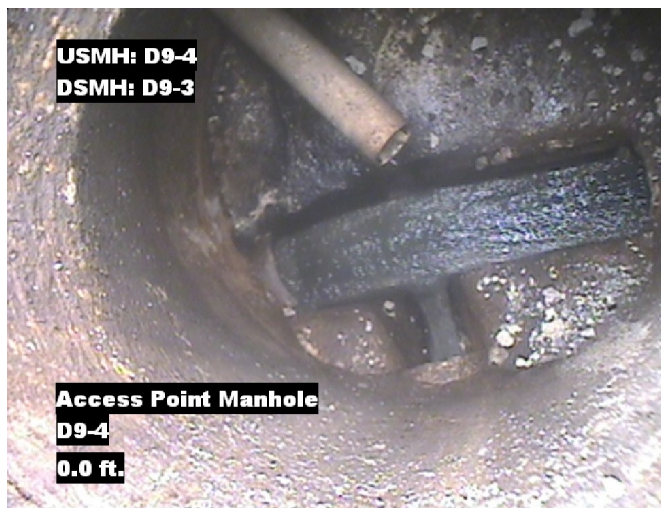
Distance: 0.0 ft. Grade: 0
Condition: Access Point Manhole
Remarks: D9-4

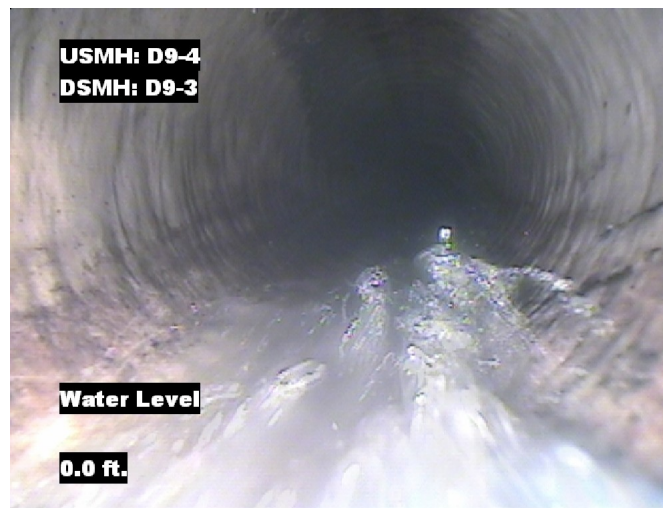
Distance: 0.0 ft. Grade: 0
Condition: Water Level
Remarks: N/A

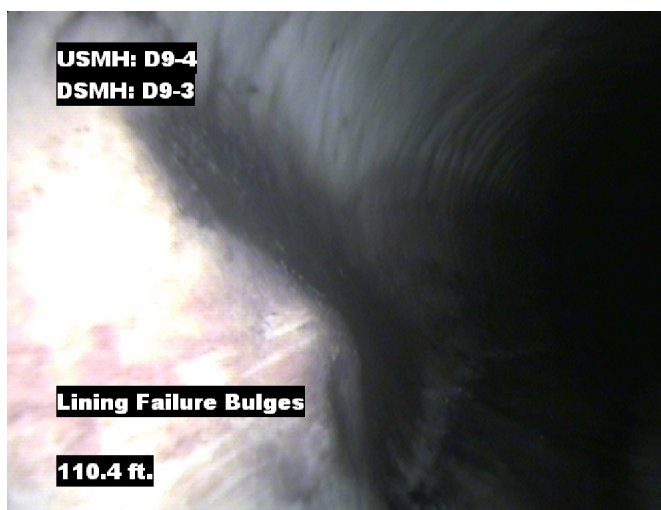
Distance: 110.4 ft. Grade: 3
Condition: Lining Failure Bulges
Remarks: N/A

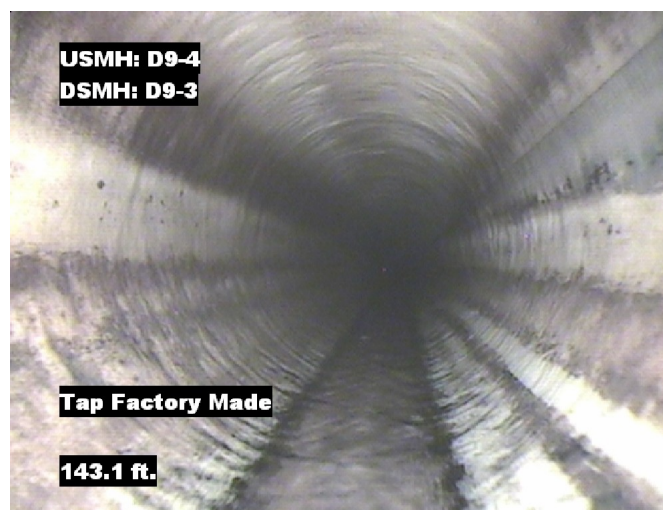
Distance: 143.1 ft. Grade: 0
Condition: Tap Factory Made
Remarks: N/A

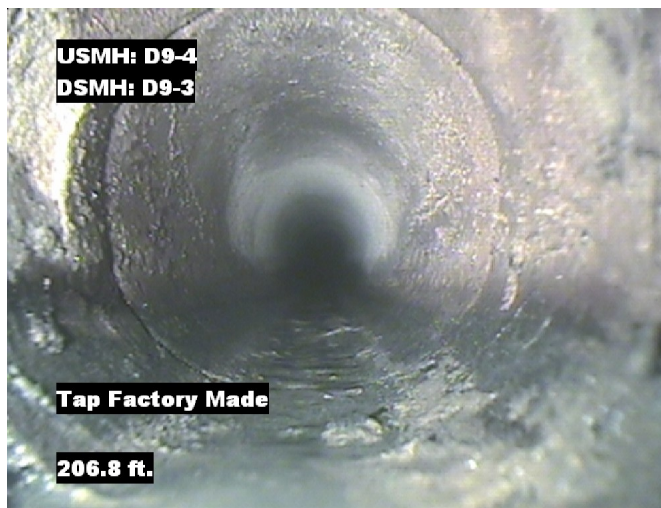
Distance: 206.8 ft. Grade: 0
Condition: Tap Factory Made
Remarks: N/A

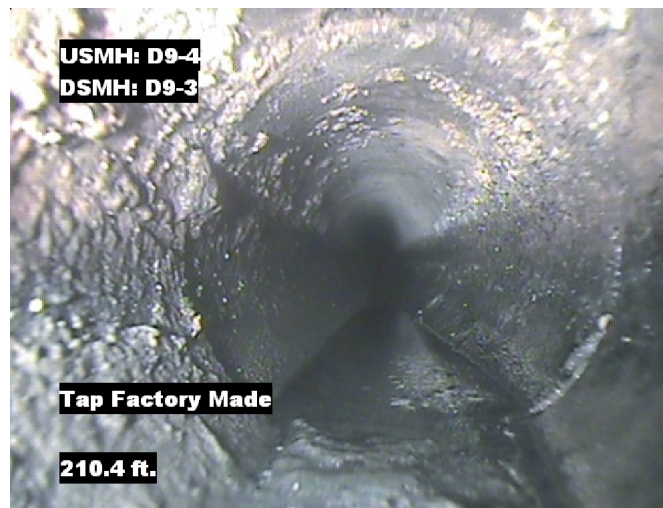
Distance: 210.4 ft. Grade: 0
Condition: Tap Factory Made
Remarks: N/A

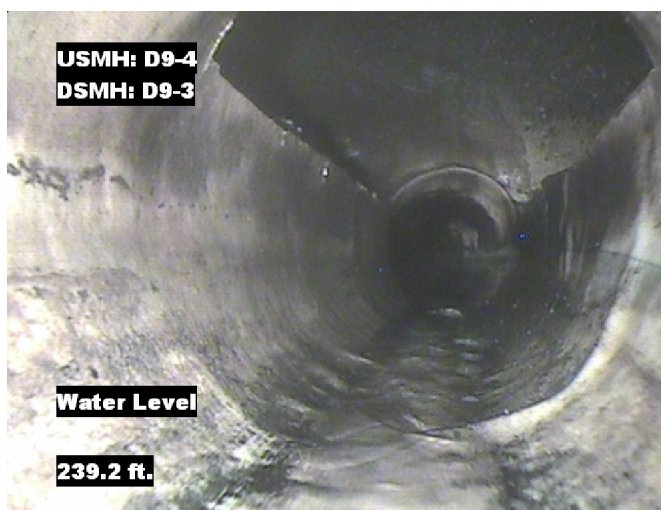
Distance: 239.2 ft. Grade: 0
Condition: Water Level
Remarks: N/A

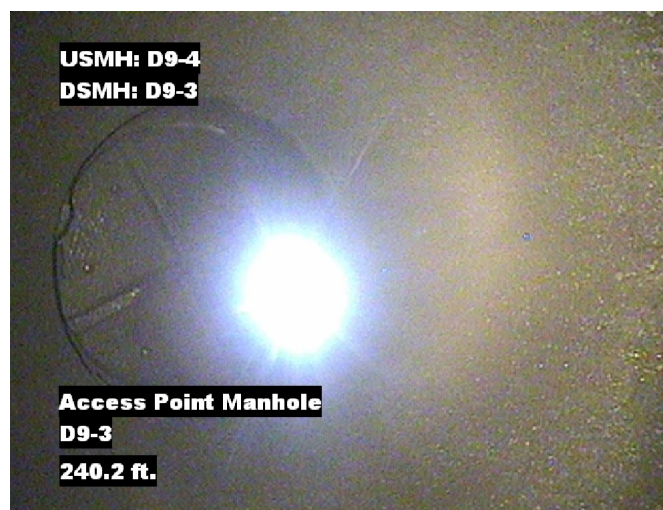
Distance: 240.2 ft. Grade: 0
Condition: Access Point Manhole
Remarks: D9-3
