Defect Listing

Pipe Segment Refere... D9-5_D9-4	City Oliver Springs	Street Midway Dr	Material Concrete Pipe (non-...	Location C... Light High...	Sewer Use Sanitary
Upstream MH D9-5	Total Length 362.3	Year Laid	Shape Circular	Location Details	
DS Manhole D9-4	Length surveyed 362.3	Year Renewed	Height 10	Width 10	Pipe Joint... 4

SPR 6	MPR 6	PO Number 4397-03	Customer GRW
SPRI 3	MPRI 3	Work Order 4397-02	Purpose Pre-Rehabilitation Survey
QSR 5111	QMR 4121		
OPR 12	Surveyed By Barry Rogers	Direction Downstream	Date 20150701
OPRI 3	Certificate Number U-1012-16405	Pre-Cleaning Jetting	Time 14:09
	Date Cleaned 20150701	End Time 14:24	Weather Light Rain
		Additional Info

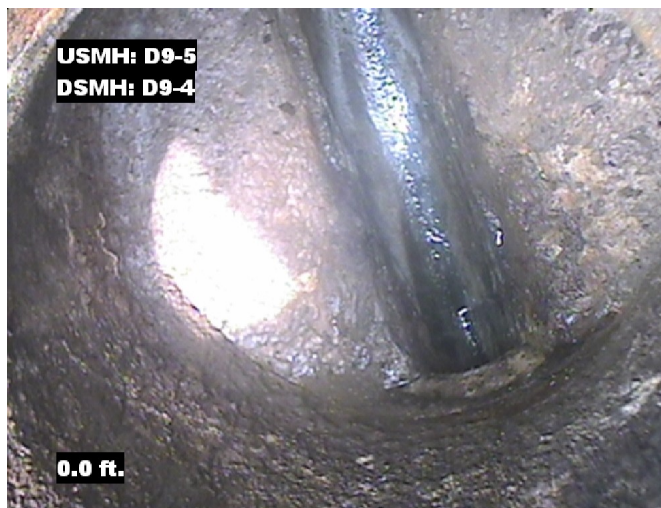
Distance: 0.0 ft. Grade: 0
Condition: Access Point Manhole
Remarks: D9-5

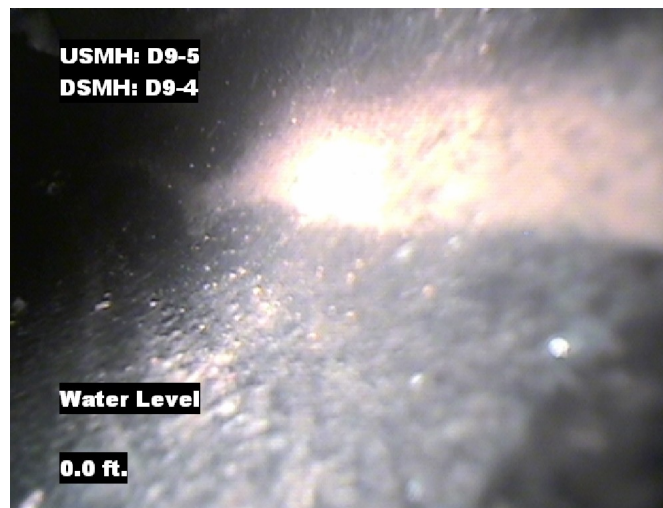
Distance: 0.0 ft. Grade: 0
Condition: Water Level
Remarks: N/A

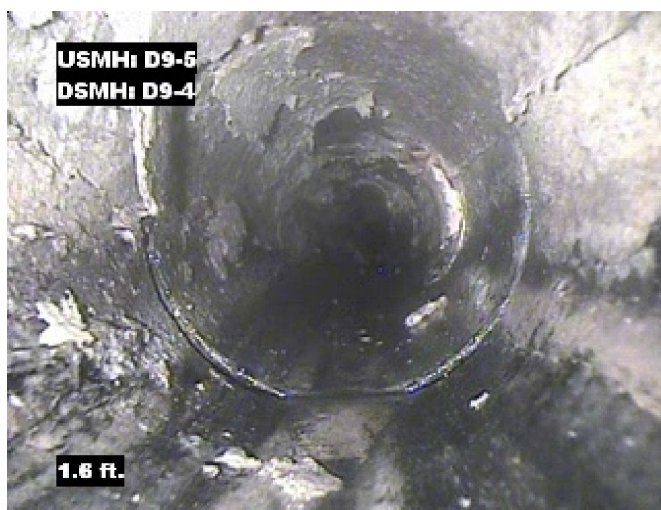
0.0 ft.	Water Level				5	<input type="checkbox"/>			
1.6 ft.	Deposits Attached Grease				10	<input type="checkbox"/>	8	4	2
Remarks: CONT. DEFECT

Distance: 1.6 ft. Grade: 2
Condition: Deposits Attached Grease
Remarks: CONT. DEFECT

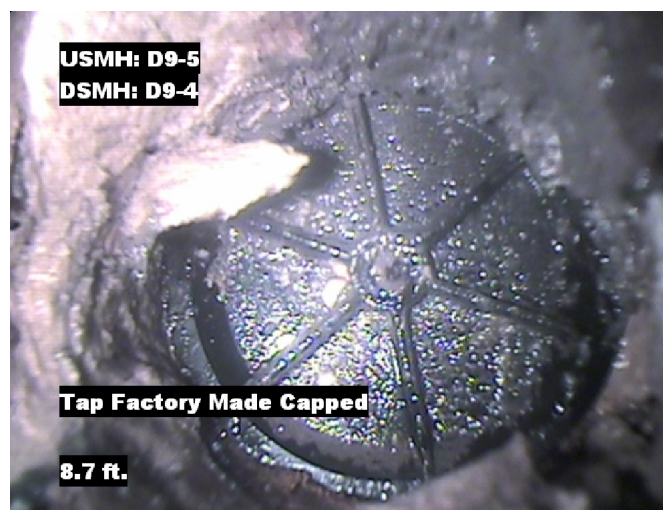
Distance: 8.7 ft. Grade: 0
Condition: Tap Factory Made Capped
Remarks: N/A

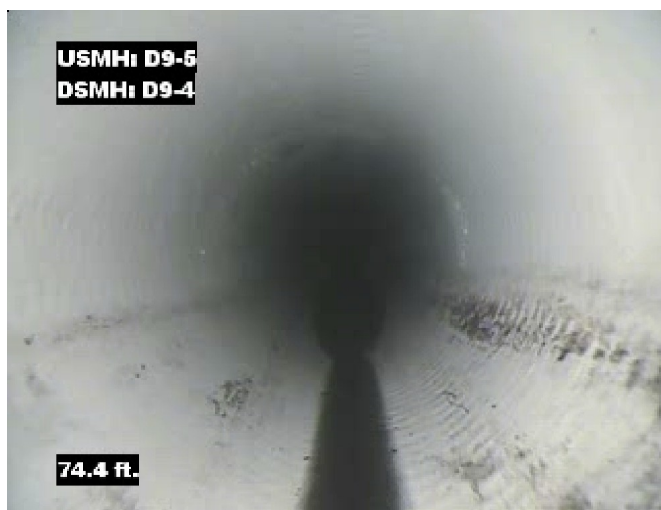
Distance: 74.4 ft. Grade: 0
Condition: Repair Point Pipe Replaced
Remarks: PVC

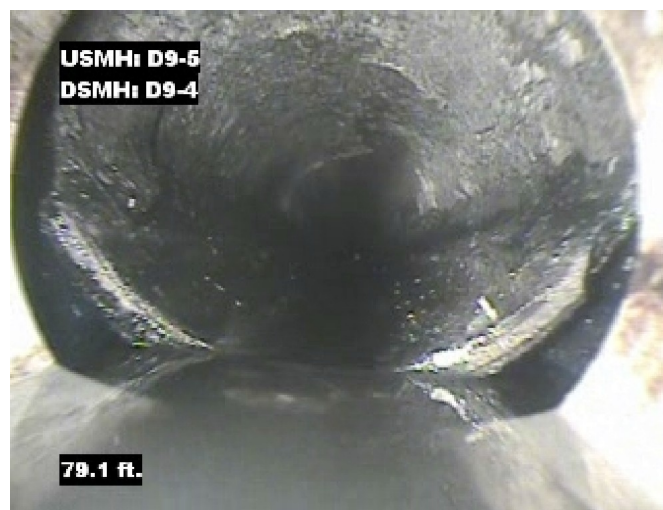
Distance: 79.1 ft. Grade: 1
Condition: Joint Offset Medium
Remarks: N/A

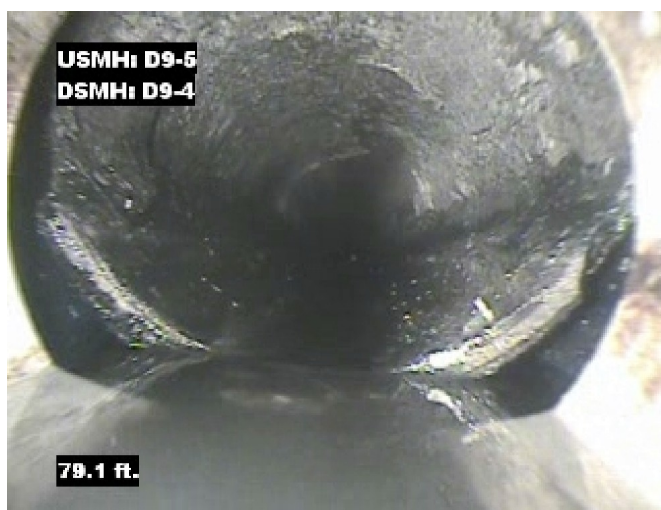
Distance: 79.1 ft. Grade: 5
Condition: Hole Void Visible
Remarks: N/A

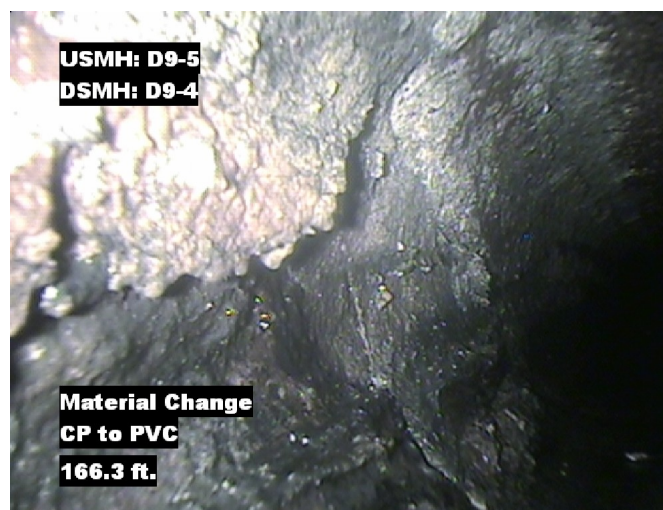
Distance: 166.3 ft. Grade: 0
Condition: Material Change
Remarks: CP to PVC

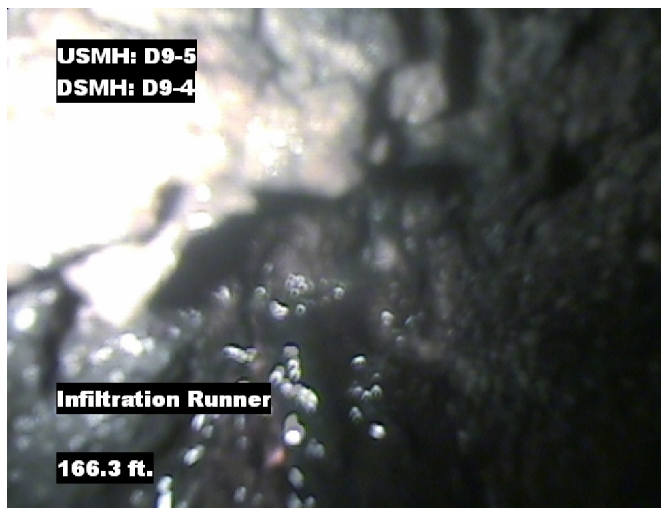
Distance: 166.3 ft. Grade: 4
Condition: Infiltration Runner
Remarks: N/A

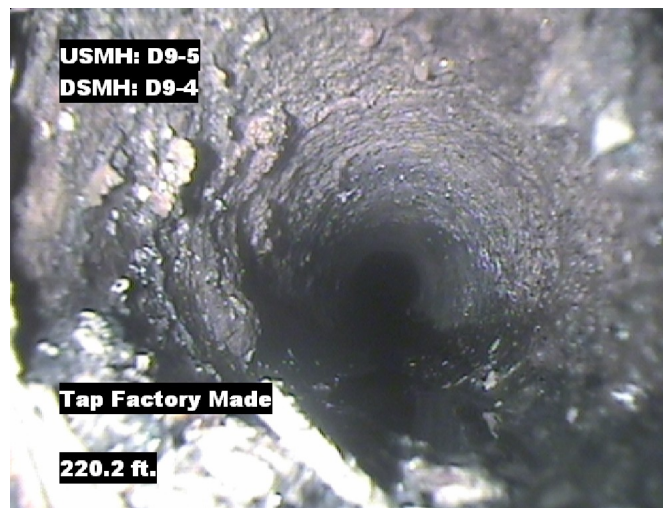
Distance: 220.2 ft. Grade: 0
Condition: Tap Factory Made
Remarks: N/A

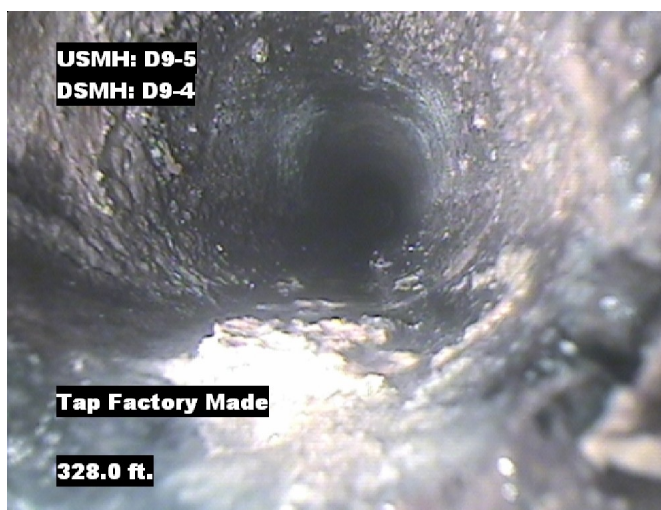
Distance: 328.0 ft. Grade: 0
Condition: Tap Factory Made
Remarks: N/A

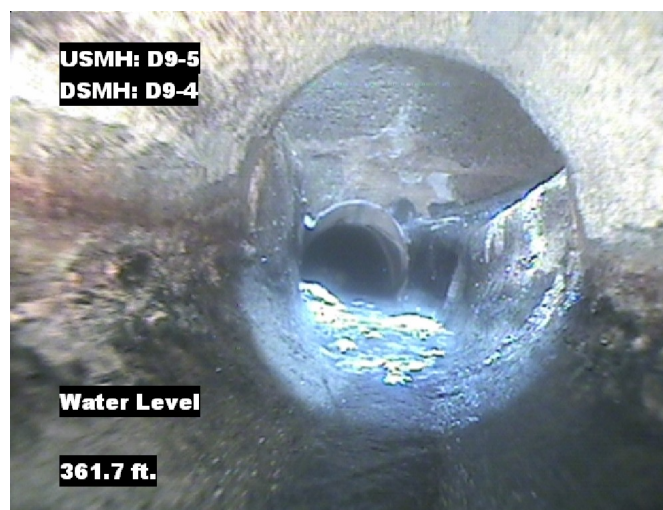
Distance: 361.7 ft. Grade: 0
Condition: Water Level
Remarks: N/A

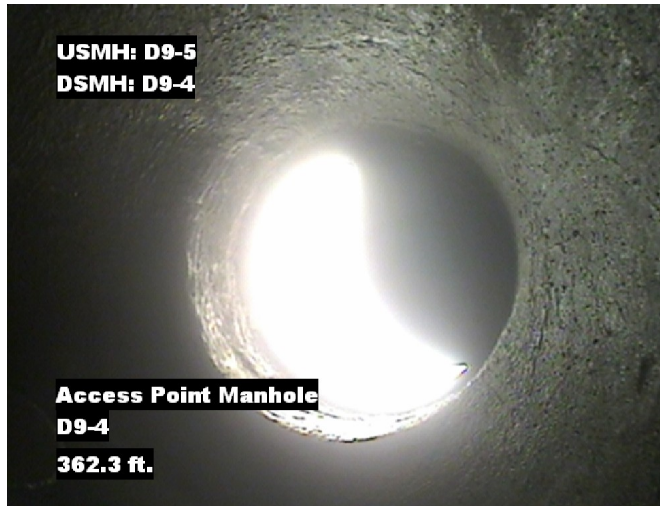
Distance: 362.3 ft. Grade: 0
Condition: Access Point Manhole
Remarks: D9-4
