Defect Listing

Pipe Segment Refere... E-10_E-9	City Oliver Springs	Street Oak Circle	Material Concrete Pipe (non-...	Location C... Easement/R...	Sewer Use Sanitary
Upstream MH E-10	Total Length 365.3	Year Laid	Shape Circular	Location Details Cow Pasture	
DS Manhole E-9	Length surveyed 365.3	Year Renewed	Height 8	Width 8	Pipe Joint... 4

SPR N/A	MPR 13	PO Number 4397-03	Customer GRW
SPRI N/A	MPRI 2.6	Work Order 4397-02	Purpose Pre-Rehabilitation Survey
QSR N/A	QMR 4131		
OPR 13	Surveyed By Barry Rogers	Direction Downstream	Date 20150610
OPRI 2.6	Certificate Number U-1012-16405	Pre-Cleaning Jetting	Time 10:41
	Date Cleaned 20150610	End Time 11:00	Weather Dry
			Additional Info

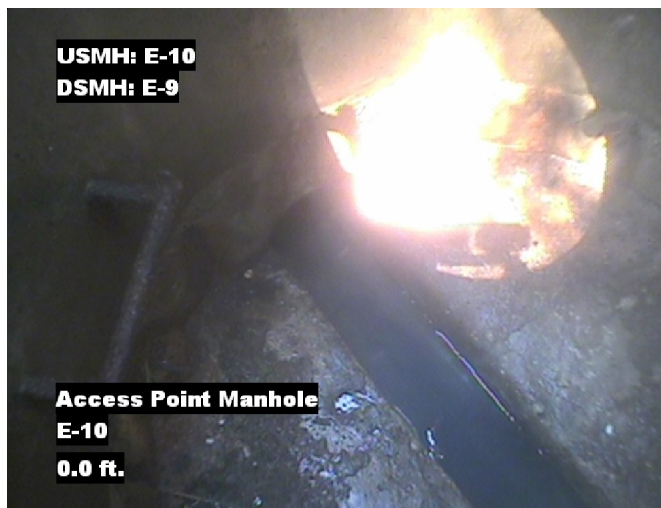
Distance: 0.0 ft. Grade: 0
Condition: Access Point Manhole
Remarks: E-10

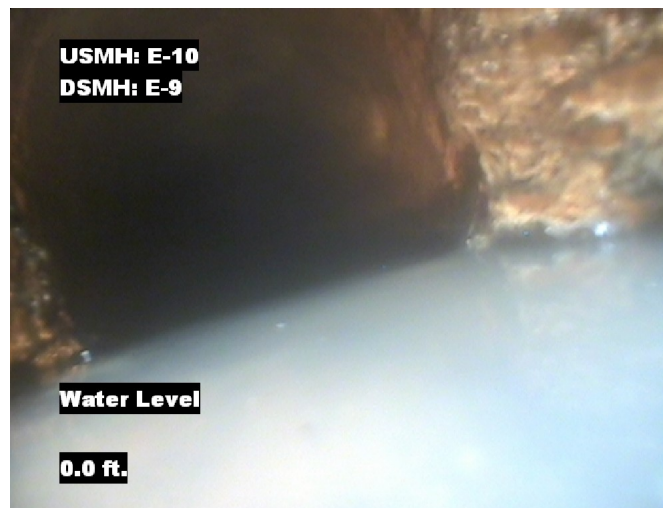
Distance: 0.0 ft. Grade: 0
Condition: Water Level
Remarks: N/A

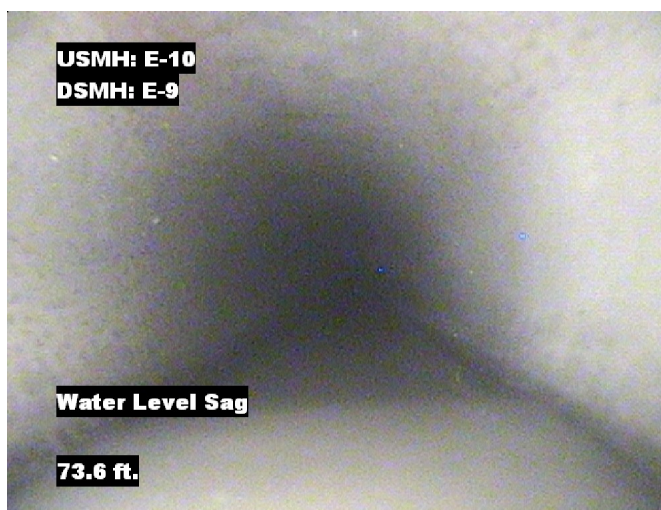
Distance: 73.5 ft. Grade: 2
Condition: Water Level Sag
Remarks: N/A

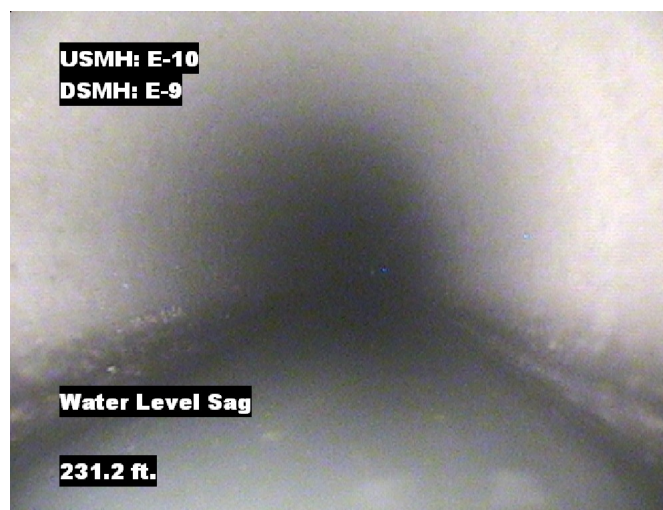
Distance: 231.2 ft. Grade: 2
Condition: Water Level Sag
Remarks: N/A

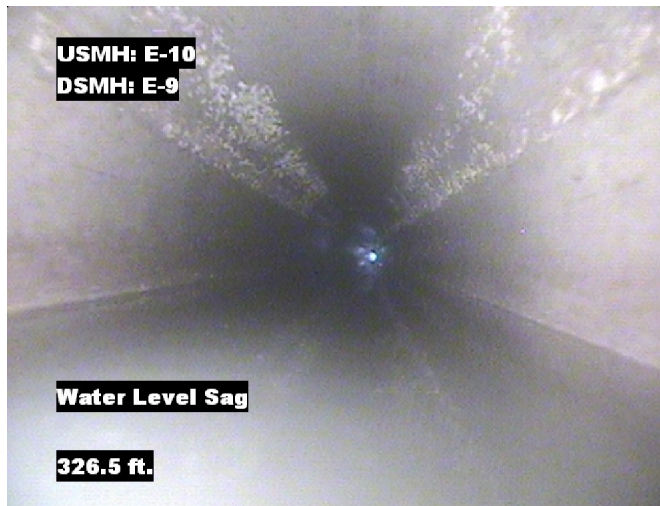
Distance: 326.4 ft. Grade: 2
Condition: Water Level Sag
Remarks: N/A

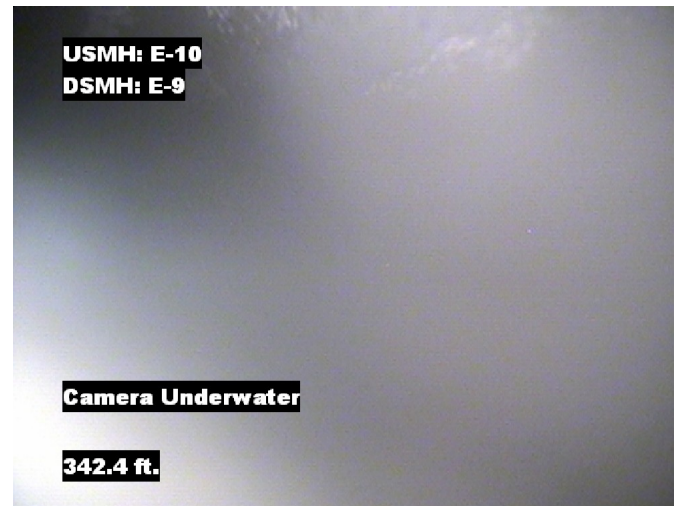
Distance: 342.4 ft. Grade: 4
Condition: Camera Underwater
Remarks: N/A

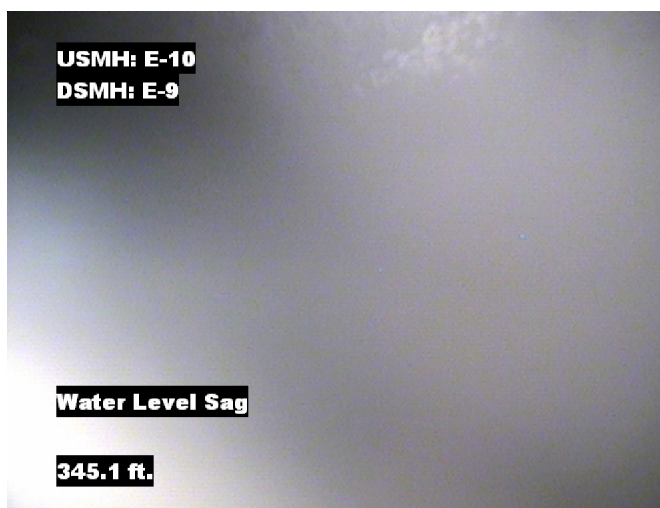
Distance: 345.1 ft. Grade: 3
Condition: Water Level Sag
Remarks: N/A

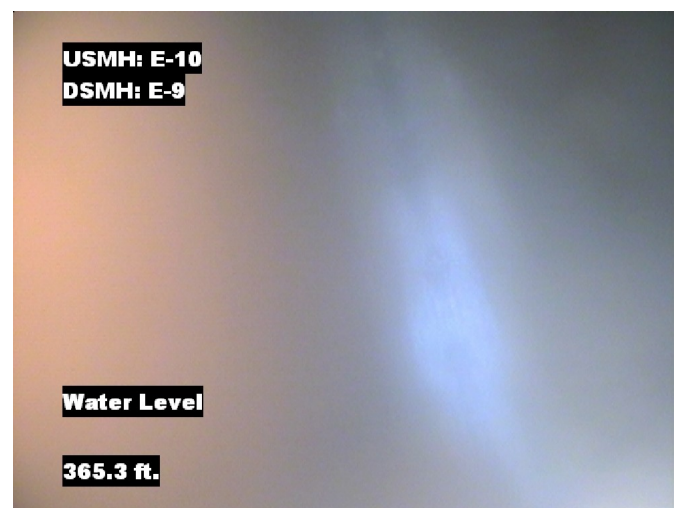
Distance: 365.3 ft. Grade: 0
Condition: Water Level
Remarks: N/A

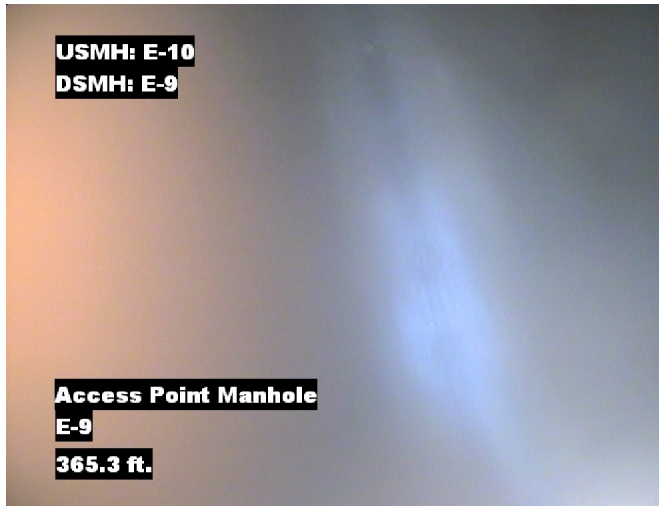
Distance: 365.3 ft. Grade: 0
Condition: Access Point Manhole
Remarks: E-9
