Defect Listing

Pipe Segment Refere		City		Street	Mat	Material		Sewer Use	
E-11_E-10		Oliver Springs		NUII	Concrete Pipe (non		Easement/R	Sanitary	
Upstream MH		Total Length		Year Laid	Sha	ape	Location Details		
E-11		36	9.7		Circ	ular	Cow Pasture		
DS Manhole		Length surveyed		Year Renewed	Height	Width	Pipe Joint		
E-	E-10		9.7		8	8	4		
SPR	N/A	MPR	10	PO Number		Customer			
CDDI	NI/A	MDDI		4397-03			GRW		
SPRI	N/A	MPRI	2.5	Work Order		Purpose			
QSR	N/A	QMR	4123	4397-02	4397-02		Pre-Rehabilitation Surv		
OF	PR	Surve	yed By	Direction	Date		Media label		
1	0	Barry_Rogers		Downstream	20150610				
OF	PRI	Certificate Number		Pre-Cleaning	Time		Weather		
2.5		U-1012-16405		Jetting	08:42		Dry		
		Date C	Cleaned	End Time		Additional Info			
		2015	0610	09:22

Image Report 4/Page

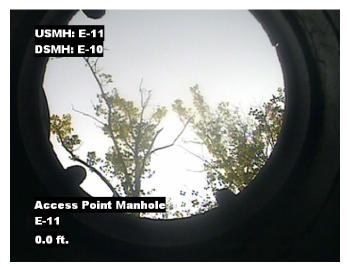
Distance: 0.0 ft. Grade: 0

Condition: Access Point Manhole

Remarks: E-11

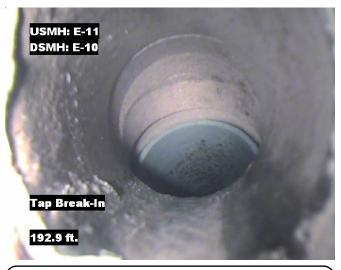
Distance: 192.9 ft. Grade: 0

Condition: Tap Break-In

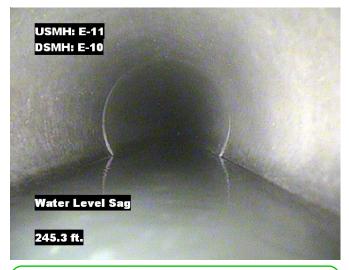
Distance: 245.3 ft. Grade: 2

Condition: Water Level Sag

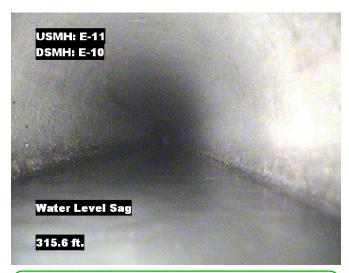
Distance: 315.6 ft. Grade: 2

Condition: Water Level Sag

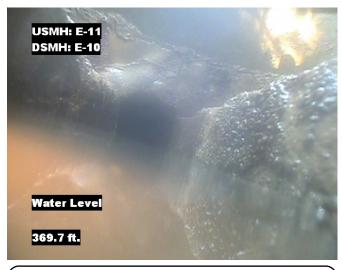
Distance: 369.7 ft. Grade: 0

Condition: Water Level

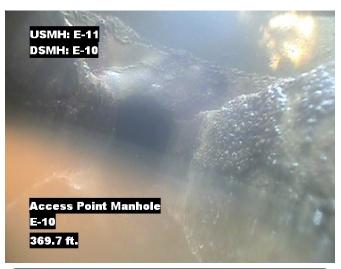
Distance: 369.7 ft. Grade: 0

Condition: Access Point Manhole

Remarks: E-10
