Defect Listing

Pipe Segment Refere... E-12_E-12A	City Oliver Springs	Street 745 Sleepy Hollow	Material PolyVinyl Chloride	Location C... Yard	Sewer Use Sanitary
Upstream MH E-12	Total Length 312.7	Year Laid	Shape Circular	Location Details Front Yard	
DS Manhole E-12A	Length surveyed 312.7	Year Renewed	Height 8	Width 8	Pipe Joint... 13

SPR N/A	MPR 16	PO Number 4397-03	Customer GRW
SPRI N/A	MPRI 2.3	Work Order 4397-02	Purpose Pre-Rehabilitation Survey
QSR N/A	QMR 4126		
OPR 16	Surveyed By Barry Rogers	Direction Downstream	Date 20150608
OPRI 2.3	Certificate Number U-1012-16405	Pre-Cleaning No Pre-Cleaning	Time 12:01
	Date Cleaned	End Time 12:24	Weather Dry
		Additional Info

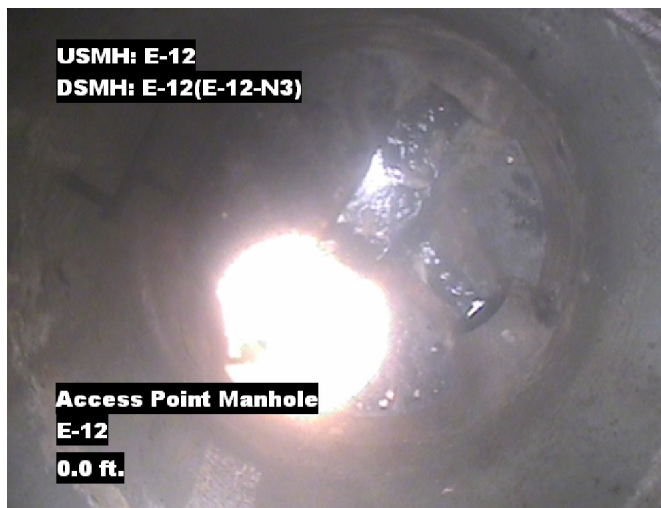
Distance: 0.0 ft. Grade: 0
Condition: Access Point Manhole
Remarks: E-12

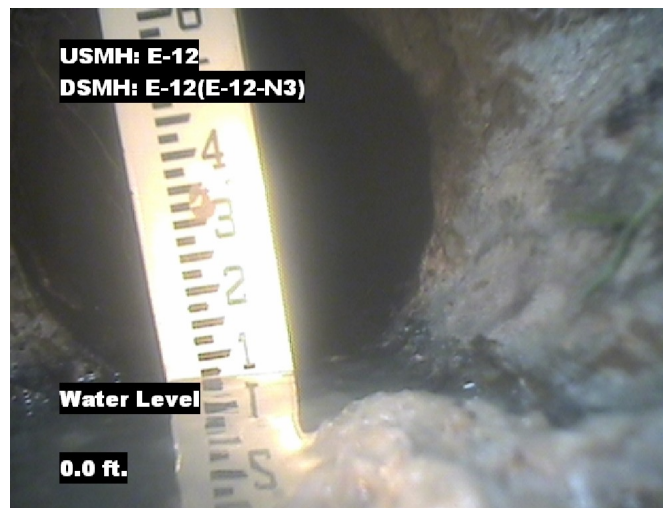
Distance: 0.0 ft. Grade: 0
Condition: Water Level
Remarks: N/A

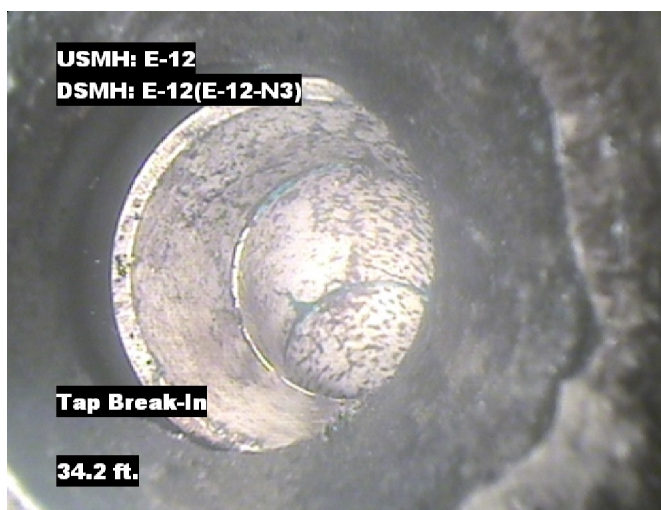
Distance: 34.2 ft. Grade: 0
Condition: Tap Break-In
Remarks: N/A

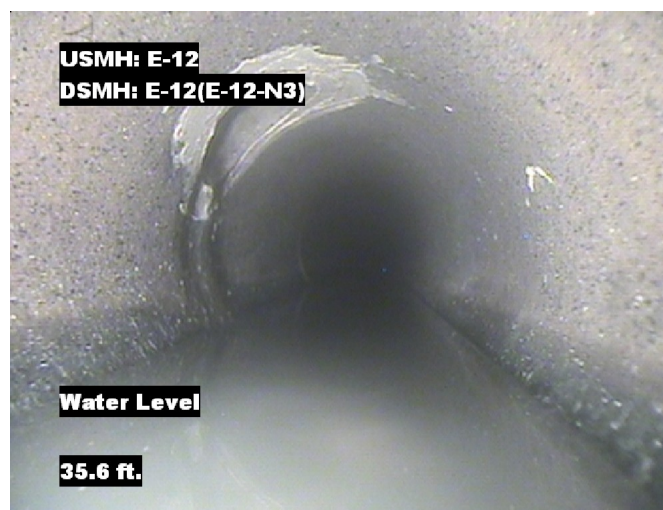
Distance: 35.6 ft. Grade: 0
Condition: Water Level
Remarks: N/A

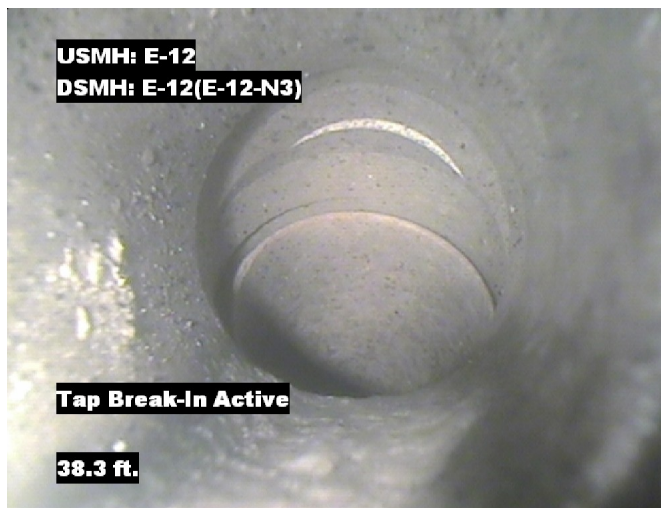
Distance: 38.3 ft. Grade: 0
Condition: Tap Break-In Active
Remarks: N/A

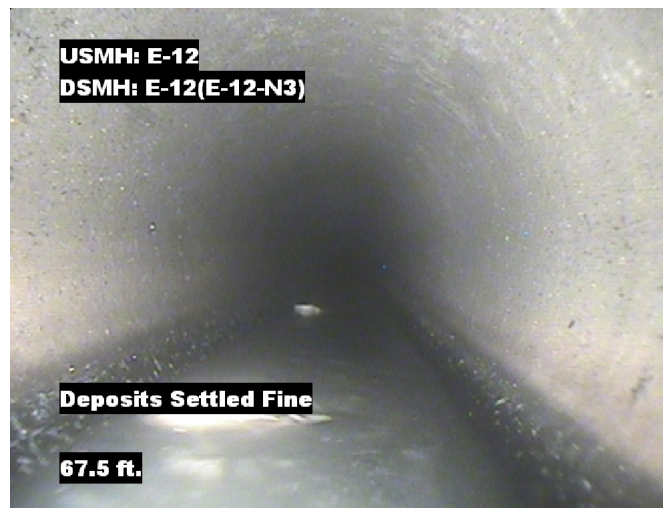
Distance: 67.5 ft. Grade: 2
Condition: Deposits Settled Fine
Remarks: N/A

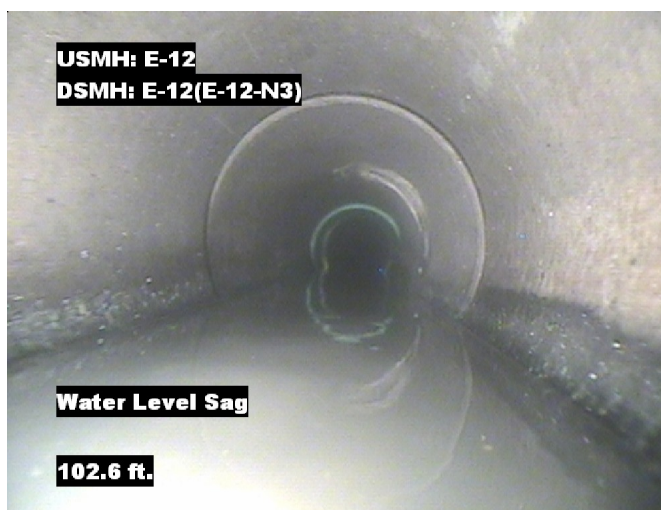
Distance: 102.6 ft. Grade: 2
Condition: Water Level Sag
Remarks: N/A

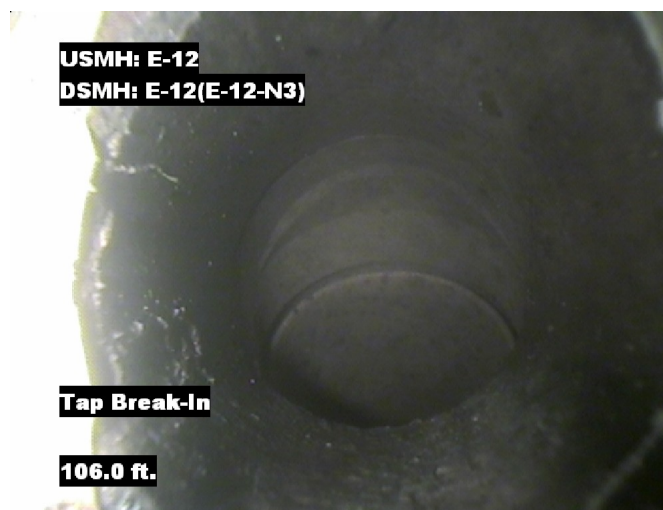
Distance: 106.0 ft. Grade: 0
Condition: Tap Break-In
Remarks: N/A

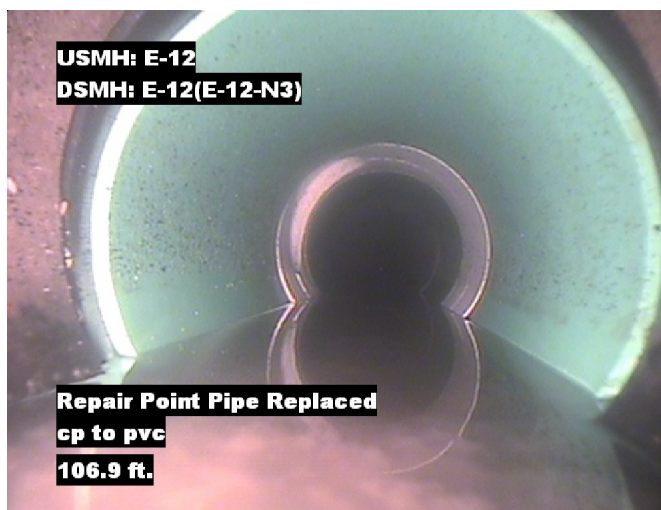
Distance: 106.9 ft. Grade: 0
Condition: Repair Point Pipe Replaced
Remarks: cp to pvc

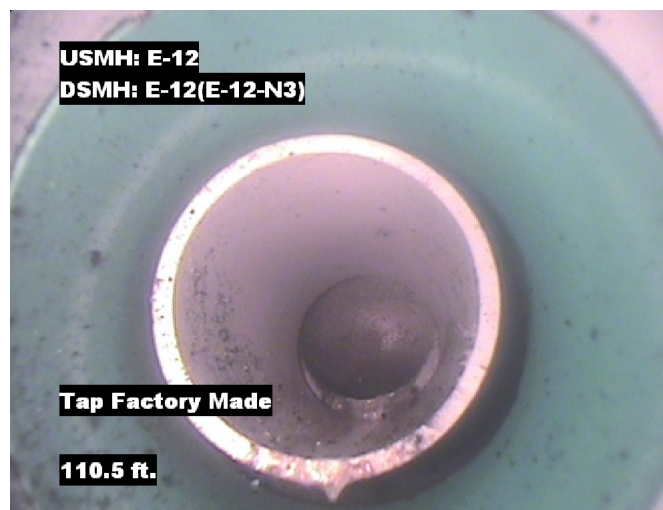
Distance: 110.5 ft. Grade: 0
Condition: Tap Factory Made
Remarks: N/A

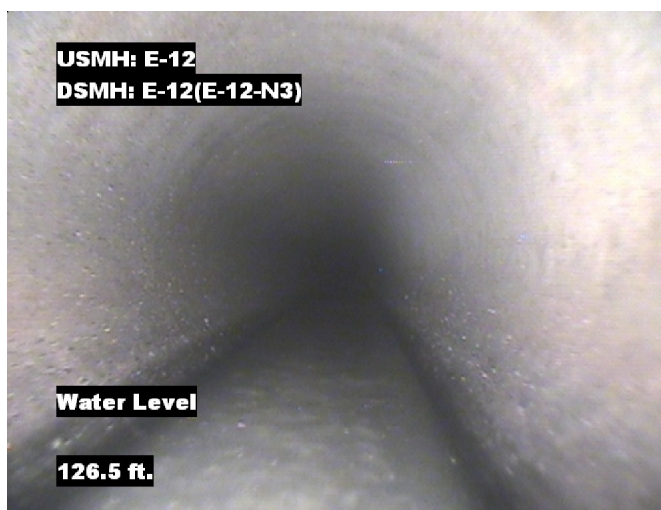
Distance: 126.4 ft. Grade: 0
Condition: Water Level
Remarks: N/A

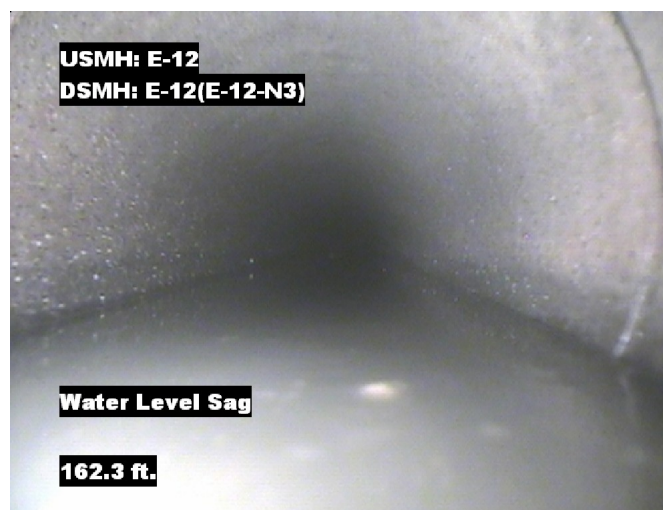
Distance: 162.3 ft. Grade: 2
Condition: Water Level Sag
Remarks: N/A

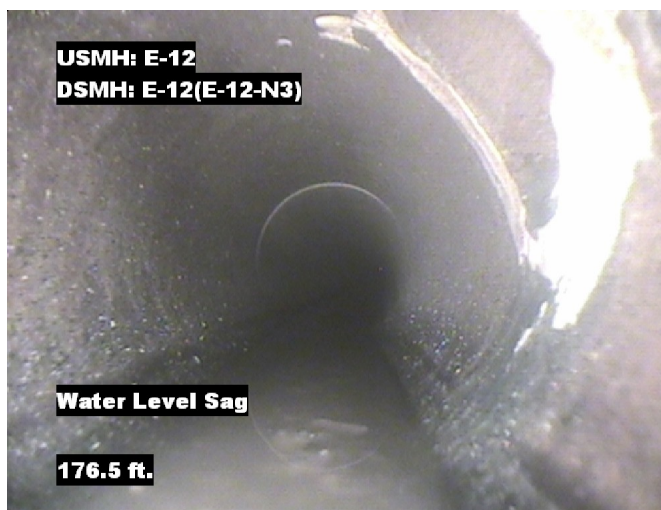
Distance: 176.5 ft. Grade: 2
Condition: Water Level Sag
Remarks: N/A

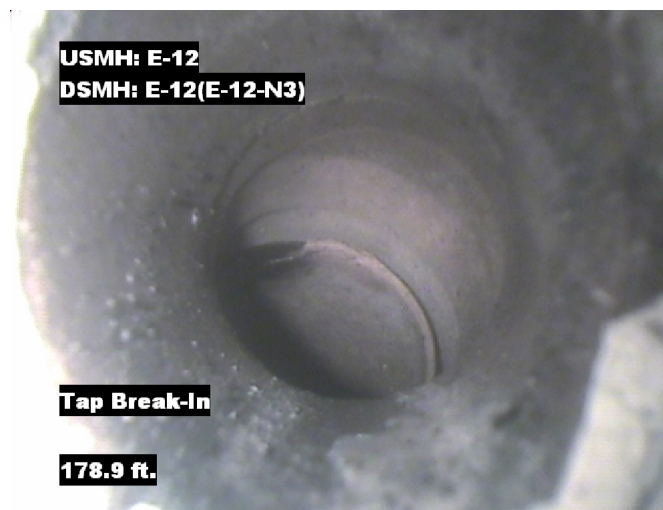
Distance: 178.9 ft. Grade: 0
Condition: Tap Break-In
Remarks: N/A

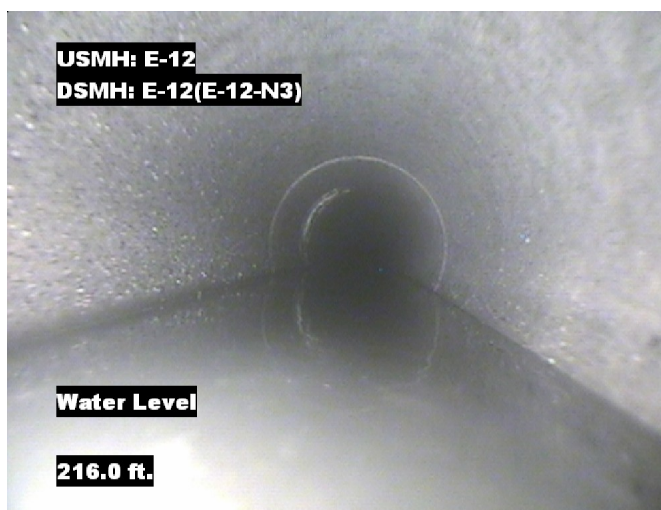
Distance: 216.0 ft. Grade: 0
Condition: Water Level
Remarks: N/A

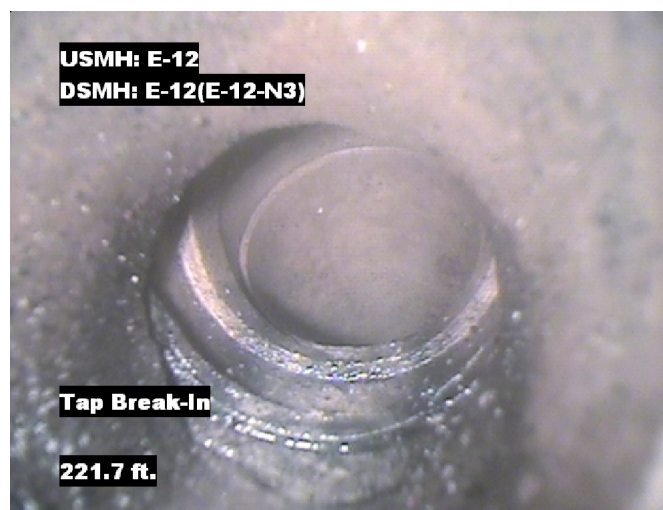
Distance: 221.7 ft. Grade: 0
Condition: Tap Break-In
Remarks: N/A

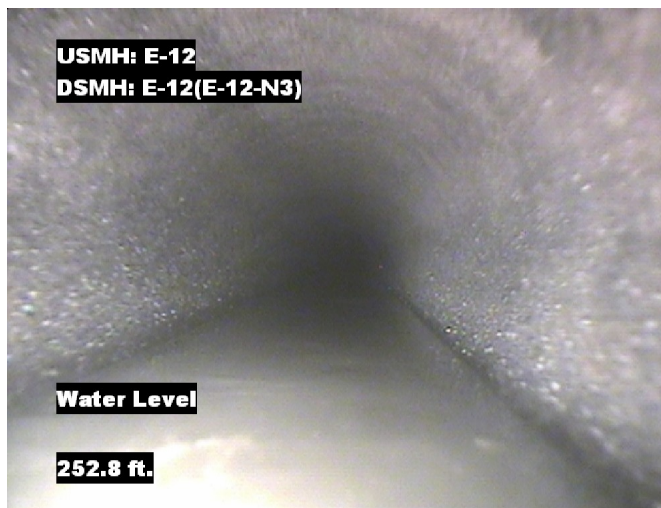
Distance: 252.8 ft. Grade: 0
Condition: Water Level
Remarks: N/A

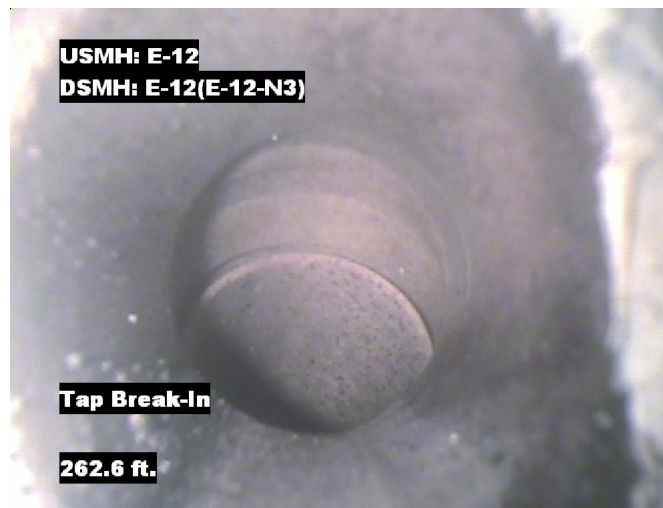
Distance: 262.6 ft. Grade: 0
Condition: Tap Break-In
Remarks: N/A

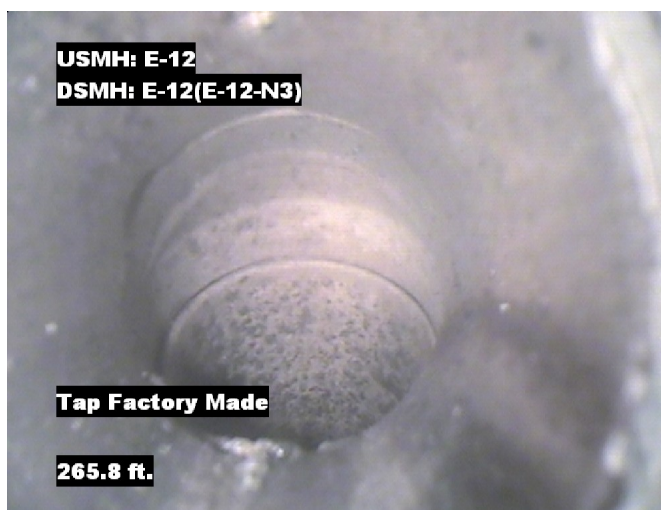
Distance: 265.8 ft. Grade: 0
Condition: Tap Factory Made
Remarks: N/A

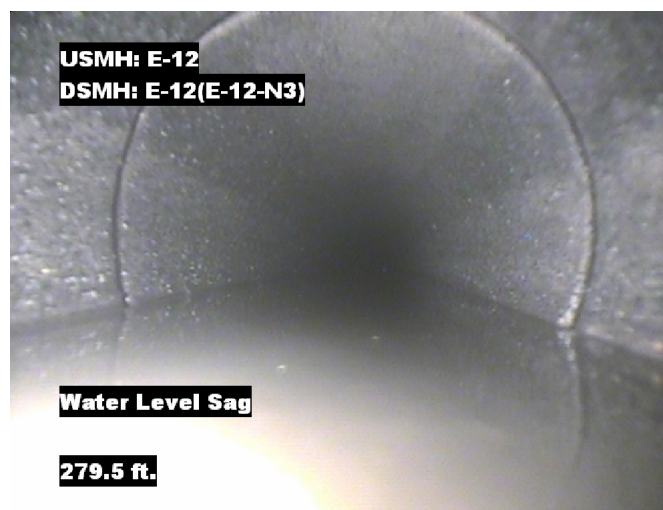
Distance: 279.4 ft. Grade: 2
Condition: Water Level Sag
Remarks: N/A

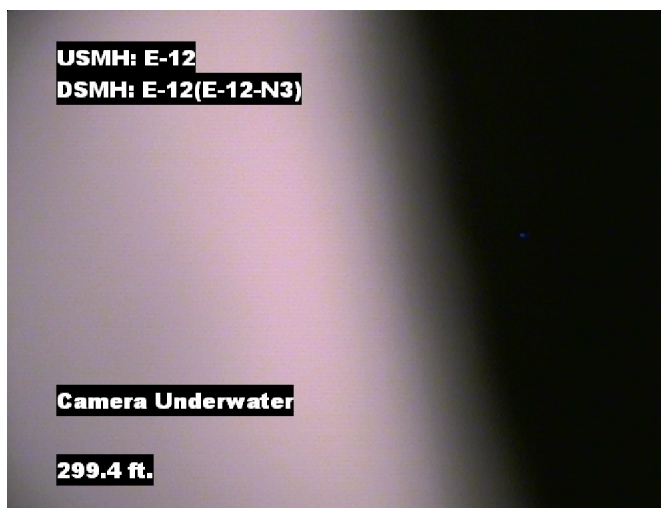
Distance: 299.4 ft. Grade: 4
Condition: Camera Underwater
Remarks: N/A

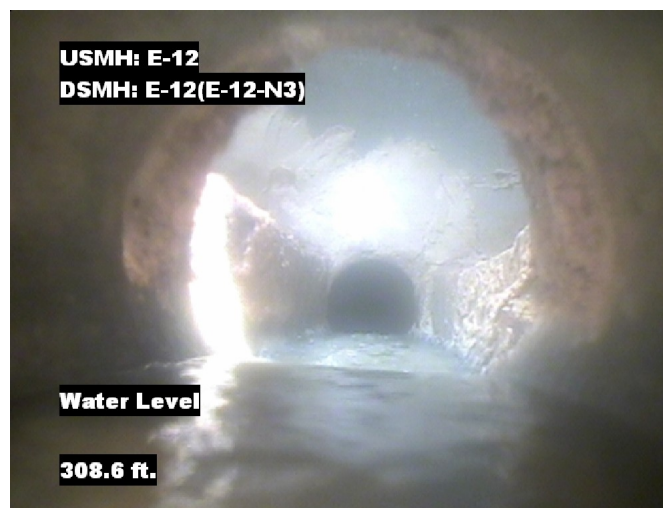
Distance: 308.6 ft. Grade: 0
Condition: Water Level
Remarks: N/A

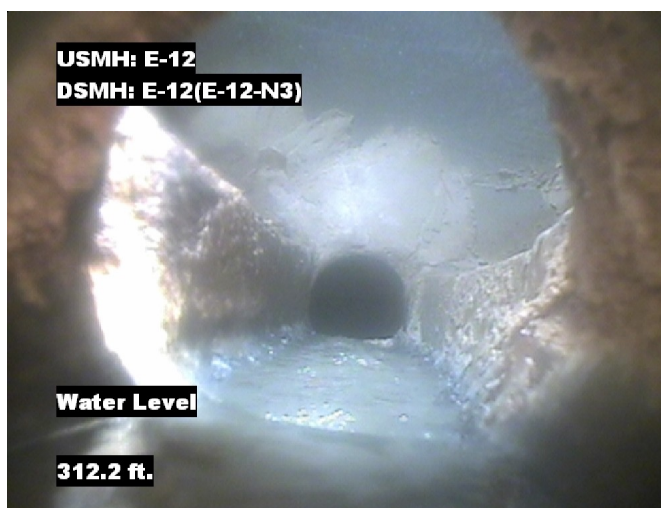
Distance: 312.2 ft. Grade: 0
Condition: Water Level
Remarks: N/A

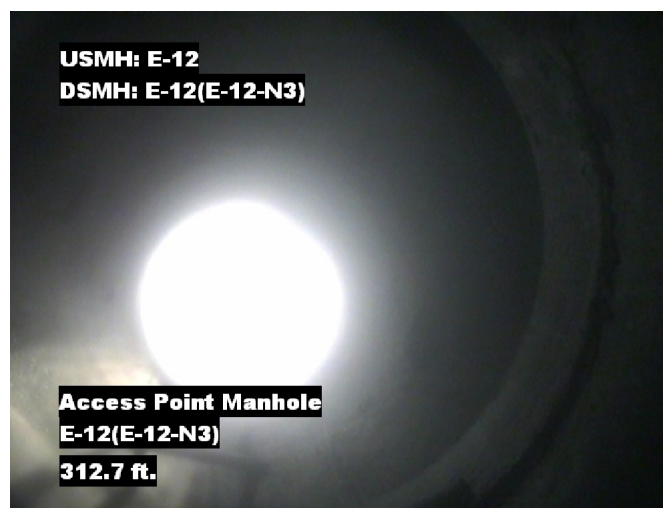
Distance: 312.7 ft. Grade: 0
Condition: Access Point Manhole
Remarks: E-12A
