Defect Listing

Pipe Segment Refere... E-12A_E-12B	City Oliver Springs	Street 761 Sleepy Hollow	Material PolyVinyl Chloride	Location C... Yard	Sewer Use Sanitary
Upstream MH E-12A	Total Length 135.7	Year Laid	Shape Circular	Location Details Front Yard	
DS Manhole E-12B	Length surveyed 135.7	Year Renewed	Height 8	Width 8	Pipe Joint... 13

SPR 81	MPR 2	PO Number 4397-03	Customer GRW
SPRI 3	MPRI 2	Work Order 4397-02	Purpose Pre-Rehabilitation Survey
QSR 3D00	QMR 2100		
OPR 83	Surveyed By Barry Rogers	Direction Downstream	Date 20150608
OPRI 3	Certificate Number U-1012-16405	Pre-Cleaning No Pre-Cleaning	Time 12:44
	Date Cleaned	End Time 12:52	Weather Dry
		Additional Info

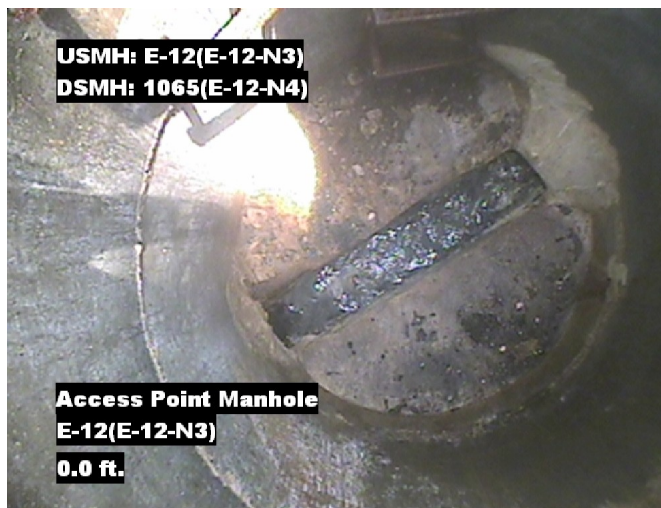
Distance: 0.0 ft. Grade: 0
Condition: Access Point Manhole
Remarks: E-12A

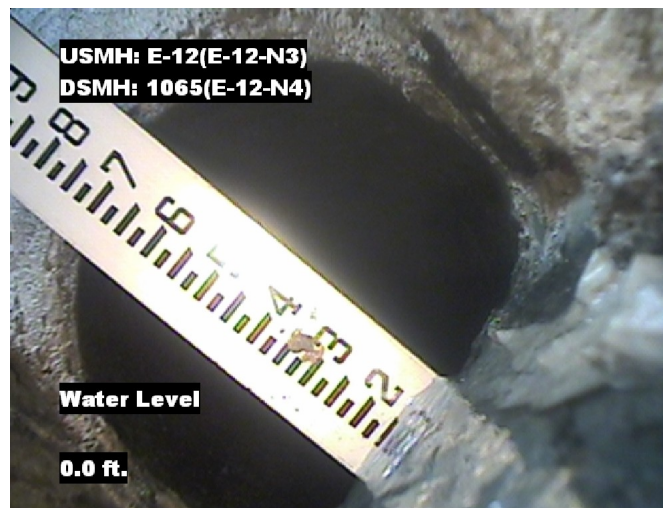
Distance: 0.0 ft. Grade: 0
Condition: Water Level
Remarks: N/A

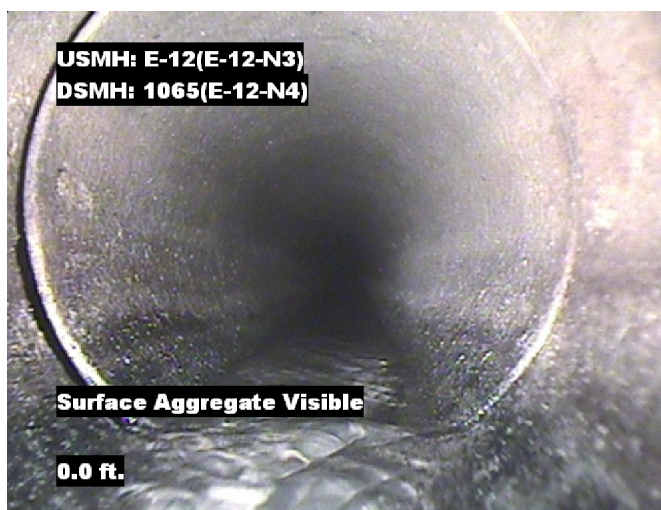
Distance: 0.0 ft. Grade: 3
Condition: Surface Aggregate Visible
Remarks: N/A

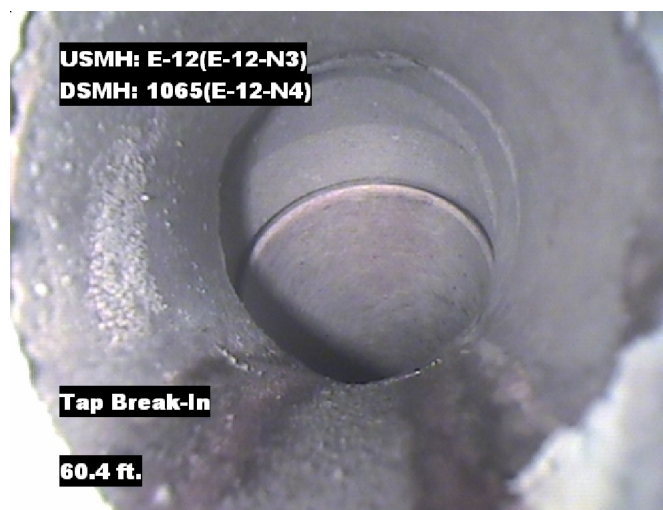
Distance: 60.4 ft. Grade: 0
Condition: Tap Break-In
Remarks: N/A

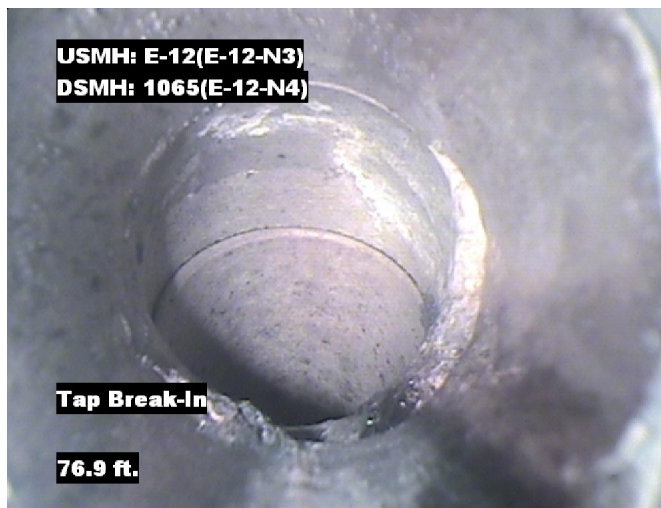
Distance: 76.9 ft. Grade: 0
Condition: Tap Break-In
Remarks: N/A

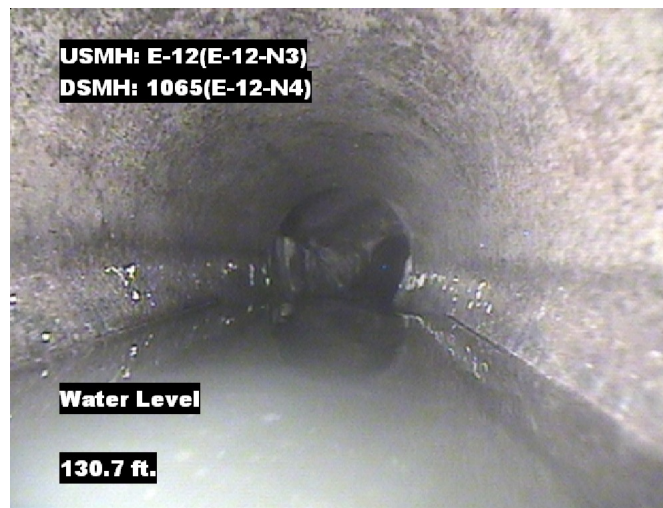
Distance: 130.7 ft. Grade: 0
Condition: Water Level
Remarks: N/A

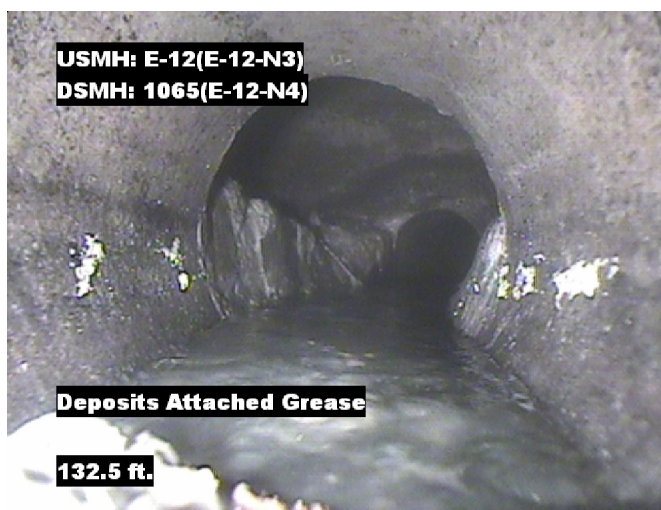
Distance: 132.5 ft. Grade: 2
Condition: Deposits Attached Grease
Remarks: N/A

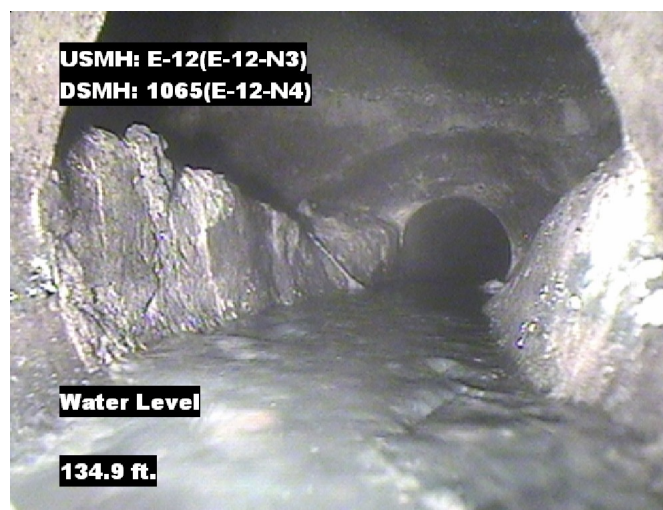
Distance: 134.9 ft. Grade: 0
Condition: Water Level
Remarks: N/A

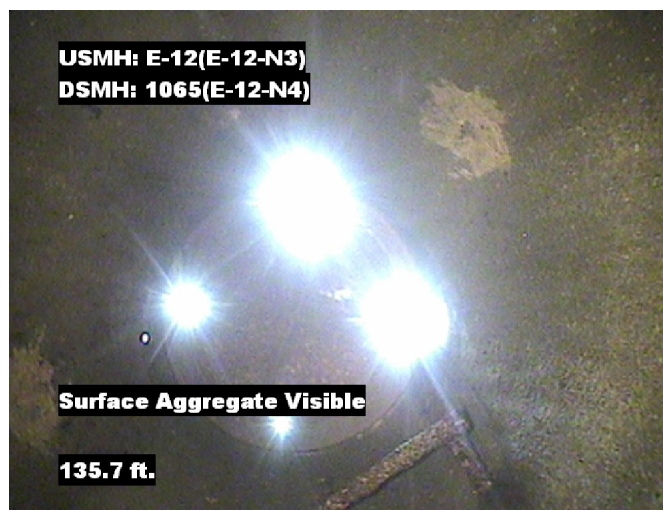
Distance: 135.0 ft. Grade: 3
Condition: Surface Aggregate Visible
Remarks: N/A

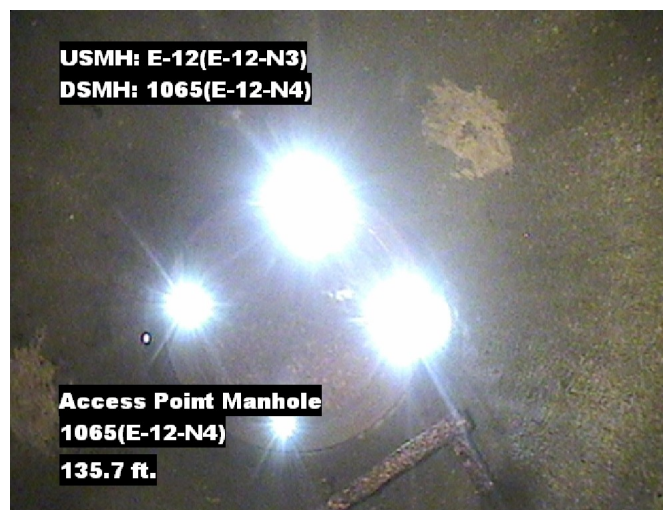
Distance: 135.7 ft. Grade: 0
Condition: Access Point Manhole
Remarks: E-12B
