## Defect Listing

Pipe Segment Refere... <b>E-12B_E-11</b>	City <b>Oliver Springs</b>	Street <b>Null</b>	Material <b>Concrete Pipe (non-...</b>	Location C... <b>Easement/R...</b>	Sewer Use <b>Sanitary</b>
Upstream MH <b>E-12B</b>	Total Length <b>385.1</b>	Year Laid	Shape <b>Circular</b>	Location Details <b>Between houses to F...</b>	
DS Manhole <b>E-11</b>	Length surveyed <b>385.1</b>	Year Renewed	Height <b>8</b>	Width <b>8</b>	Pipe Joint... <b>4</b>

SPR <b>N/A</b>	MPR <b>18</b>	PO Number <b>4397-03</b>	Customer <b>GRW</b>
SPRI <b>N/A</b>	MPRI <b>2</b>	Work Order <b>4397-02</b>	Purpose <b>Pre-Rehabilitation Survey</b>
QSR <b>N/A</b>	QMR <b>2900</b>		
OPR <b>18</b>	Surveyed By <b>Barry Rogers</b>	Direction <b>Downstream</b>	Date <b>20150610</b>
OPRI <b>2</b>	Certificate Number <b>U-1012-16405</b>	Pre-Cleaning <b>Jetting</b>	Time <b>08:22</b>
	Date Cleaned <b>20150610</b>	End Time <b>08:39</b>	Weather <b>Dry</b>
			Media label
			Additional Info

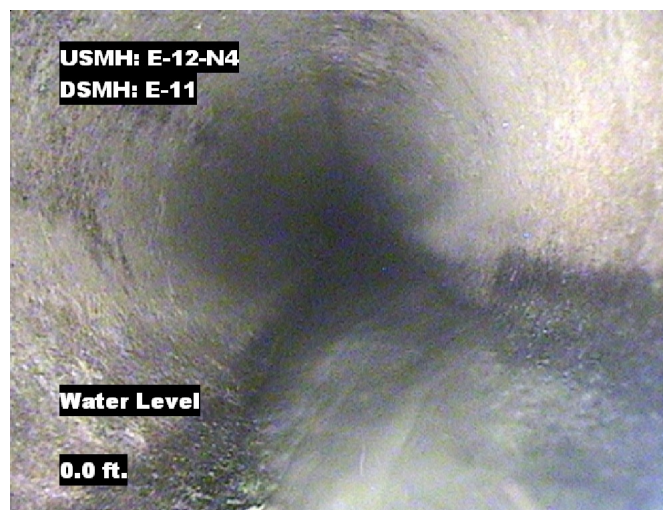
Distance: 0.0 ft. Grade: 0  
Condition: Water Level  
Remarks: N/A

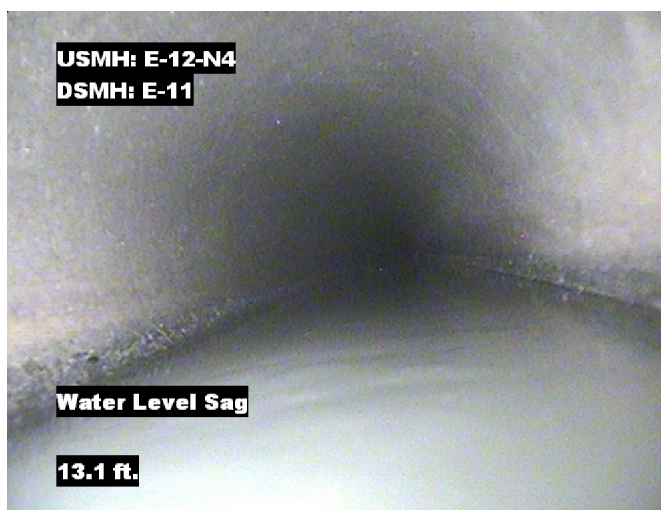
Distance: 13.1 ft. Grade: 2  
Condition: Water Level Sag  
Remarks: N/A

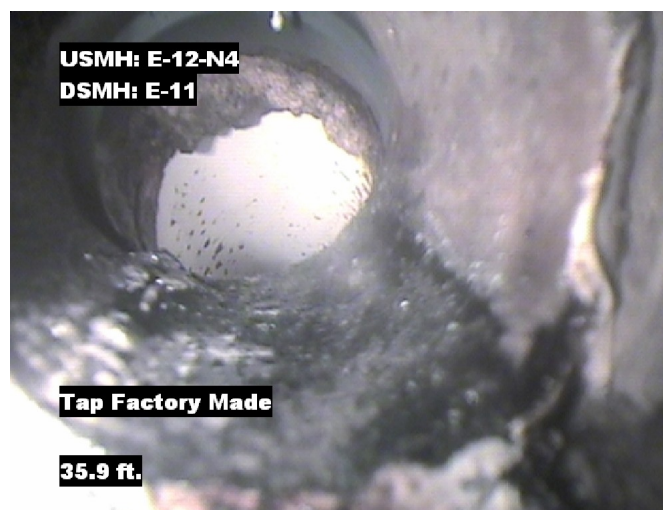
Distance: 35.9 ft. Grade: 0  
Condition: Tap Factory Made  
Remarks: N/A

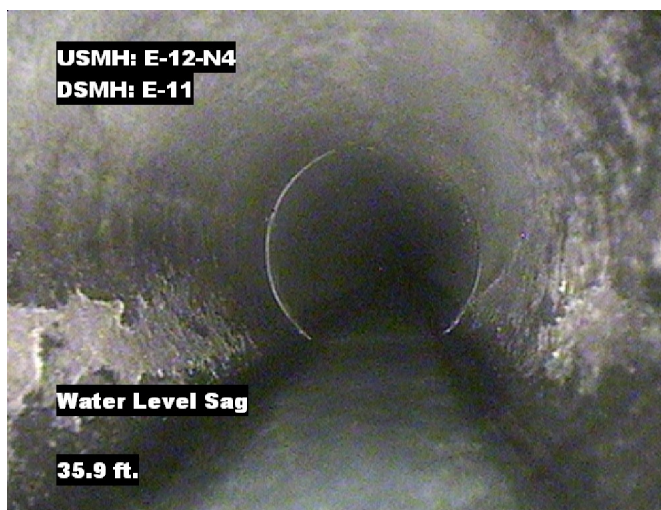
Distance: 35.9 ft. Grade: 2  
Condition: Water Level Sag  
Remarks: N/A

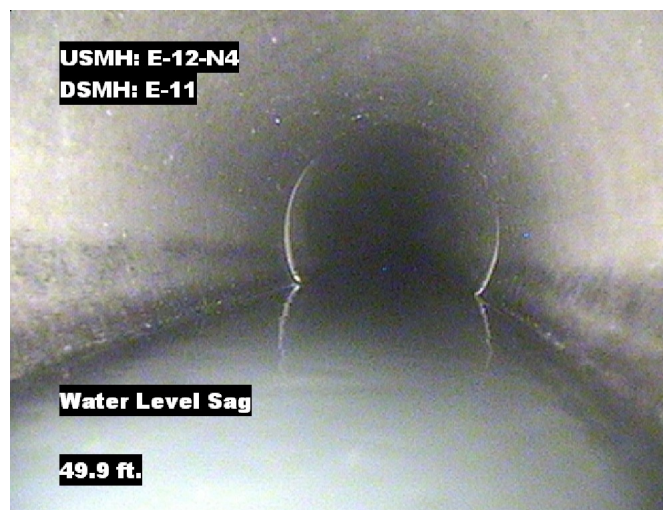
Distance: 49.9 ft. Grade: 2  
Condition: Water Level Sag  
Remarks: N/A

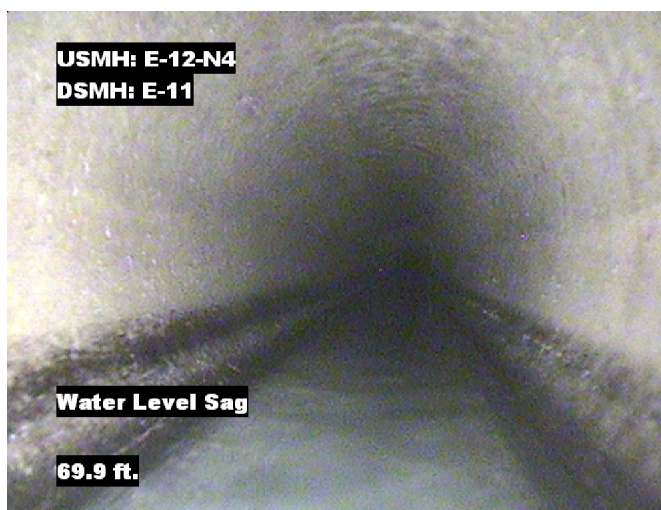
Distance: 69.9 ft. Grade: 2  
Condition: Water Level Sag  
Remarks: N/A

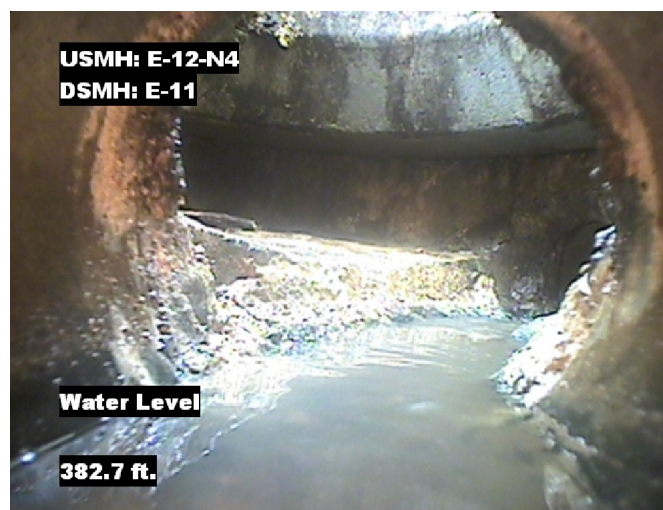
Distance: 382.7 ft. Grade: 0  
Condition: Water Level  
Remarks: N/A
