Defect Listing

Pipe Segment Refere... E-13_E-12	City Oliver Springs	Street Cedar Ln	Material PolyVinyl Chloride	Location C... Yard	Sewer Use Sanitary
Upstream MH E-13	Total Length 7.3	Year Laid	Shape Circular	Location Details Front Yard	
DS Manhole E-12	Length surveyed 7.3	Year Renewed	Height 8	Width 8	Pipe Joint... 13

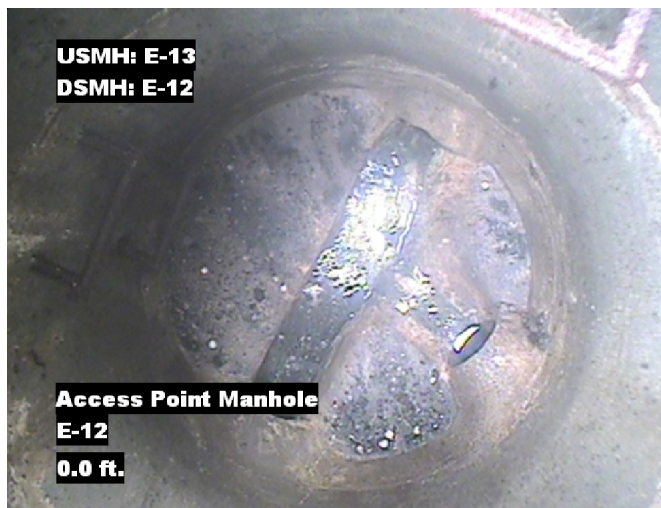
Distance: 0.0 ft. Grade: 0
Condition: Access Point Manhole
Remarks: E-12

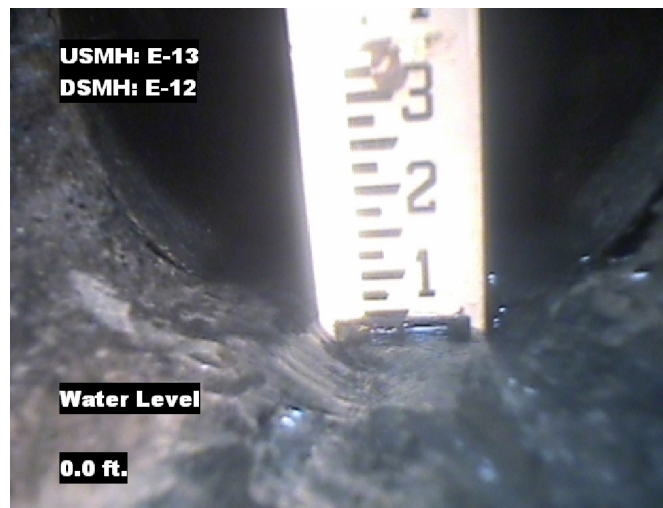
Distance: 0.0 ft. Grade: 0
Condition: Water Level
Remarks: N/A

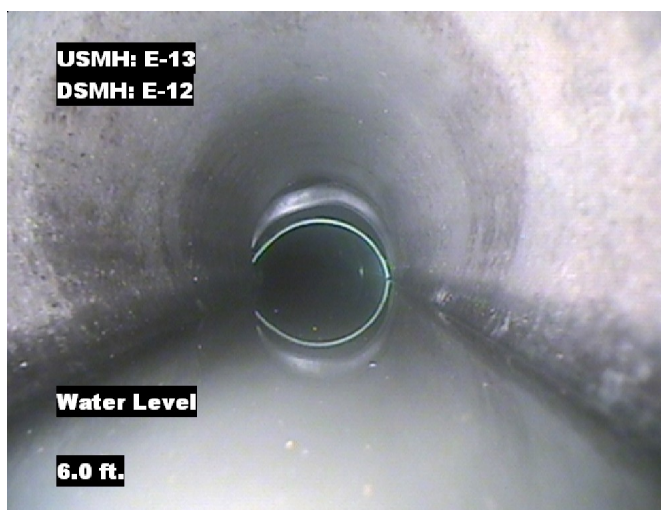
Distance: 6.0 ft. Grade: 0
Condition: Water Level
Remarks: N/A

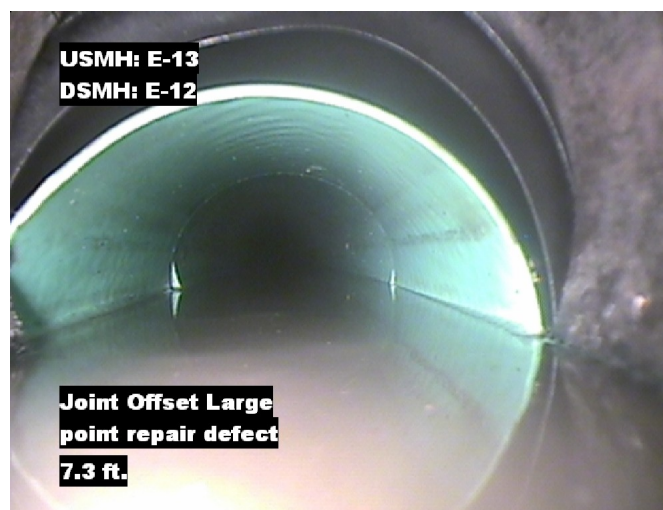
Distance: 7.3 ft. Grade: 2
Condition: Joint Offset Large
Remarks: point repair defect

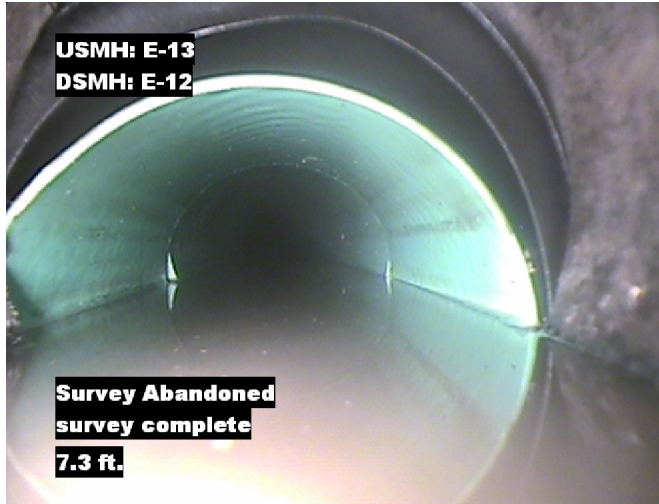
Distance: 7.3 ft. Grade: 0
Condition: Survey Abandoned
Remarks: survey complete
