## Defect Listing

Pipe Segment Refere... <b>E-14_E-13</b>	City <b>Oliver Springs</b>	Street <b>Cedar Ln</b>	Material <b>PolyVinyl Chloride</b>	Location C... <b>Yard</b>	Sewer Use <b>Sanitary</b>
Upstream MH <b>E-14</b>	Total Length <b>244.5</b>	Year Laid	Shape <b>Circular</b>	Location Details <b>Side of Rd</b>	
DS Manhole <b>E-13</b>	Length surveyed <b>244.5</b>	Year Renewed	Height <b>8</b>	Width <b>8</b>	Pipe Joint... <b>13</b>

SPR <b>N/A</b>	MPR <b>14</b>	PO Number <b>4397-03</b>	Customer <b>GRW</b>
SPRI <b>N/A</b>	MPRI <b>2.8</b>	Work Order <b>4397-02</b>	Purpose <b>Pre-Rehabilitation Survey</b>
QSR <b>N/A</b>	QMR <b>4223</b>		
OPR <b>14</b>	Surveyed By <b>Barry Rogers</b>	Direction <b>Downstream</b>	Date <b>20150605</b>
OPRI <b>2.8</b>	Certificate Number <b>U-1012-16405</b>	Pre-Cleaning <b>Jetting</b>	Time <b>15:18</b>
	Date Cleaned <b>20150605</b>	End Time <b>15:34</b>	Weather <b>Dry</b>
			Media label
			Additional Info

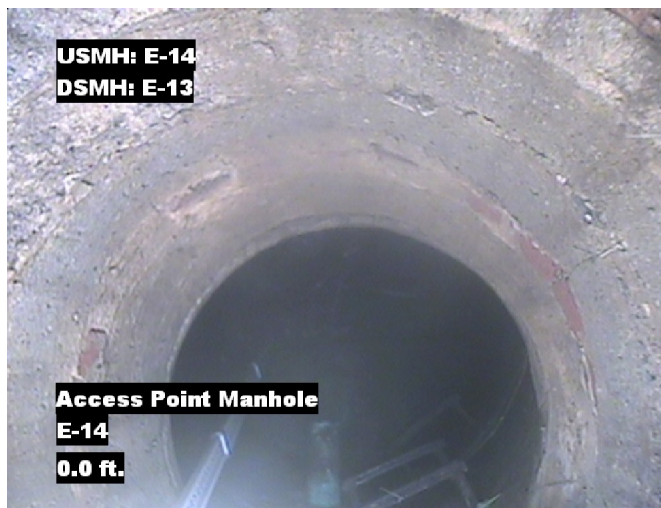
Distance: 0.0 ft. Grade: 0  
Condition: Access Point Manhole  
Remarks: E-14

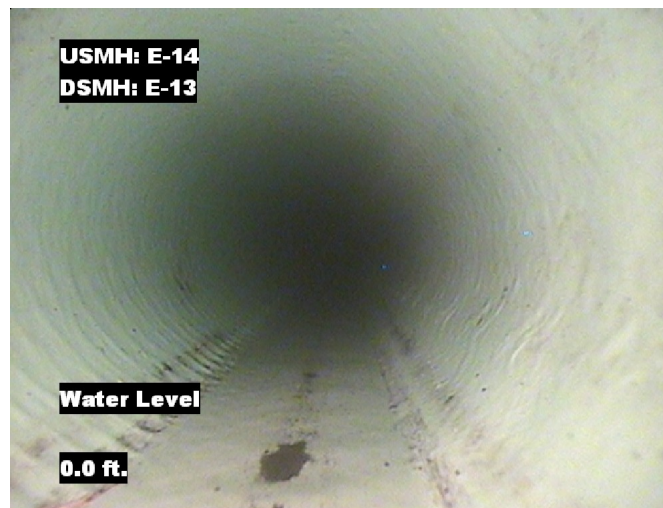
Distance: 0.0 ft. Grade: 0  
Condition: Water Level  
Remarks: N/A

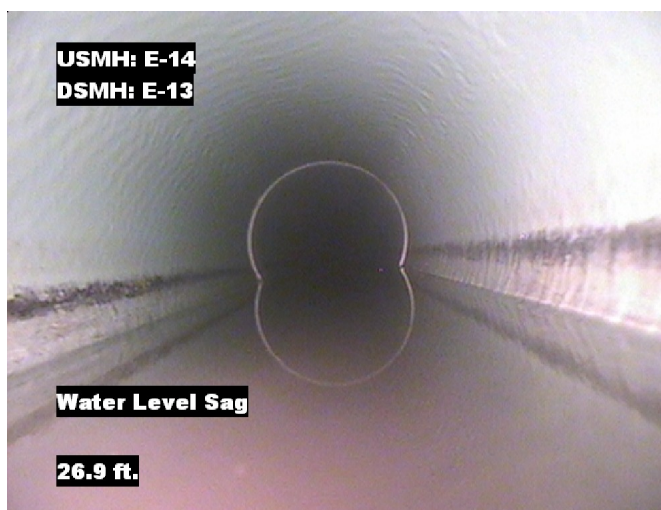
Distance: 26.9 ft. Grade: 2  
Condition: Water Level Sag  
Remarks: N/A

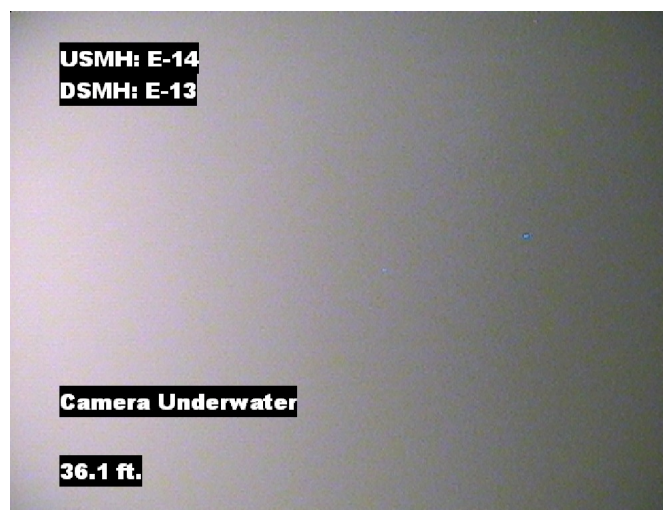
Distance: 36.1 ft. Grade: 4  
Condition: Camera Underwater  
Remarks: N/A

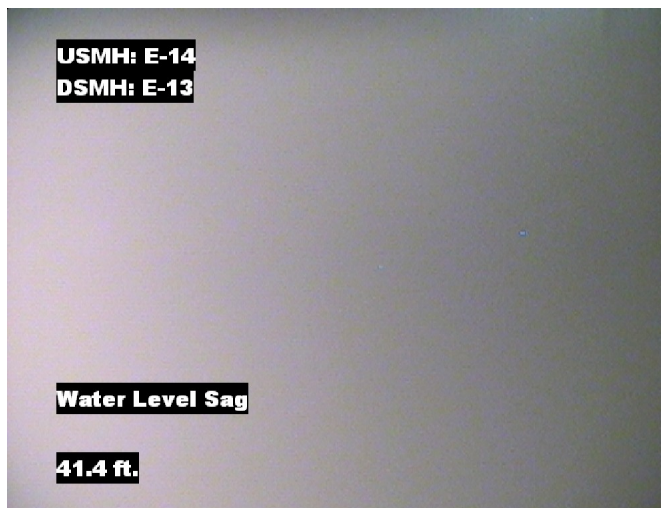
Distance: 41.4 ft. Grade: 4  
Condition: Water Level Sag  
Remarks: N/A

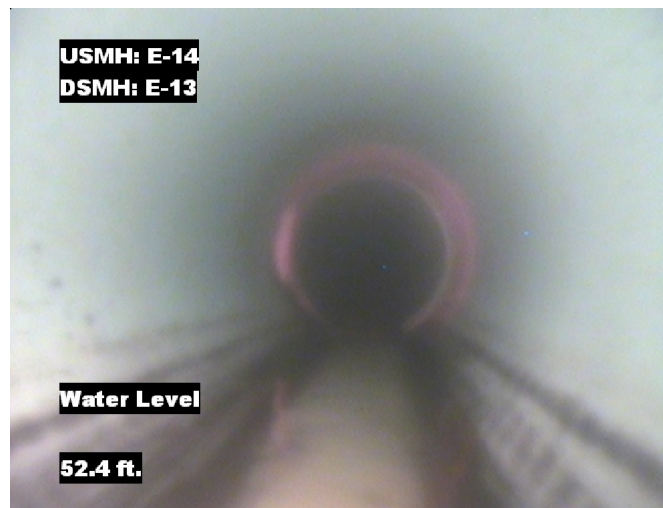
Distance: 52.4 ft. Grade: 0  
Condition: Water Level  
Remarks: N/A

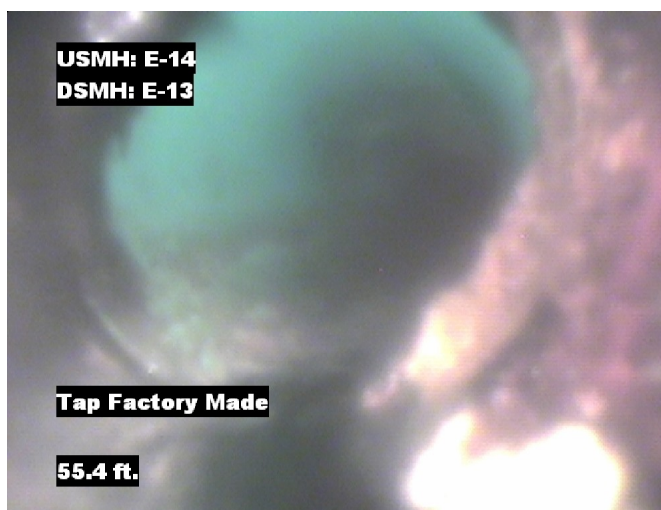
Distance: 55.4 ft. Grade: 0  
Condition: Tap Factory Made  
Remarks: N/A

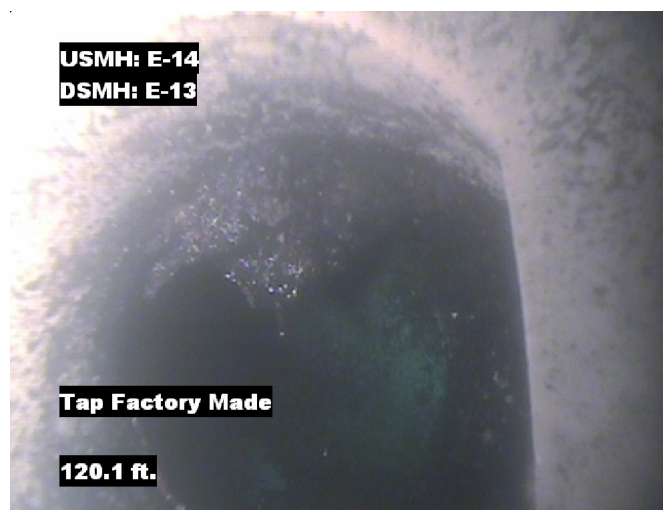
Distance: 120.1 ft. Grade: 0  
Condition: Tap Factory Made  
Remarks: N/A

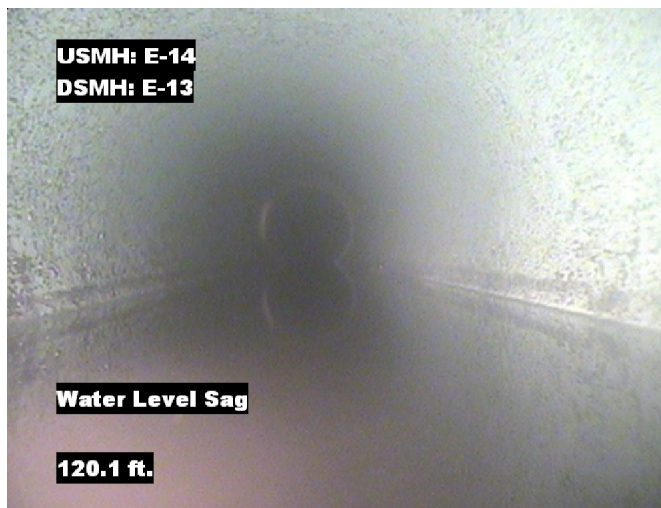
Distance: 120.1 ft. Grade: 2  
Condition: Water Level Sag  
Remarks: N/A

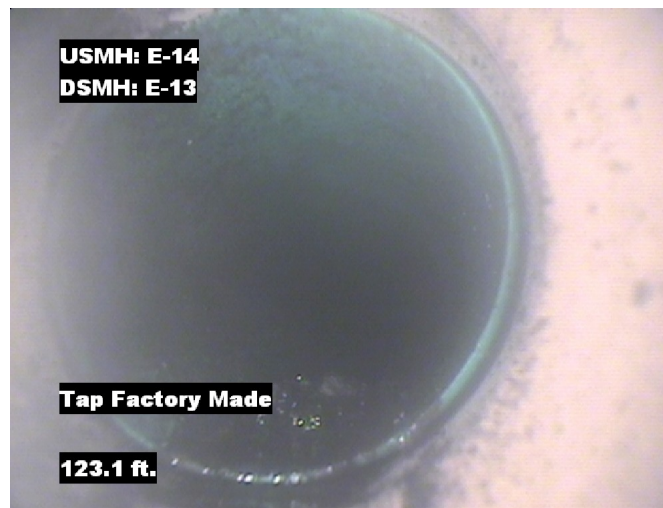
Distance: 123.1 ft. Grade: 0  
Condition: Tap Factory Made  
Remarks: N/A

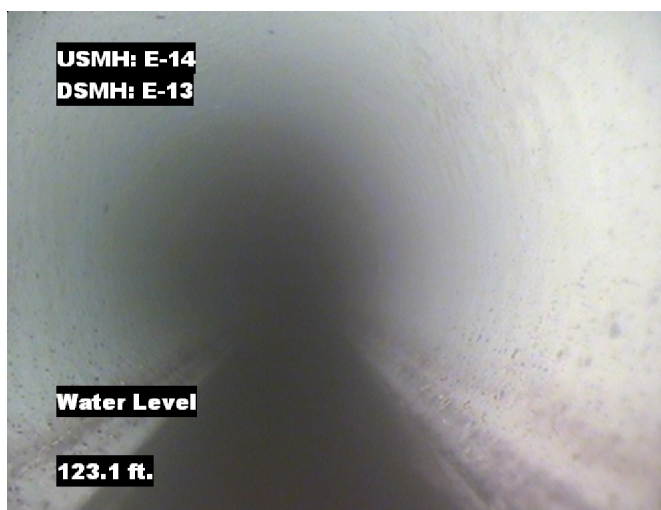
Distance: 123.1 ft. Grade: 0  
Condition: Water Level  
Remarks: N/A

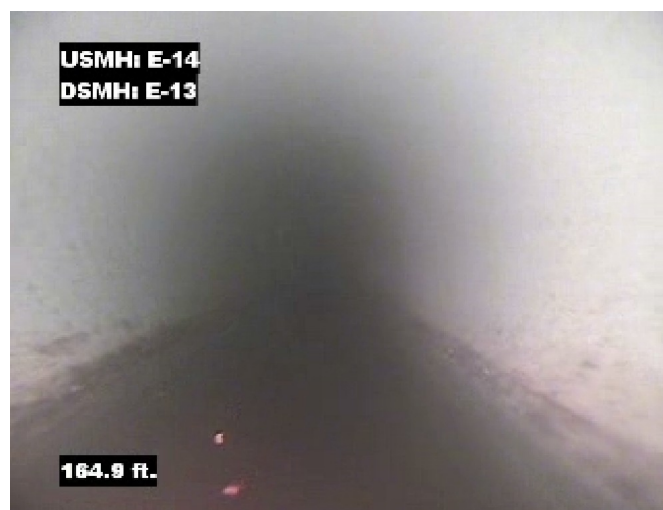
Distance: 164.9 ft. Grade: 0  
Condition: Water Level  
Remarks: N/A

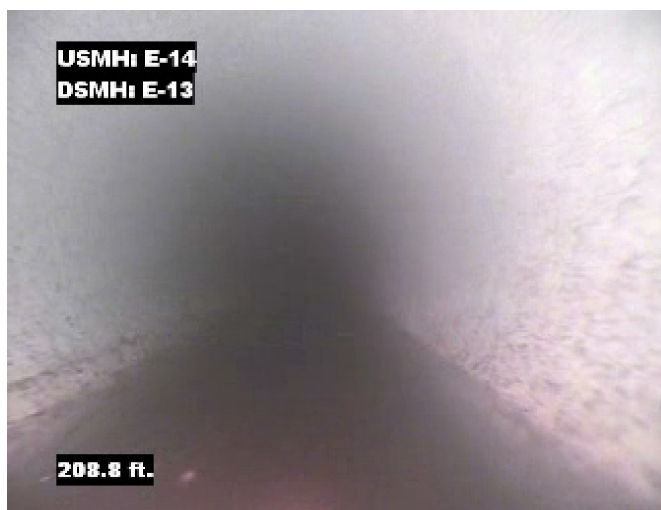
Distance: 208.8 ft. Grade: 2  
Condition: Water Level Sag  
Remarks: N/A

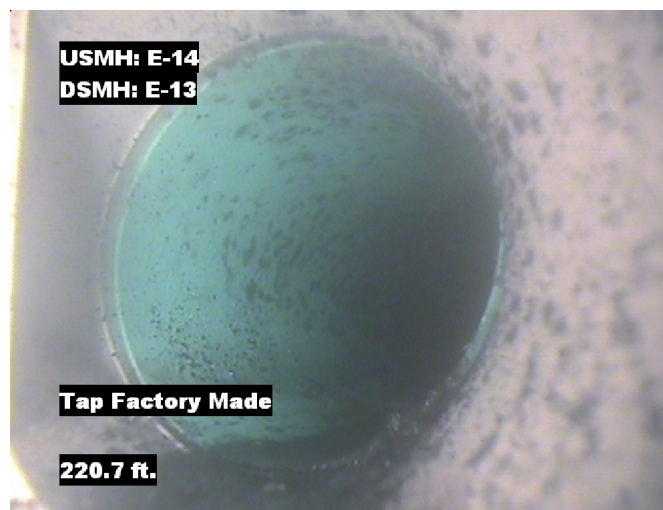
Distance: 220.7 ft. Grade: 0  
Condition: Tap Factory Made  
Remarks: N/A

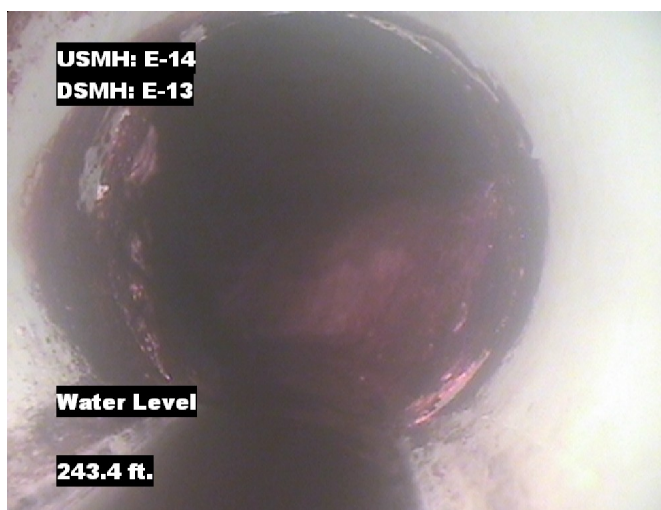
Distance: 243.4 ft. Grade: 0  
Condition: Water Level  
Remarks: N/A

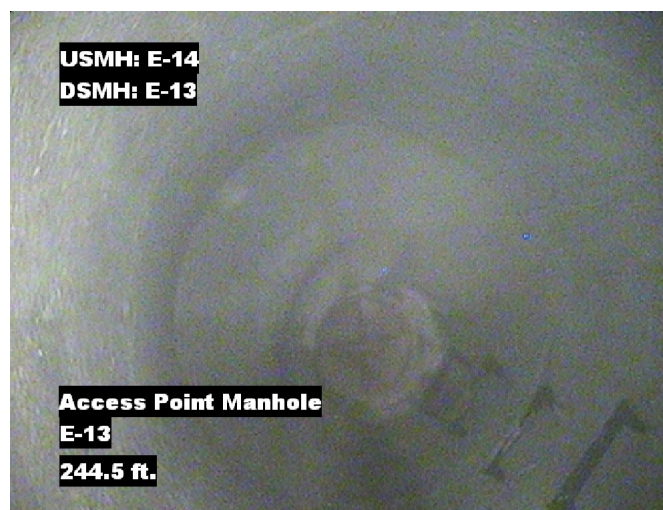
Distance: 244.5 ft. Grade: 0  
Condition: Access Point Manhole  
Remarks: E-13
