Defect Listing

Pipe Segment Refere... E-15_E-14	City Oliver Springs	Street Cedar Ln	Material PolyVinyl Chloride	Location C... Easement/R...	Sewer Use Sanitary
Upstream MH E-15	Total Length 188.2	Year Laid	Shape Circular	Location Details Side of Rd	
DS Manhole E-14	Length surveyed 188.2	Year Renewed	Height 8	Width 8	Pipe Joint... 13

Image Report 4/Page

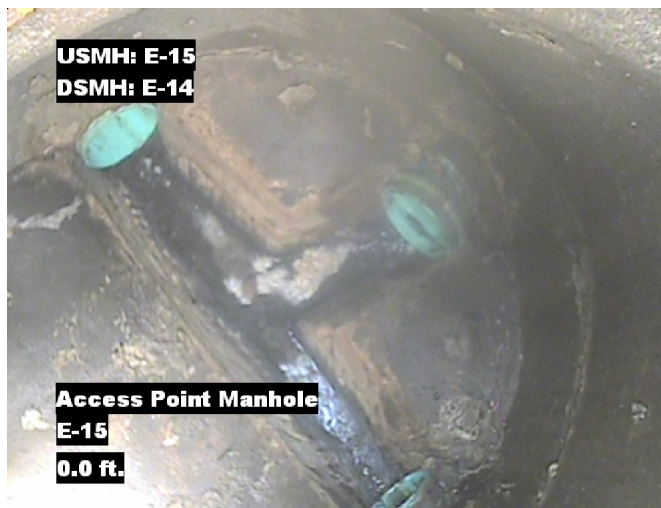
Distance: 0.0 ft. Grade: 0
Condition: Access Point Manhole
Remarks: E-15

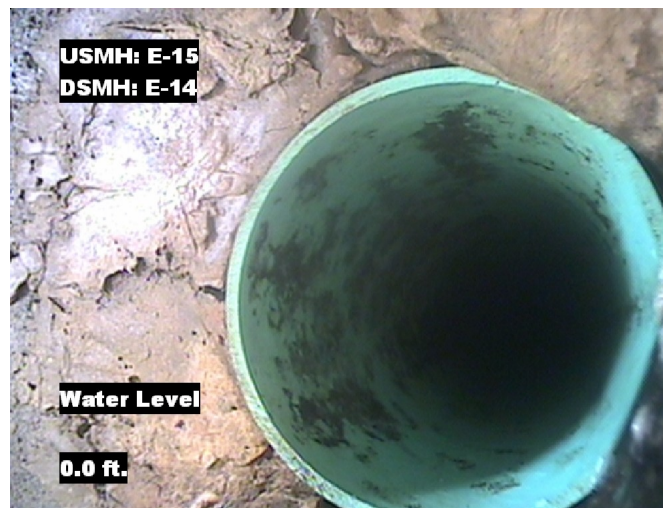
Distance: 0.0 ft. Grade: 0
Condition: Water Level
Remarks: N/A

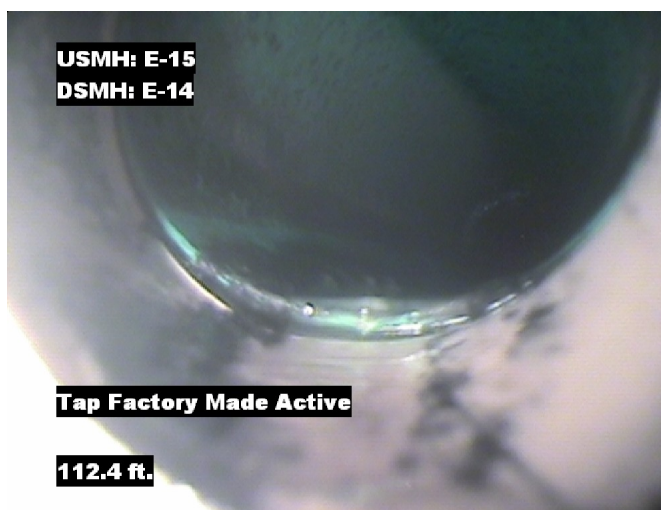
Distance: 112.4 ft. Grade: 0
Condition: Tap Factory Made Active
Remarks: N/A

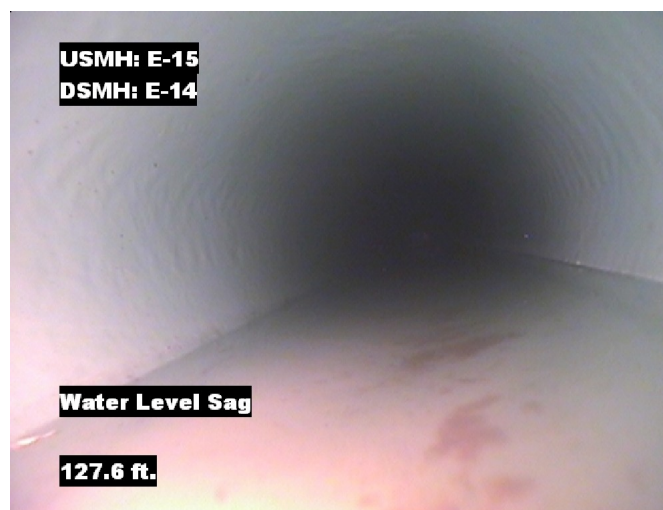
Distance: 127.6 ft. Grade: 2
Condition: Water Level Sag
Remarks: N/A

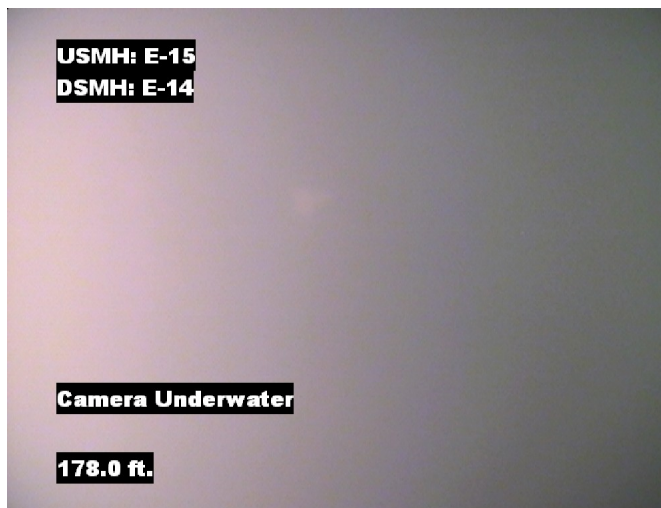
Distance: 178.0 ft. Grade: 4
Condition: Camera Underwater
Remarks: N/A

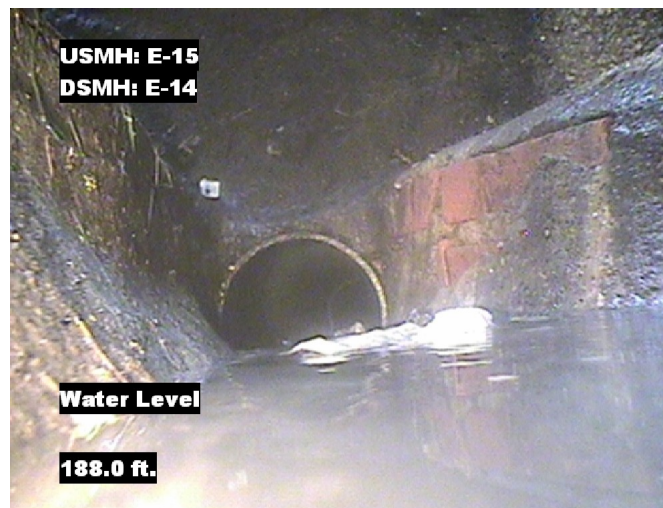
Distance: 188.0 ft. Grade: 0
Condition: Water Level
Remarks: N/A

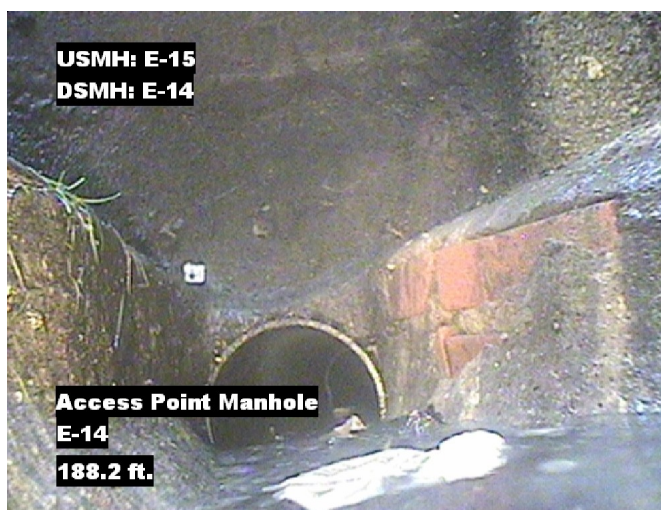
Distance: 188.2 ft. Grade: 0
Condition: Access Point Manhole
Remarks: E-14
