Defect Listing

Pipe Segment Refere... E-17_E-16	City Oliver Springs	Street Sleepy Hollow	Material PolyVinyl Chloride	Location C... Yard	Sewer Use Sanitary
Upstream MH E-17	Total Length 45.9	Year Laid	Shape Circular	Location Details Crosses Sleepy Holl...	
DS Manhole E-16	Length surveyed 45.9	Year Renewed	Height 8	Width 8	Pipe Joint... 13

SPR N/A	MPR N/A	PO Number 4397-03		Customer GRW	
SPRI N/A	MPRI N/A	Work Order 4397-02		Purpose Pre-Rehabilitation Survey	
QSR N/A	QMR N/A				
OPR N/A	Surveyed By Barry Rogers	Direction Downstream	Date 20150604	Media label	
OPRI N/A	Certificate Number U-1012-16405	Pre-Cleaning Jetting	Time 13:04	Weather Dry	
Date Cleaned 20150604			End Time 13:11	Additional Info

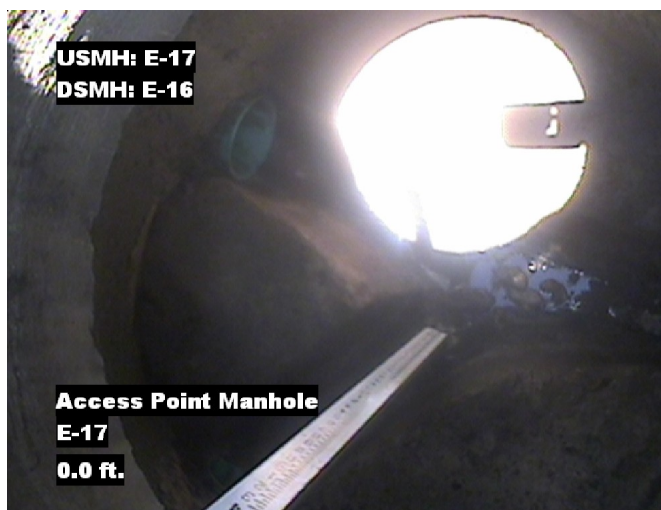
Distance: 0.0 ft. Grade: 0
Condition: Access Point Manhole
Remarks: E-17

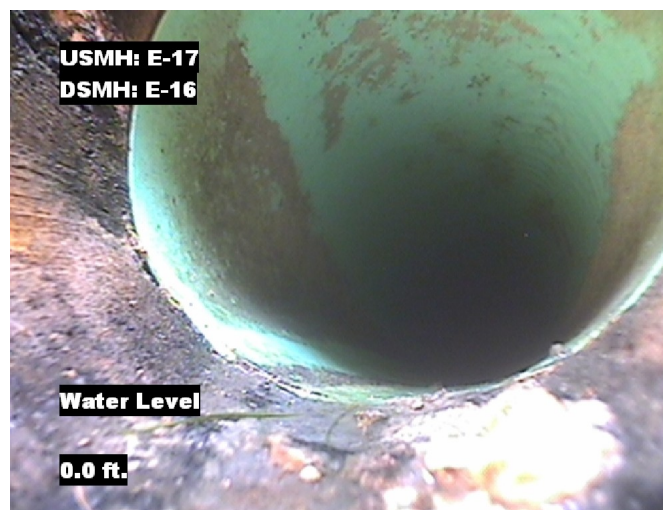
Distance: 0.0 ft. Grade: 0
Condition: Water Level
Remarks: N/A

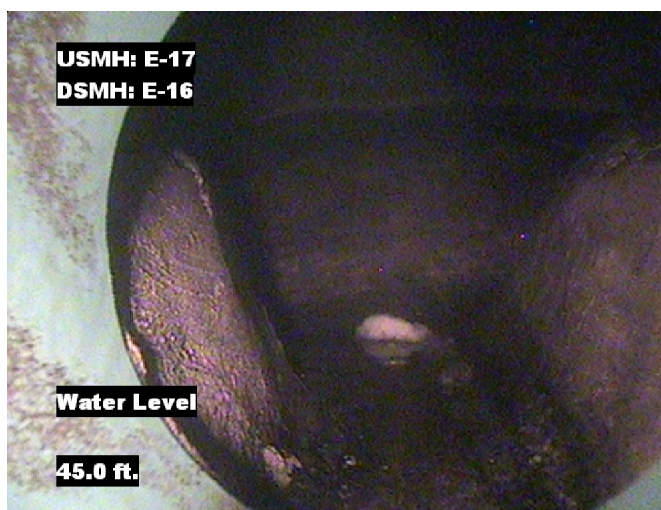
Distance: 45.0 ft. Grade: 0
Condition: Water Level
Remarks: N/A

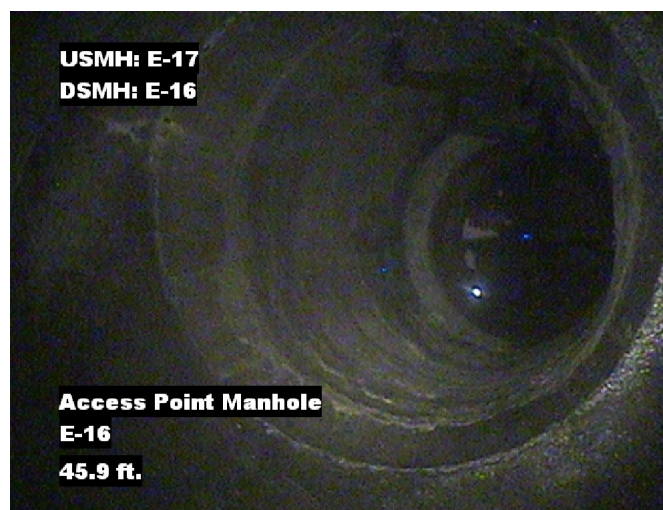
Distance: 45.9 ft. Grade: 0
Condition: Access Point Manhole
Remarks: E-16
