Defect Listing

Pipe Segment Refere... E-18_E-17	City Oliver Springs	Street Red Bud Ln	Material PolyVinyl Chloride	Location C... Easement/R...	Sewer Use Sanitary
Upstream MH E-18	Total Length 130.5	Year Laid	Shape Circular	Location Details Side of rd	
DS Manhole E-17	Length surveyed 130.5	Year Renewed	Height 8	Width 8	Pipe Joint... 13

SPR N/A	MPR 2	PO Number 4397-03	Customer GRW
SPRI N/A	MPRI 2	Work Order 4397-02	Purpose Pre-Rehabilitation Survey
QSR N/A	QMR 2100		
OPR 2	Surveyed By Barry Rogers	Direction Upstream	Date 20150604
OPRI 2	Certificate Number U-1012-16405	Pre-Cleaning Jetting	Time 12:32
	Date Cleaned 20150604	End Time 12:56	Weather Dry
		Additional Info

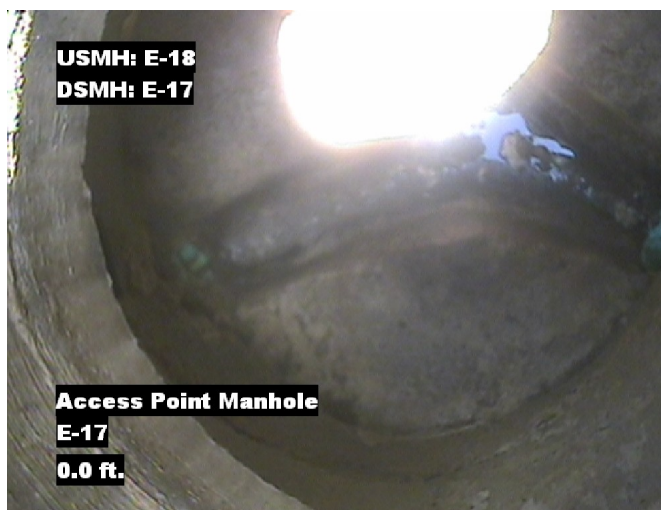
Distance: 0.0 ft. Grade: 0
Condition: Access Point Manhole
Remarks: E-17

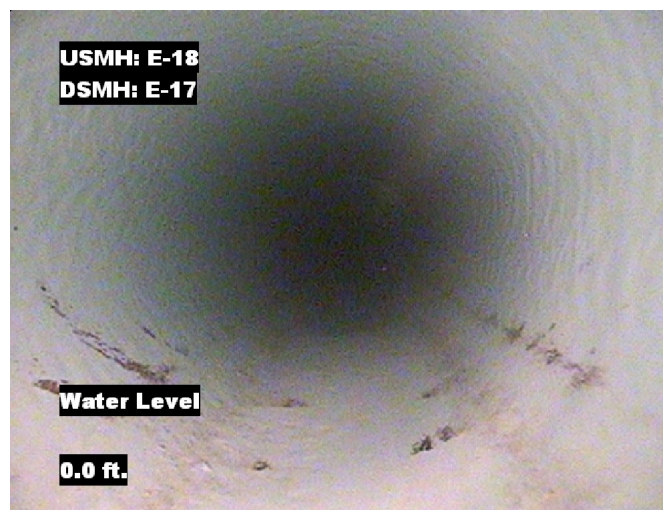
Distance: 0.0 ft. Grade: 0
Condition: Water Level
Remarks: N/A

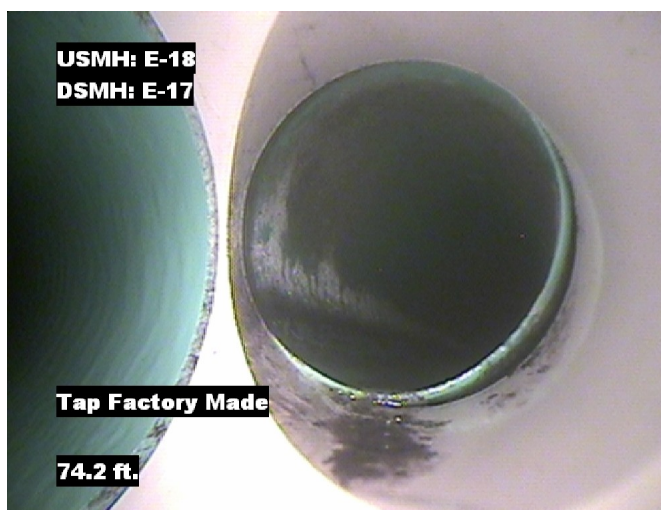
Distance: 74.2 ft. Grade: 0
Condition: Tap Factory Made
Remarks: N/A

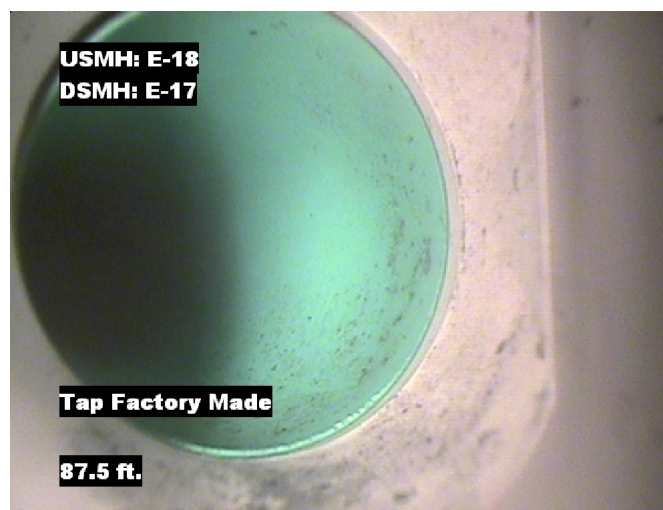
Distance: 87.5 ft. Grade: 0
Condition: Tap Factory Made
Remarks: N/A

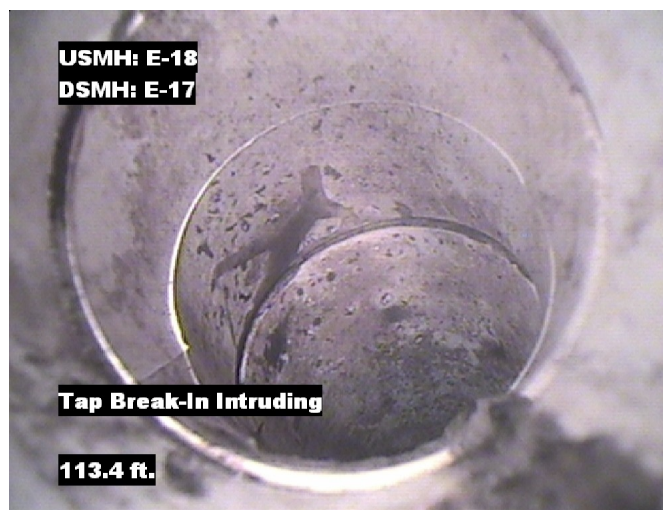
Distance: 113.4 ft. Grade: 2
Condition: Tap Break-In Intruding
Remarks: N/A

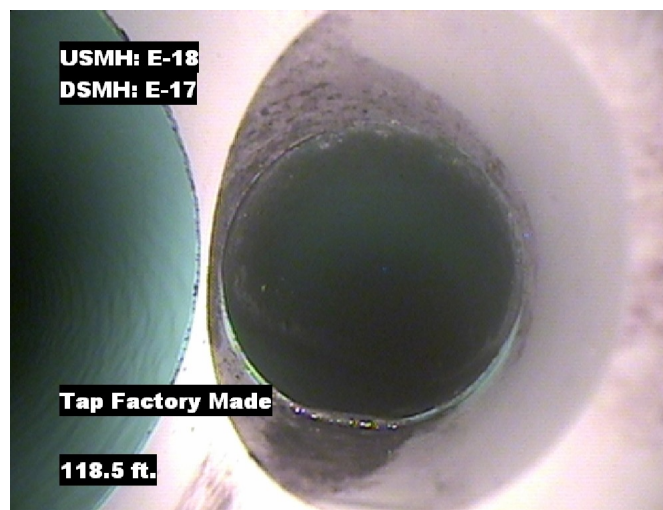
Distance: 118.5 ft. Grade: 0
Condition: Tap Factory Made
Remarks: N/A

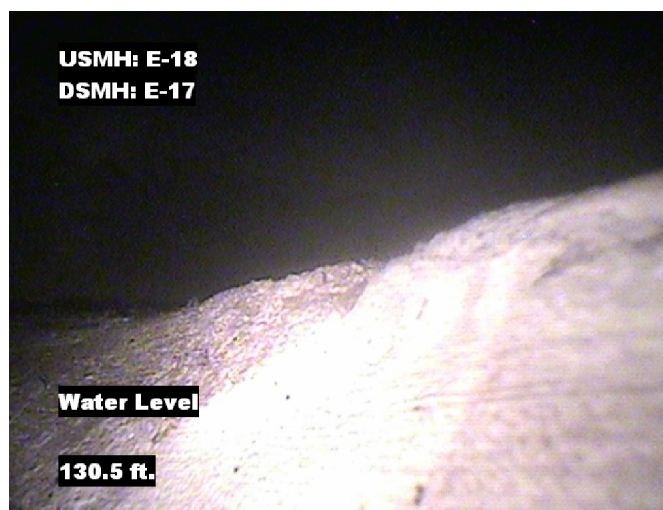
Distance: 130.5 ft. Grade: 0
Condition: Water Level
Remarks: N/A

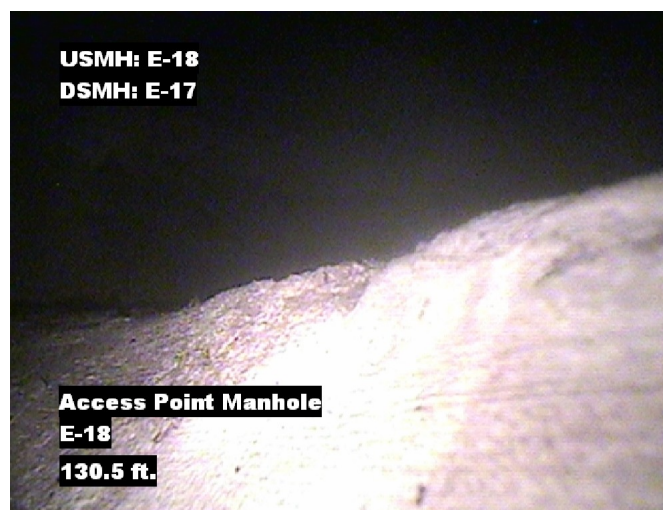
Distance: 130.5 ft. Grade: 0
Condition: Access Point Manhole
Remarks: E-18
