Defect Listing

Pipe Segment Refere... E-19_E-18	City Oliver Springs	Street Red Bud Ln	Material PolyVinyl Chloride		Location C... Yard	Sewer Use Sanitary
Upstream MH E-19	Total Length 123	Year Laid	Shape Circular		Location Details Side of Rd between ...	
DS Manhole E-18	Length surveyed 123	Year Renewed	Height 8	Width 8	Pipe Joint... 13

SPR 8	MPR N/A	PO Number 4397-03		Customer GRW	
SPRI 4	MPRI N/A	Work Order 4397-02		Purpose Pre-Rehabilitation Survey	
QSR 4200	QMR N/A				
OPR 8	Surveyed By Barry Rogers	Direction Downstream	Date 20150604	Media label	
OPRI 4	Certificate Number U-1012-16405	Pre-Cleaning Jetting	Time 10:54	Weather Dry	
Date Cleaned 20150604			End Time 11:04	Additional Info

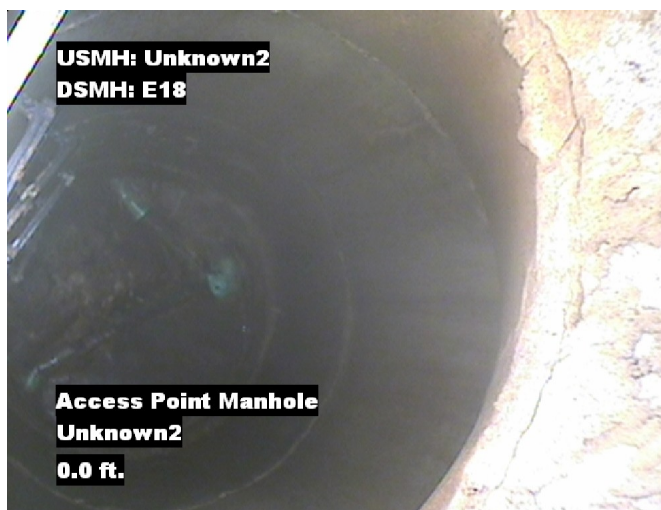
Distance: 0.0 ft. Grade: 0
Condition: Access Point Manhole
Remarks: E-19

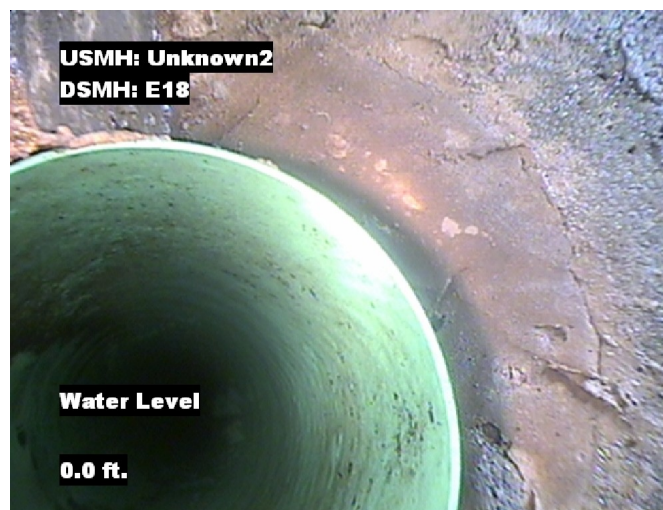
Distance: 0.0 ft. Grade: 0
Condition: Water Level
Remarks: N/A

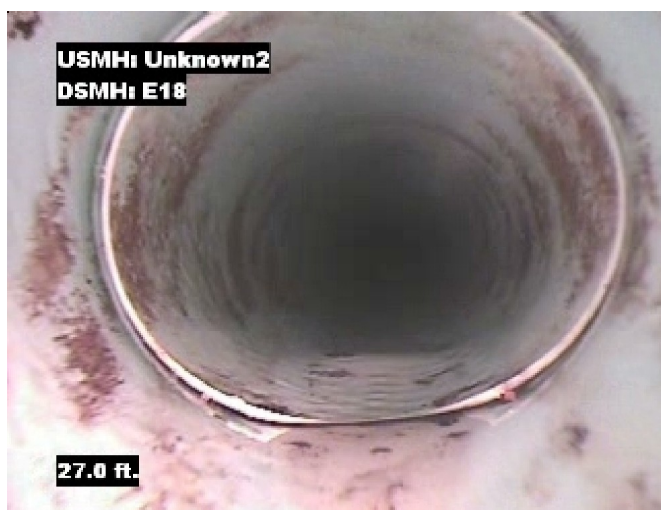
Distance: 27.0 ft. Grade: 4
Condition: Deformed Vertically
Remarks: N/A

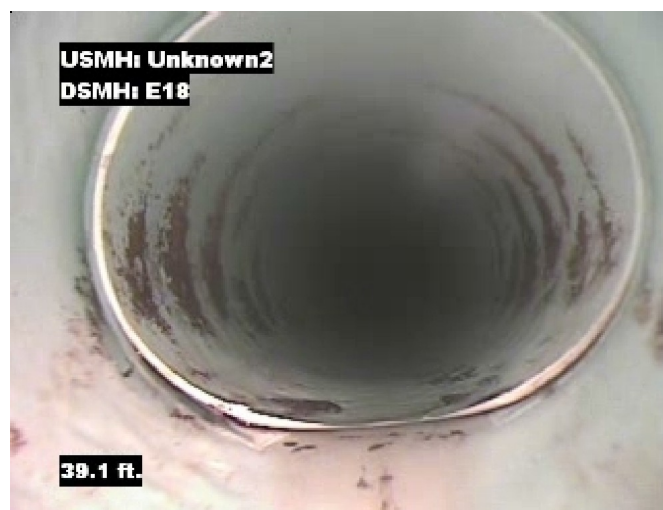
Distance: 39.1 ft. Grade: 4
Condition: Deformed Vertically
Remarks: N/A

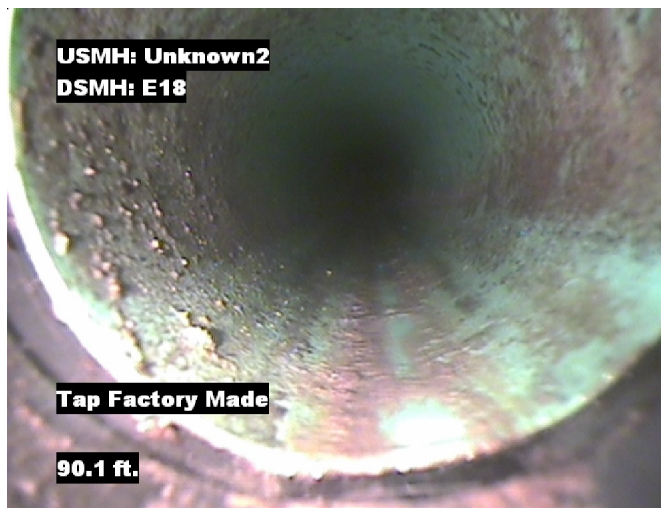
Distance: 90.1 ft. Grade: 0
Condition: Tap Factory Made
Remarks: N/A

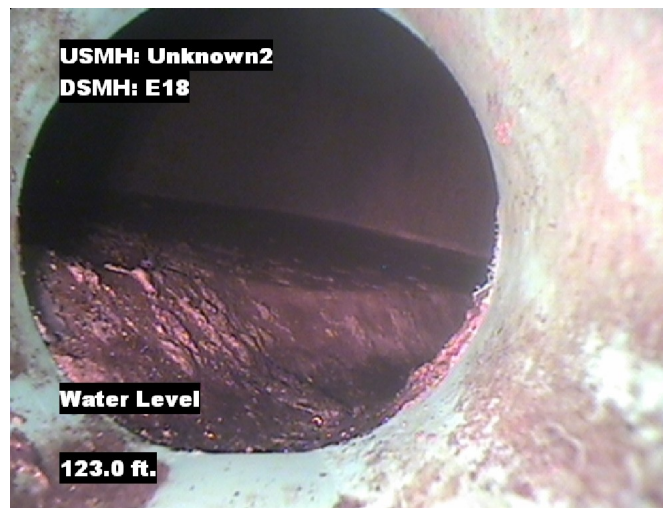
Distance: 123.0 ft. Grade: 0
Condition: Water Level
Remarks: N/A

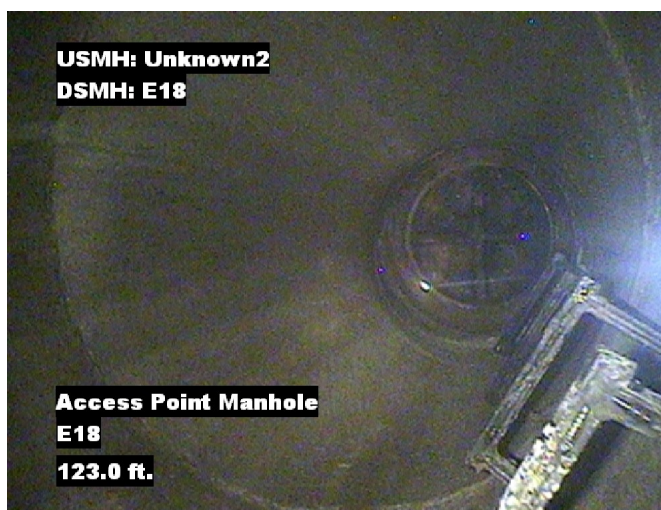
Distance: 123.0 ft. Grade: 0
Condition: Access Point Manhole
Remarks: E-18
