Defect Listing

Pipe Segment Refere... E-7_E-6	City Oliver Springs	Street Null	Material Fiberglass Reinforc...	Location C... Easement/R...	Sewer Use Sanitary
Upstream MH E-7	Total Length 341.1	Year Laid	Shape Circular	Location Details Cow Pasture	
DS Manhole E-6	Length surveyed 341.1	Year Renewed	Height 8	Width 8	Pipe Joint... N/A

SPR N/A	MPR 12	PO Number 4397-03	Customer GRW
SPRI N/A	MPRI 2	Work Order 4397-02	Purpose Pre-Rehabilitation Survey
QSR N/A	QMR 2600		
OPR 12	Surveyed By Barry Rogers	Direction Downstream	Date 20150611
OPRI 2	Certificate Number U-1012-16405	Pre-Cleaning Jetting	Time 10:41
	Date Cleaned 20150611	End Time 11:38	Weather Dry
			Media label
			Additional Info

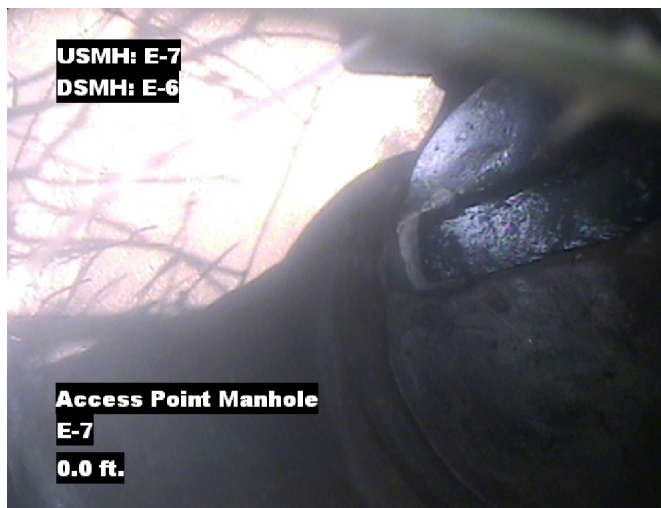
Distance: 0.0 ft. Grade: 0
Condition: Access Point Manhole
Remarks: E-7

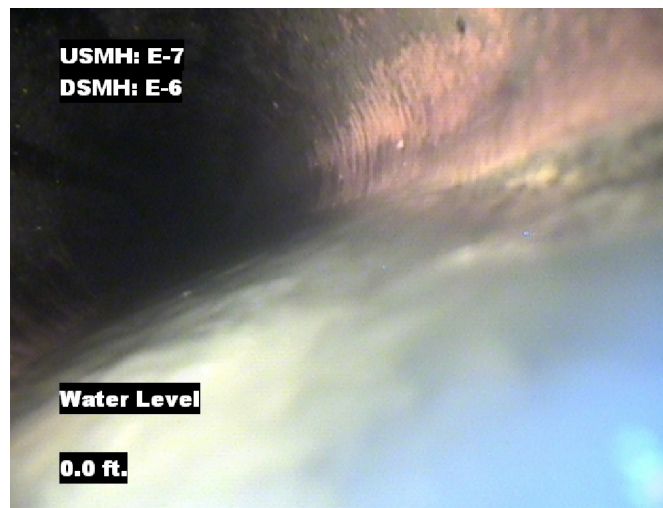
Distance: 0.0 ft. Grade: 0
Condition: Water Level
Remarks: N/A

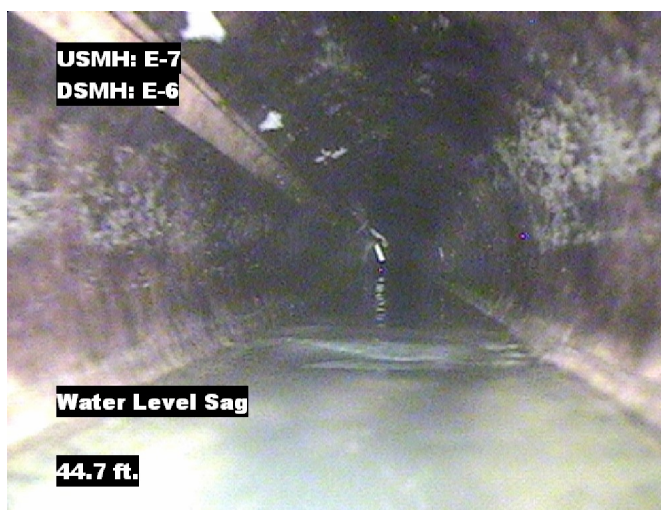
Distance: 44.6 ft. Grade: 2
Condition: Water Level Sag
Remarks: N/A

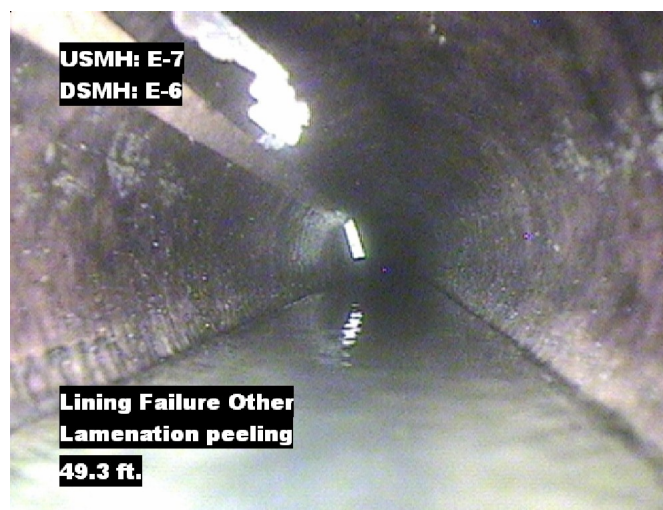
Distance: 49.3 ft. Grade: 0
Condition: Lining Failure Other
Remarks: Lamination peeling

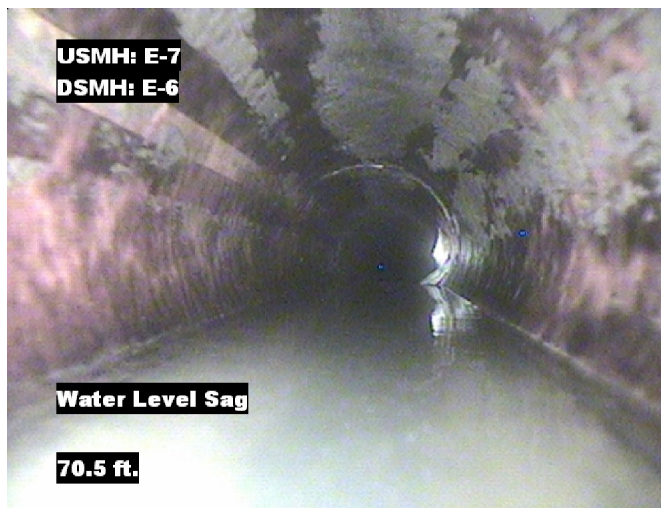
Distance: 70.5 ft. Grade: 2
Condition: Water Level Sag
Remarks: N/A

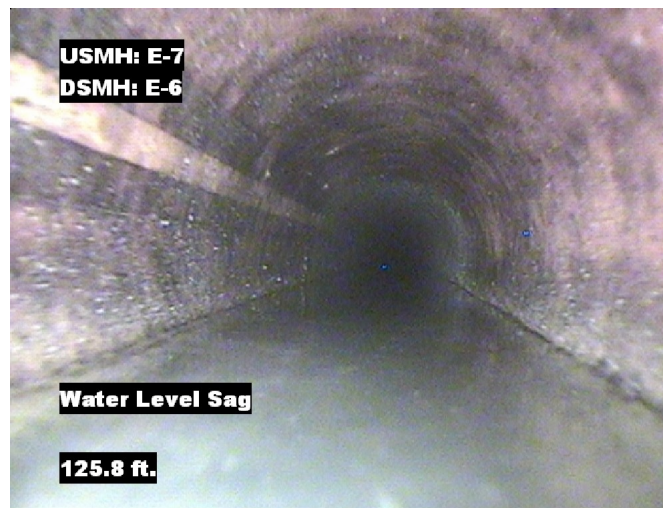
Distance: 125.8 ft. Grade: 2
Condition: Water Level Sag
Remarks: N/A

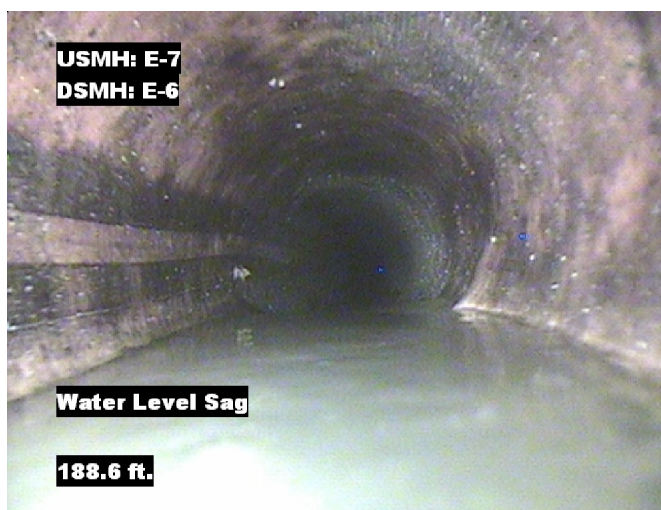
Distance: 188.6 ft. Grade: 2
Condition: Water Level Sag
Remarks: N/A

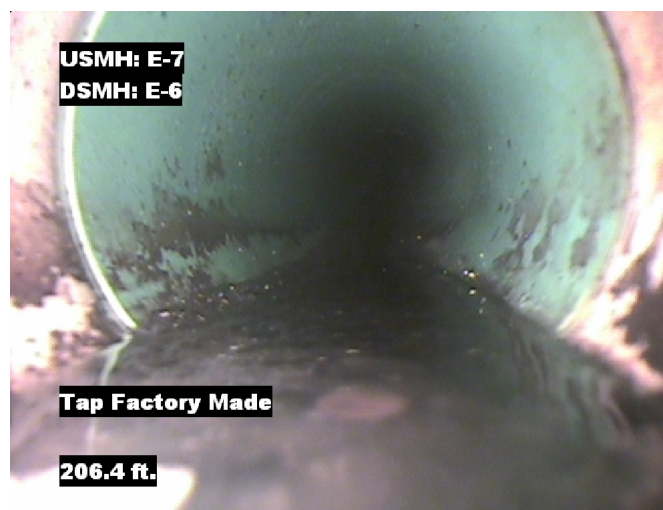
Distance: 206.4 ft. Grade: 0
Condition: Tap Factory Made
Remarks: N/A

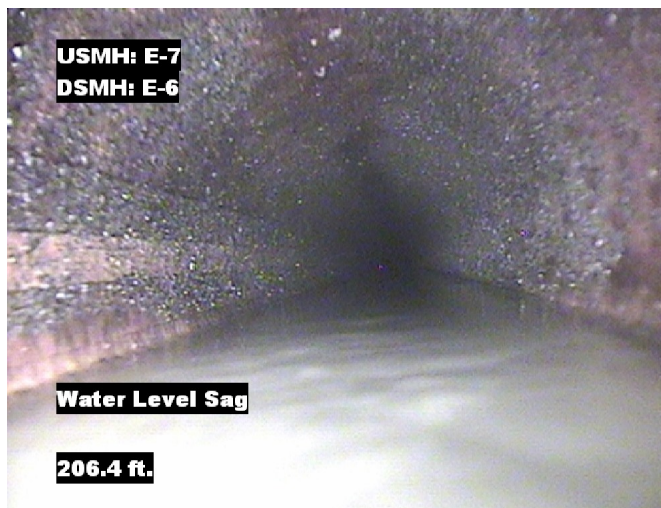
Distance: 206.4 ft. Grade: 2
Condition: Water Level Sag
Remarks: N/A

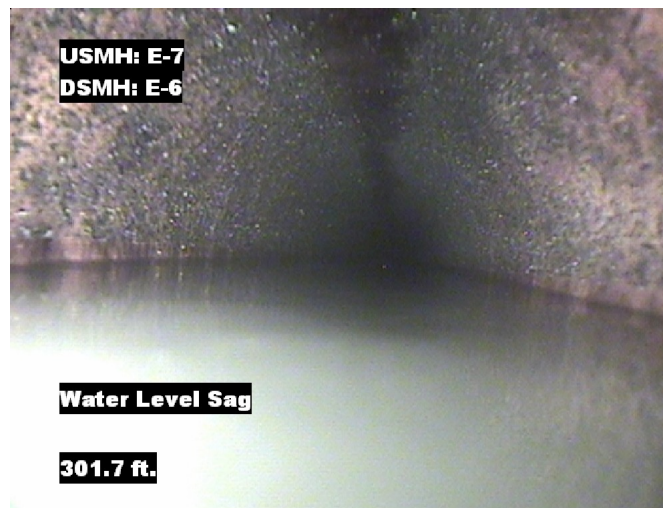
Distance: 301.7 ft. Grade: 2
Condition: Water Level Sag
Remarks: N/A
