Defect Listing

Pipe Segment Refere... E-8_E-7	City Oliver Springs	Street Null	Material Fiberglass Reinforc...	Location C... Easement/R...	Sewer Use Sanitary
Upstream MH E-8	Total Length 379.6	Year Laid	Shape Circular	Location Details Cow Pasture	
DS Manhole E-7	Length surveyed 379.6	Year Renewed	Height 8	Width 8	Pipe Joint... N/A

Image Report 4/Page

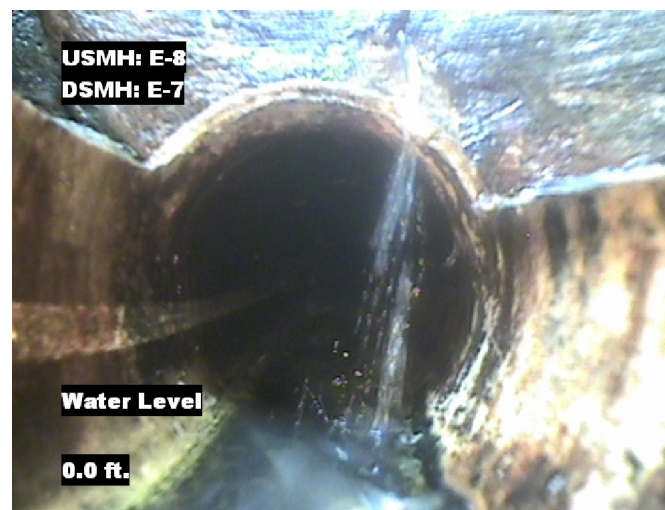
Distance: 0.0 ft. Grade: 0
Condition: Water Level
Remarks: N/A

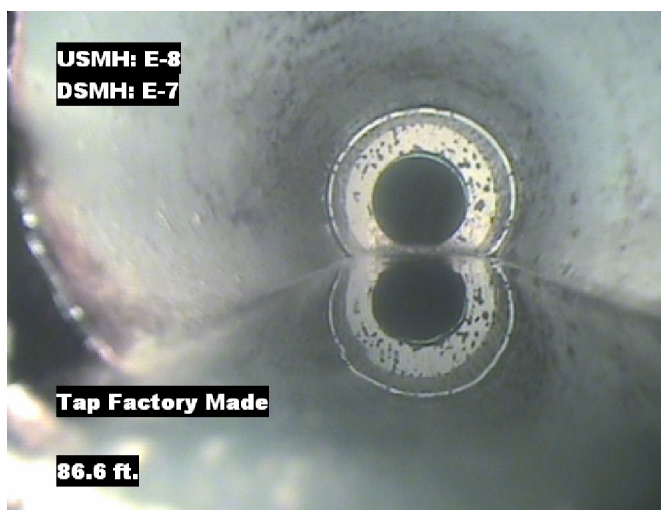
Distance: 86.6 ft. Grade: 0
Condition: Tap Factory Made
Remarks: N/A

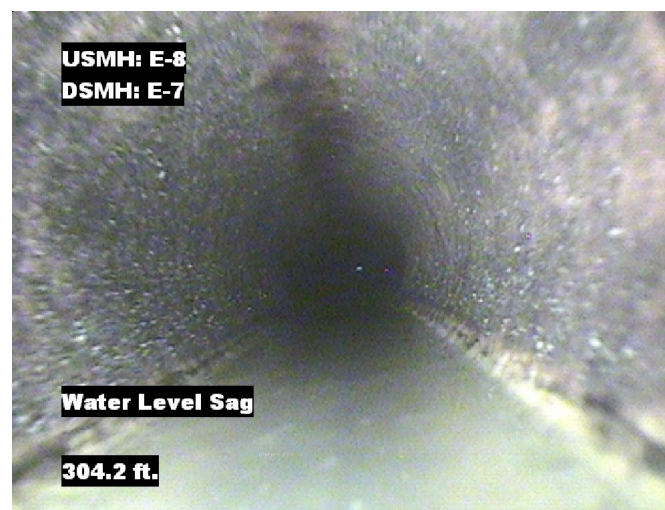
Distance: 304.1 ft. Grade: 2
Condition: Water Level Sag
Remarks: N/A

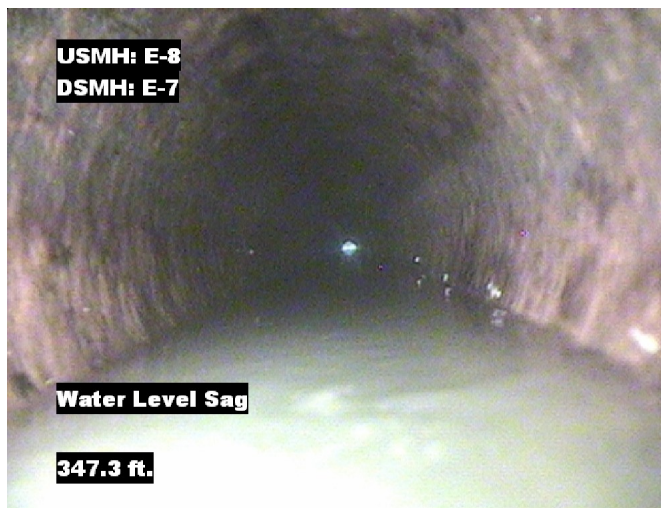
Distance: 347.3 ft. Grade: 2
Condition: Water Level Sag
Remarks: N/A

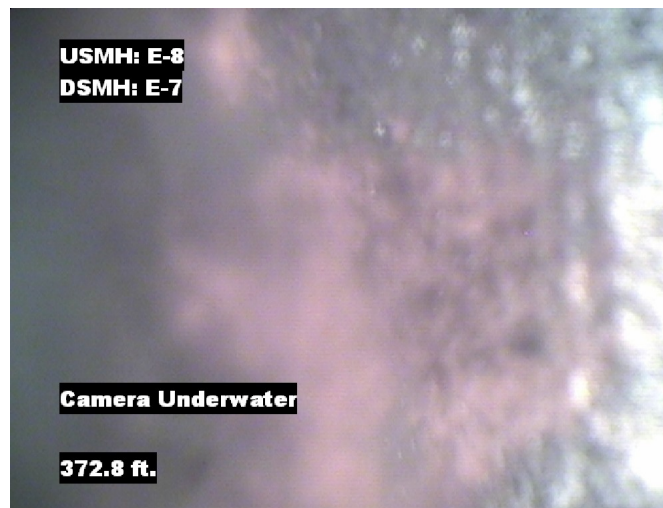
Distance: 372.8 ft. Grade: 4
Condition: Camera Underwater
Remarks: N/A
