Defect Listing

Pipe Segment Refere... E-9_E-8	City Oliver Springs	Street Null	Material Fiberglass Reinforc...	Location C... Easement/R...	Sewer Use Sanitary
Upstream MH E-9	Total Length 398.7	Year Laid	Shape Circular	Location Details Cow Pasture	
DS Manhole E-8	Length surveyed 398.7	Year Renewed	Height 8	Width 8	Pipe Joint... N/A

SPR N/A	MPR 8	PO Number 4397-03		Customer GRW	
SPRI N/A	MPRI 2	Work Order 4397-02		Purpose Pre-Rehabilitation Survey	
QSR N/A	QMR 2400				
OPR 8	Surveyed By Barry Rogers	Direction Downstream	Date 20150611	Media label	
OPRI 2	Certificate Number U-1012-16405	Pre-Cleaning Jetting	Time 07:25	Weather Dry	
Date Cleaned 20150611			End Time 07:50	Additional Info

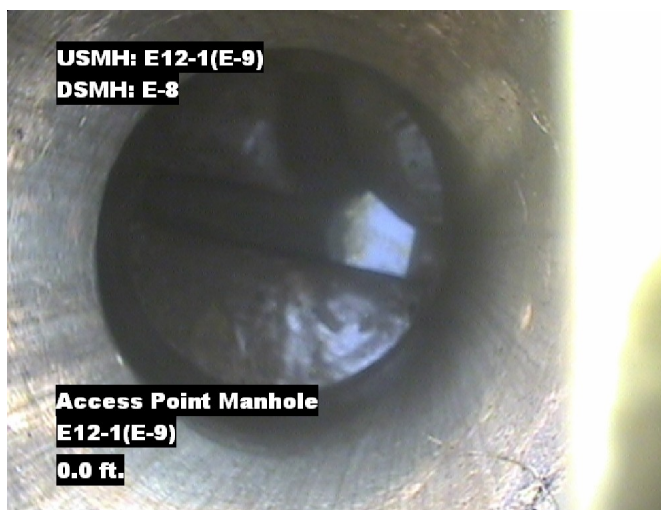
Distance: 0.0 ft. Grade: 0
Condition: Access Point Manhole
Remarks: E-9

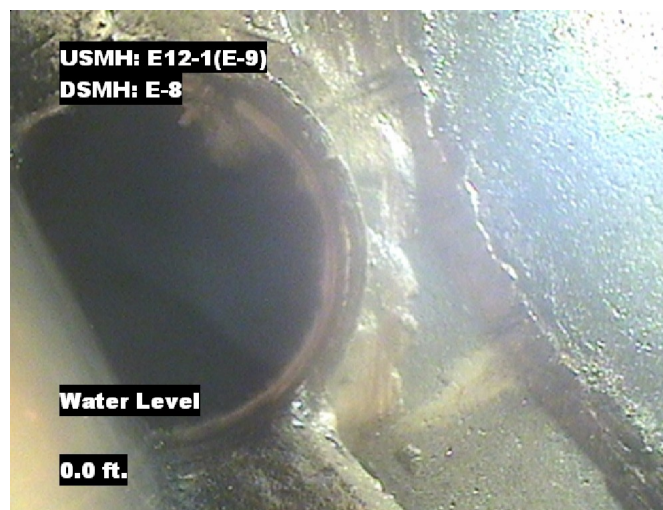
Distance: 0.0 ft. Grade: 0
Condition: Water Level
Remarks: N/A

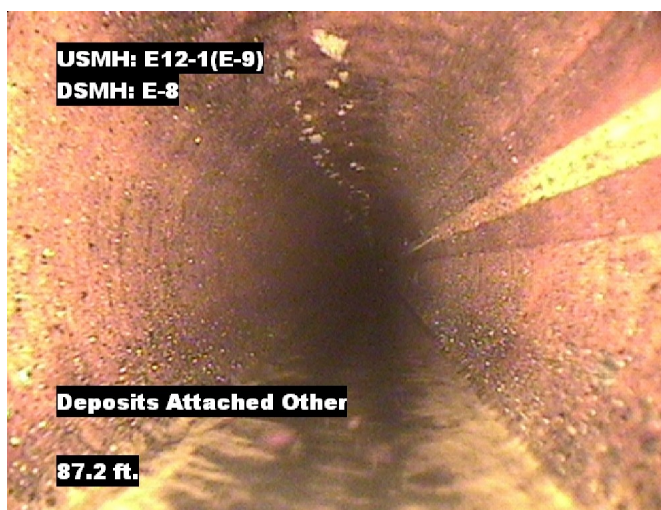
Distance: 87.2 ft. Grade: 2
Condition: Deposits Attached Other
Remarks: N/A

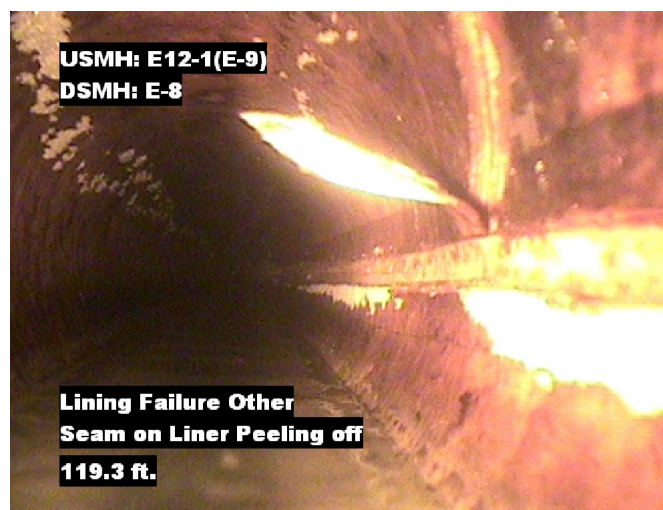
0.0 ft.	Water Level				20	<input type="checkbox"/>			
87.2 ft.	Deposits Attached Other				5	<input type="checkbox"/>	7	5	2
119.3 ft.	Lining Failure Other				0	<input type="checkbox"/>	3		
Remarks: Seam on Liner Peeling off

Distance: 119.3 ft. Grade: 0
Condition: Lining Failure Other
Remarks: Seam on Liner Peeling off

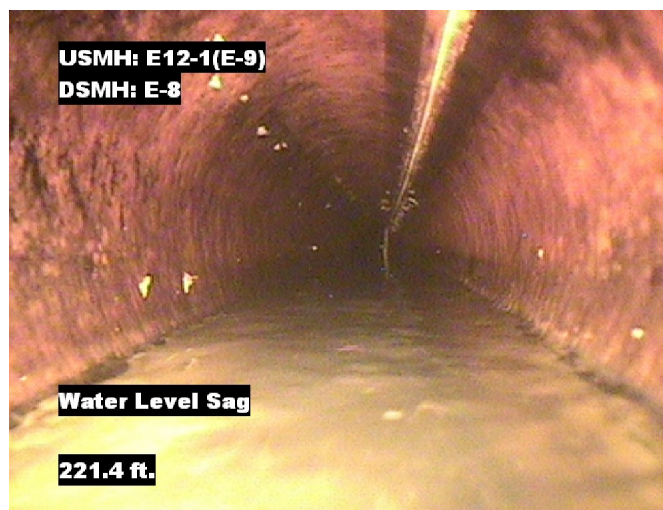
Distance: 221.4 ft. Grade: 2
Condition: Water Level Sag
Remarks: N/A

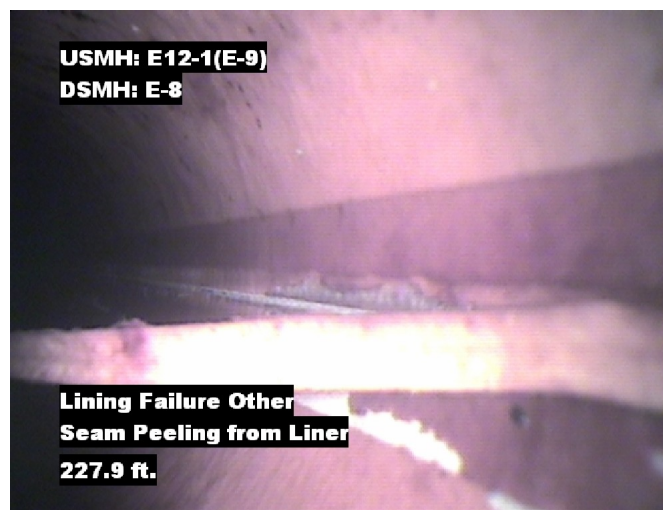
221.4 ft.	Water Level Sag				20	<input type="checkbox"/>			2
227.9 ft.	Lining Failure Other				0	<input type="checkbox"/>	12		
Remarks: Seam Peeling from Liner

Distance: 227.9 ft. Grade: 0
Condition: Lining Failure Other
Remarks: Seam Peeling from Liner

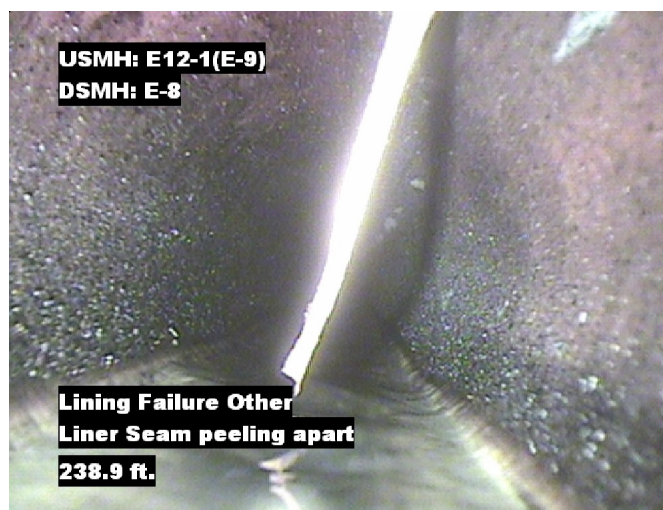
238.9 ft.	Lining Failure Other				0	<input type="checkbox"/>	12		
Remarks: Liner Seam peeling apart									
264.7 ft.	Water Level Sag				15	<input type="checkbox"/>			2

Distance: 238.9 ft. Grade: 0
Condition: Lining Failure Other
Remarks: Liner Seam peeling apart

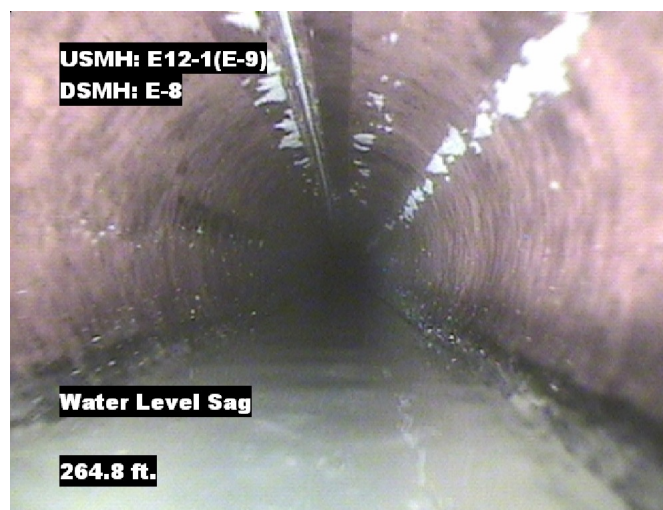
Distance: 264.7 ft. Grade: 2
Condition: Water Level Sag
Remarks: N/A

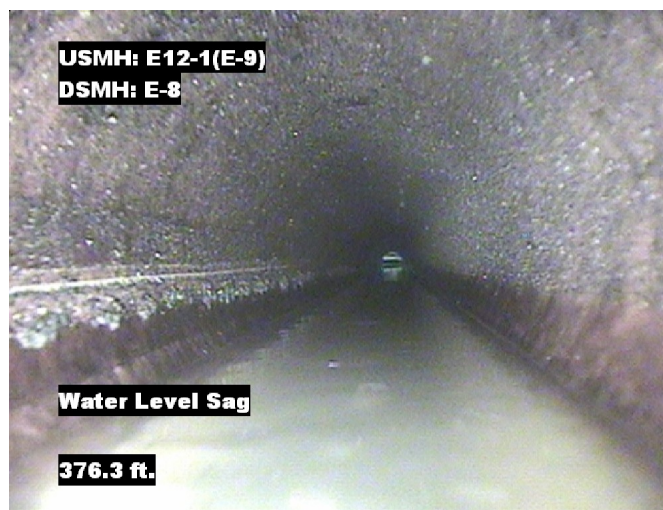
Distance: 376.3 ft. Grade: 2
Condition: Water Level Sag
Remarks: N/A

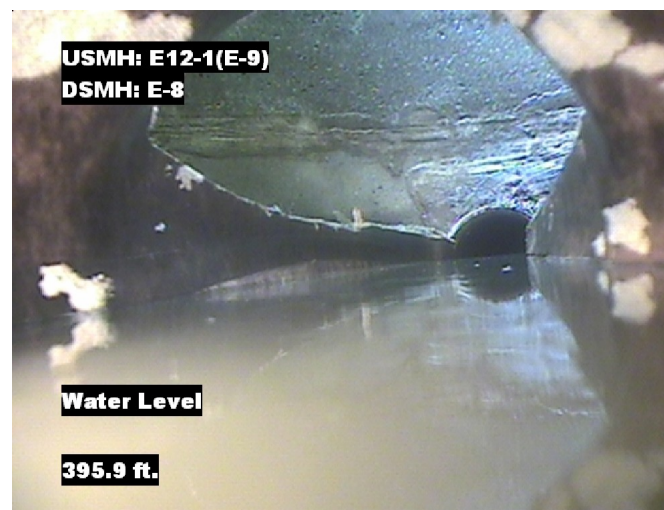
Distance: 395.9 ft. Grade: 0
Condition: Water Level
Remarks: N/A

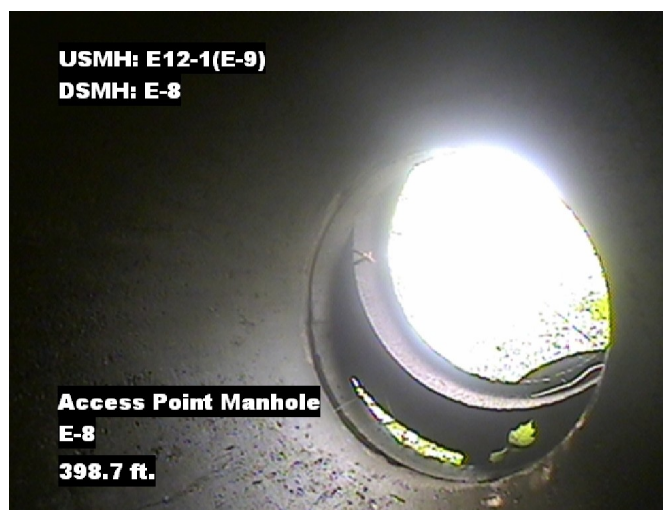
Distance: 398.7 ft. Grade: 0
Condition: Access Point Manhole
Remarks: E-8
