## Defect Listing

Pipe Segment Refere... <b>E1-2_E-1</b>	City <b>Oliver Springs</b>	Street <b>Hwy62</b>	Material <b>PolyVinyl Chloride</b>	Location C... <b>Easement/R...</b>	Sewer Use <b>Sanitary</b>
Upstream MH <b>E1-2</b>	Total Length <b>299</b>	Year Laid	Shape <b>Circular</b>	Location Details <b>Side of Hwy</b>	
DS Manhole <b>E-1</b>	Length surveyed <b>299</b>	Year Renewed	Height <b>8</b>	Width <b>8</b>	Pipe Joint... <b>13</b>

## Image Report 4/Page

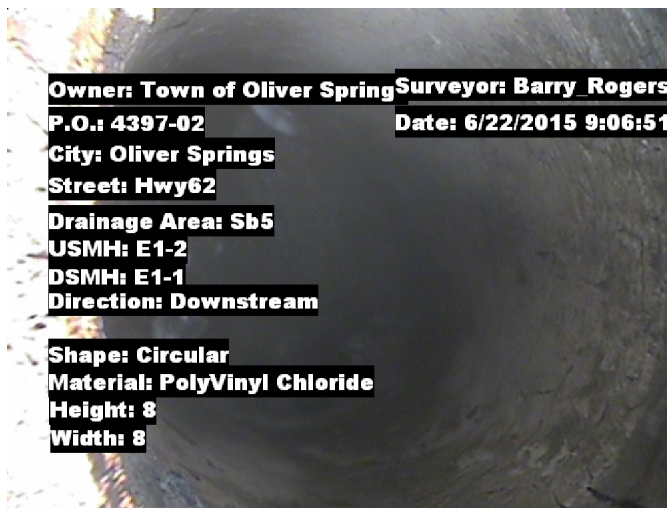
Distance: 0.0 ft. Grade: 0  
Condition: Access Point Manhole  
Remarks: E1-2

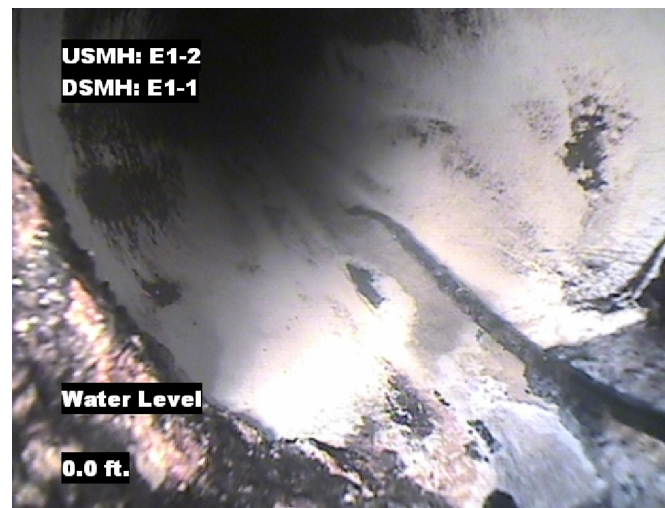
Distance: 0.0 ft. Grade: 0  
Condition: Water Level  
Remarks: N/A

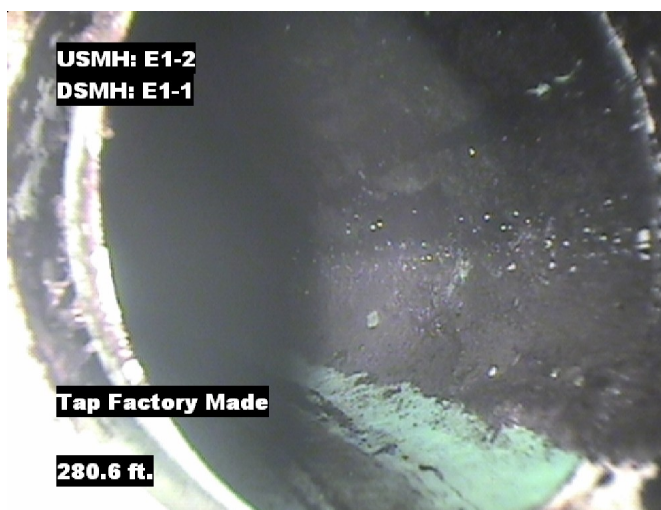
Distance: 280.6 ft. Grade: 0  
Condition: Tap Factory Made  
Remarks: N/A

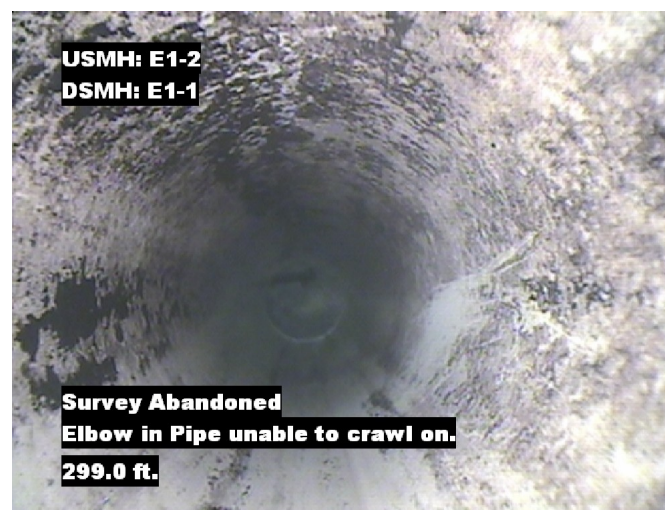
Distance: 299.0 ft. Grade: 0  
Condition: Survey Abandoned  
Remarks: Elbow in Pipe unable to crawl on.
