## Defect Listing

Pipe Segment Refere... <b>E1-3_E1-2</b>	City <b>Oliver Springs</b>	Street <b>Hwy62</b>	Material <b>PolyVinyl Chloride</b>	Location C... <b>Main Highw...</b>	Sewer Use <b>Sanitary</b>
Upstream MH <b>E1-3</b>	Total Length <b>140.1</b>	Year Laid	Shape <b>Circular</b>	Location Details <b>Side of Hwy</b>	
DS Manhole <b>E1-2</b>	Length surveyed <b>140.1</b>	Year Renewed	Height <b>8</b>	Width <b>8</b>	Pipe Joint... <b>13</b>

## Image Report 4/Page

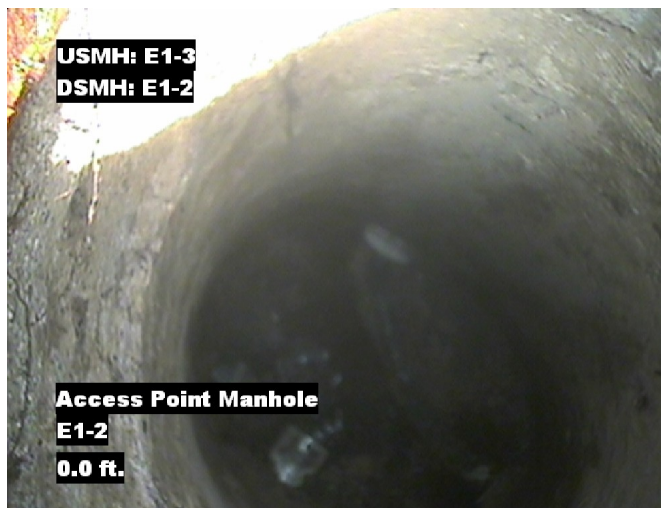
Distance: 0.0 ft. Grade: 0  
Condition: Access Point Manhole  
Remarks: E1-2

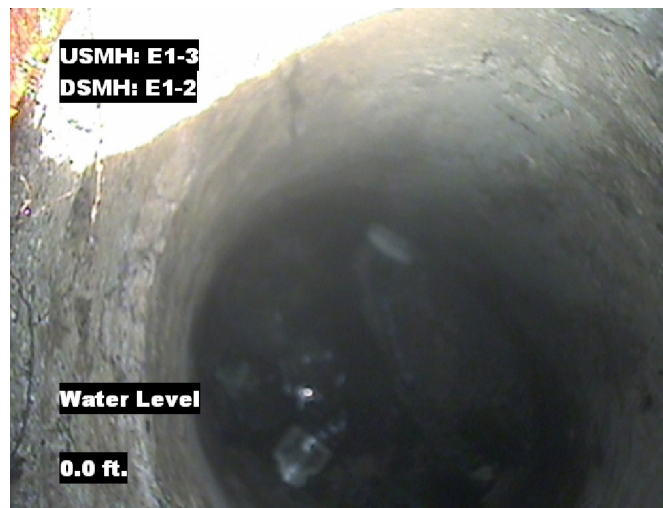
Distance: 0.0 ft. Grade: 0  
Condition: Water Level  
Remarks: N/A

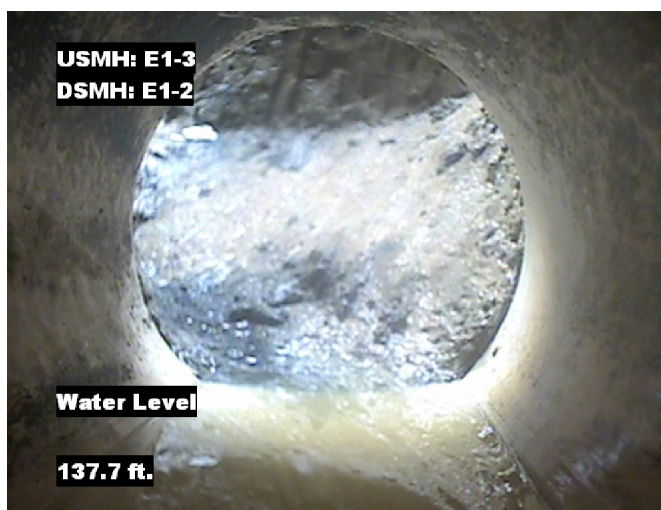
Distance: 137.7 ft. Grade: 0  
Condition: Water Level  
Remarks: N/A

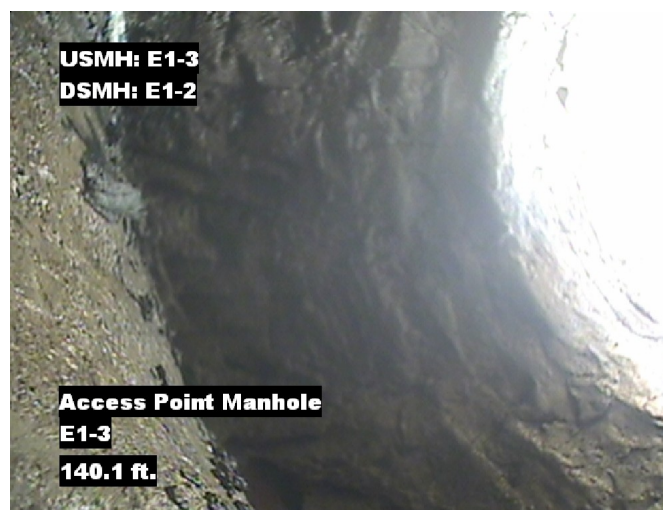
Distance: 140.1 ft. Grade: 0  
Condition: Access Point Manhole  
Remarks: E1-3
