Defect Listing

Pipe Segment Refere... E1-4_E1-3	City Oliver Springs	Street Hwy 61	Material Fiberglass Reinforc...	Location C... Easement/R...	Sewer Use Sanitary
Upstream MH E1-4	Total Length 173.3	Year Laid	Shape Circular	Location Details Under Bridge @ Skat...	
DS Manhole E1-3	Length surveyed 173.3	Year Renewed	Height 8	Width 8	Pipe Joint... N/A

SPR N/A	MPR 12	PO Number 4397-03		Customer GRW	
SPRI N/A	MPRI 2.4	Work Order 4397-02		Purpose Pre-Rehabilitation Survey	
QSR N/A	QMR 4124				
OPR 12	Surveyed By Barry Rogers	Direction Downstream	Date 20150602	Media label	
OPRI 2.4	Certificate Number U-1012-16405	Pre-Cleaning Heavy Cleaning	Time 18:05	Weather Dry	
Date Cleaned 20150602			End Time 18:11	Additional Info upstream and downst...

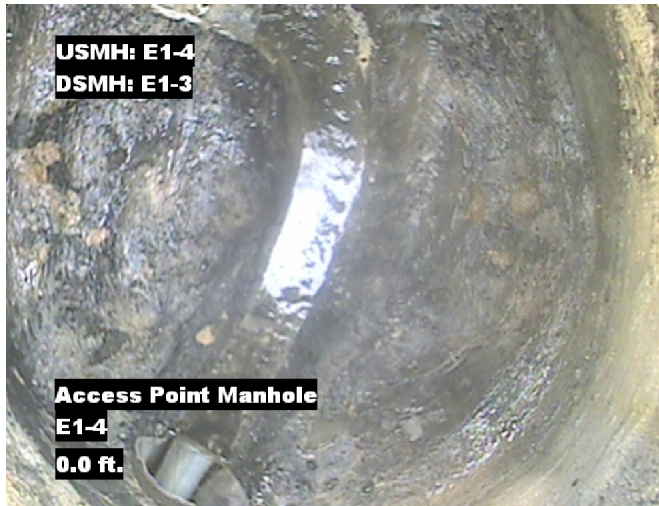
Distance: 0.0 ft. Grade: 0
Condition: Access Point Manhole
Remarks: E1-4

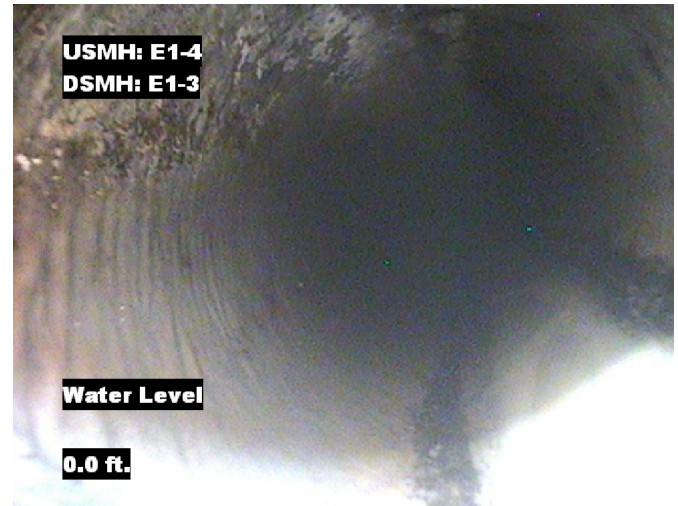
Distance: 0.0 ft. Grade: 0
Condition: Water Level
Remarks: N/A

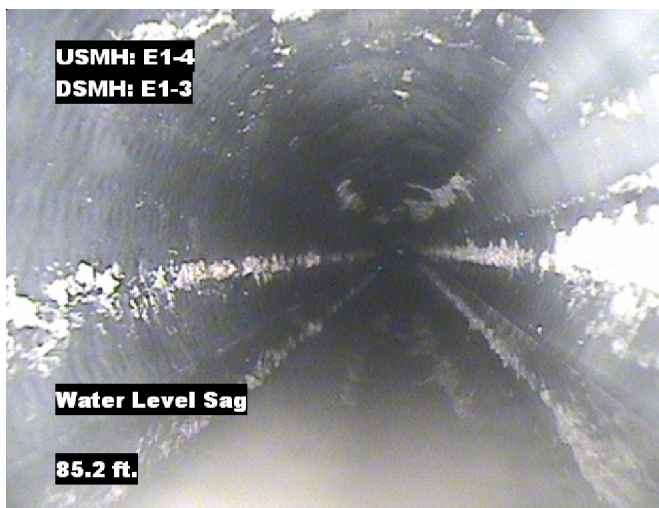
Distance: 85.2 ft. Grade: 2
Condition: Water Level Sag
Remarks: N/A

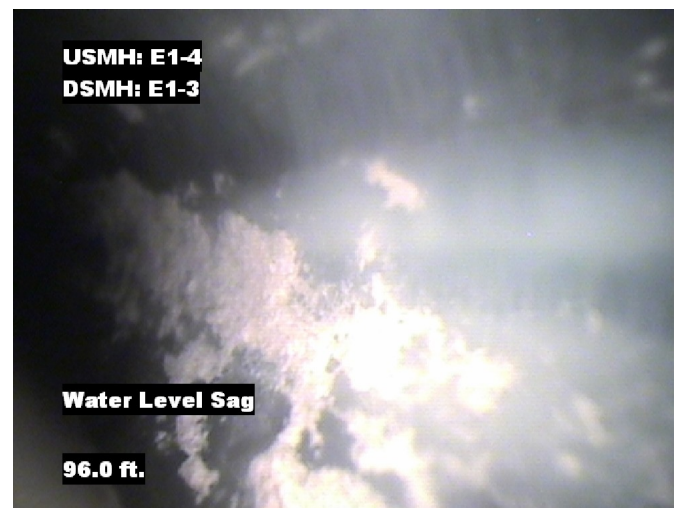
Distance: 96.0 ft. Grade: 2
Condition: Water Level Sag
Remarks: N/A

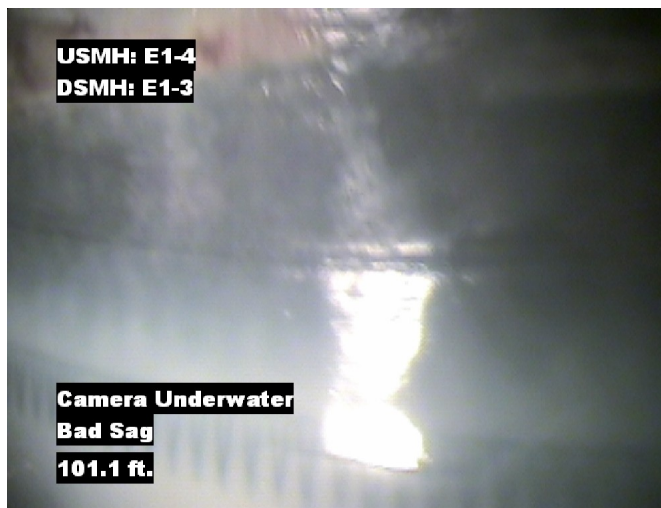
Distance: 101.1 ft. Grade: 4
Condition: Camera Underwater
Remarks: Bad Sag

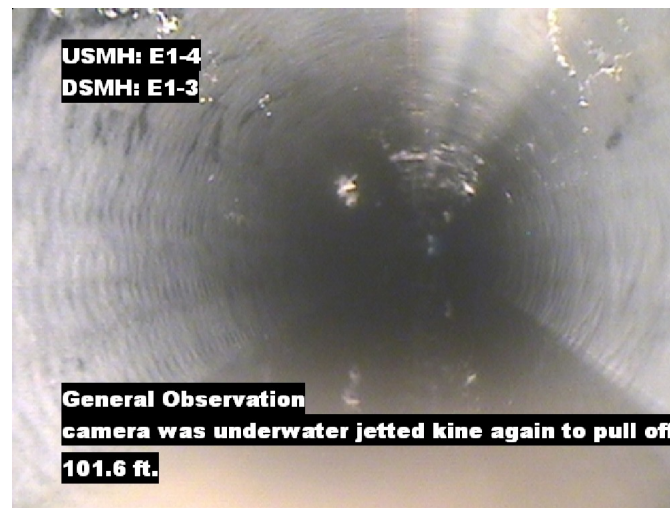
Distance: 101.6 ft. Grade: 0
Condition: General Observation
Remarks: camera was underwater jetted kine again to pull off water level

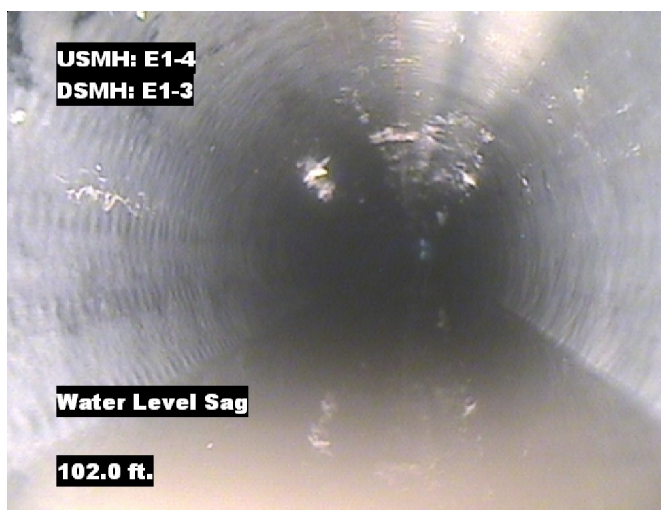
Distance: 102.0 ft. Grade: 2
Condition: Water Level Sag
Remarks: N/A

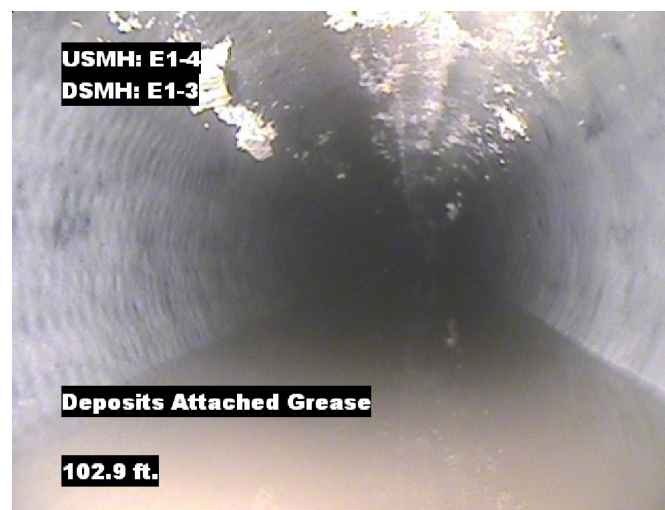
Distance: 102.9 ft. Grade: 2
Condition: Deposits Attached Grease
Remarks: N/A

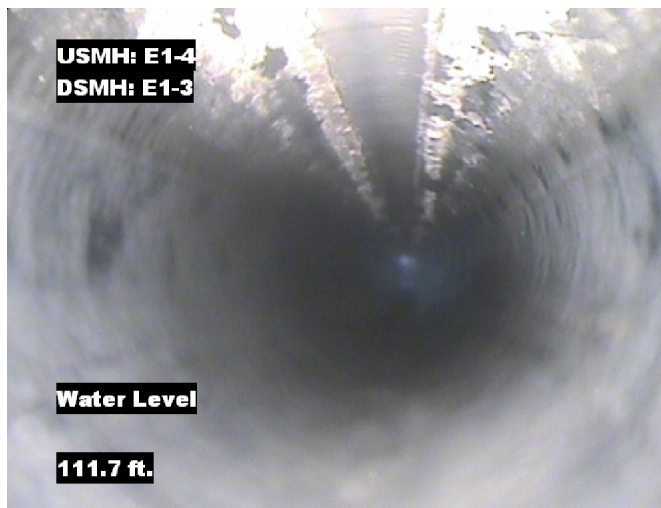
Distance: 111.7 ft. Grade: 0
Condition: Water Level
Remarks: N/A

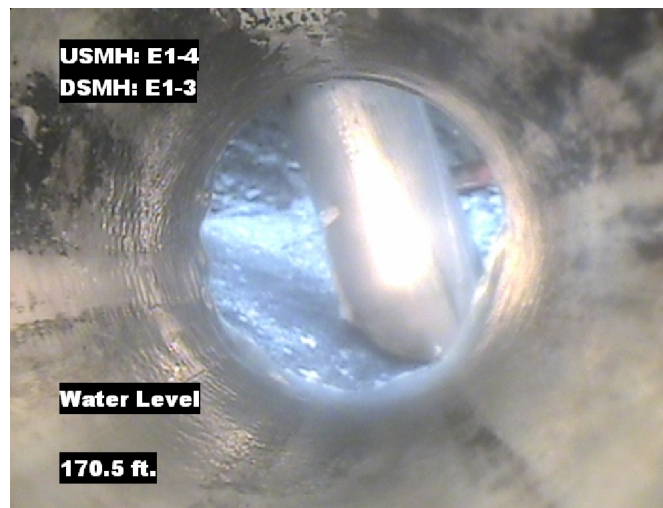
Distance: 170.5 ft. Grade: 0
Condition: Water Level
Remarks: N/A

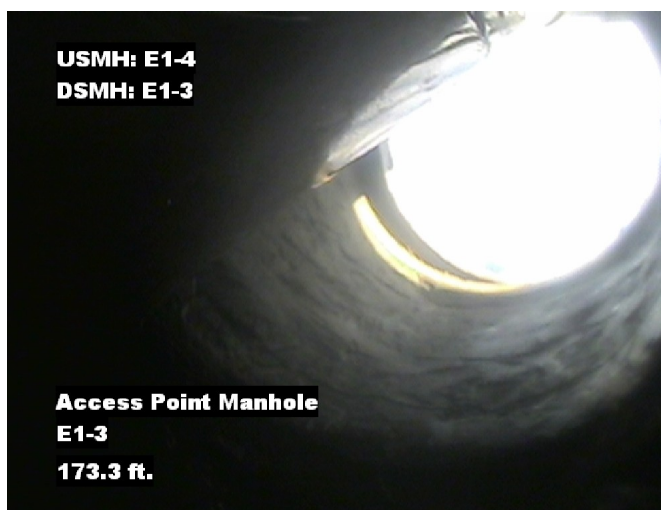
Distance: 173.3 ft. Grade: 0
Condition: Access Point Manhole
Remarks: E1-3
