Defect Listing

Pipe Segment Refere... E1-5_E1-4	City Oliver Springs	Street Hwy 62	Material PolyVinyl Chloride	Location C... Yard	Sewer Use Sanitary
Upstream MH E1-5	Total Length 239.4	Year Laid	Shape Circular	Location Details usmh located in par...	
DS Manhole E1-4	Length surveyed 239.4	Year Renewed	Height 8	Width 8	Pipe Joint... 13

SPR N/A	MPR 10	PO Number 4397-03	Customer GRW
SPRI N/A	MPRI 2	Work Order 4397-02	Purpose Pre-Rehabilitation Survey
QSR N/A	QMR 2500		
OPR 10	Surveyed By David_brown	Direction Downstream	Date 20150620
OPRI 2	Certificate Number U-607-5202	Pre-Cleaning Jetting	Time 14:22
	Date Cleaned 20150620	End Time 14:35	Weather Saturated
			Media label
			Additional Info

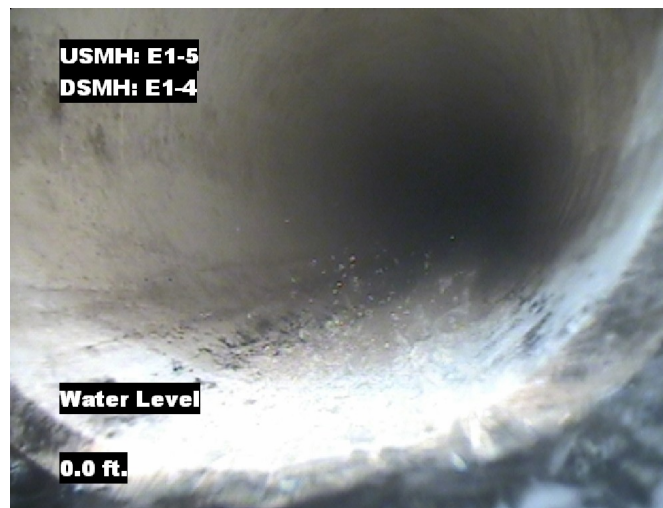
Distance: 0.0 ft. Grade: 0
Condition: Water Level
Remarks: N/A

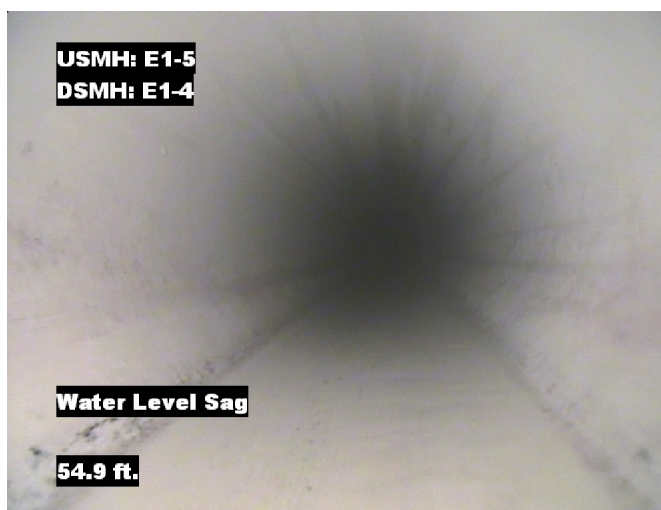
Distance: 54.9 ft. Grade: 2
Condition: Water Level Sag
Remarks: N/A

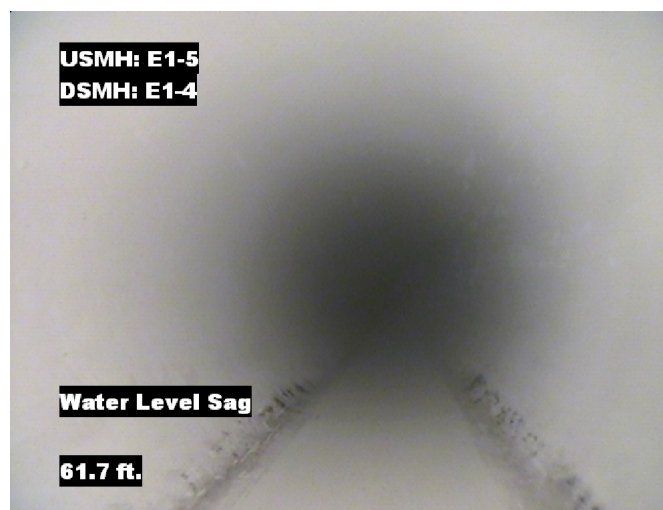
Distance: 61.7 ft. Grade: 2
Condition: Water Level Sag
Remarks: N/A

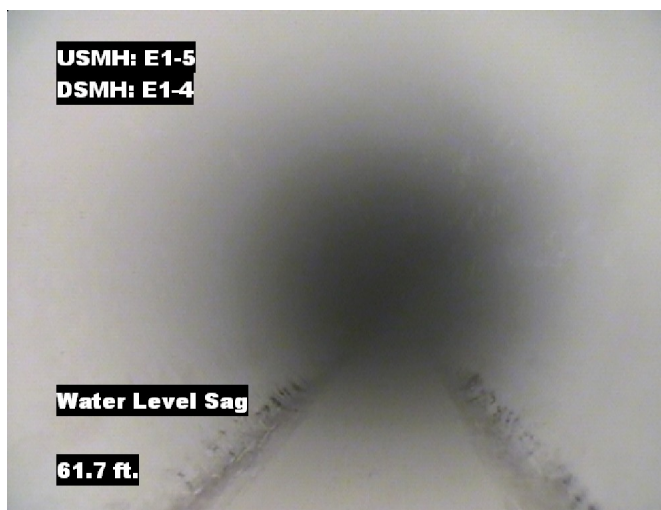
Distance: 61.7 ft. Grade: 2
Condition: Water Level Sag
Remarks: N/A

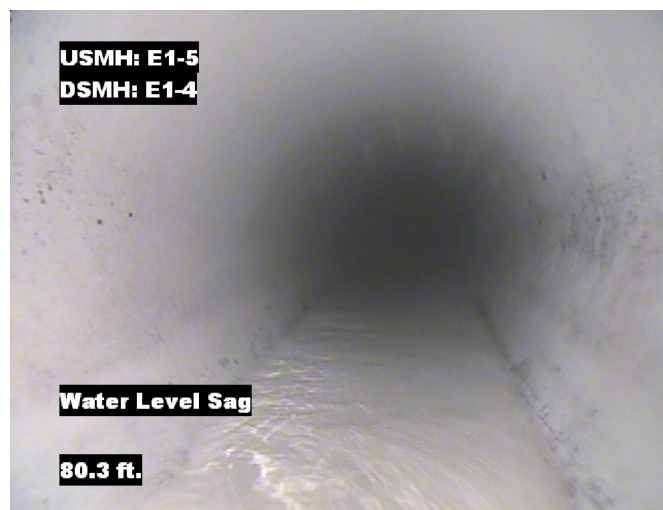
Distance: 80.3 ft. Grade: 2
Condition: Water Level Sag
Remarks: N/A

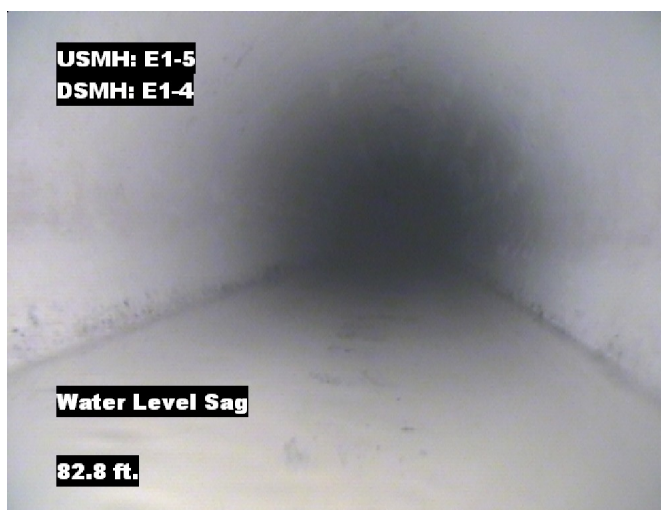
Distance: 82.8 ft. Grade: 2
Condition: Water Level Sag
Remarks: N/A

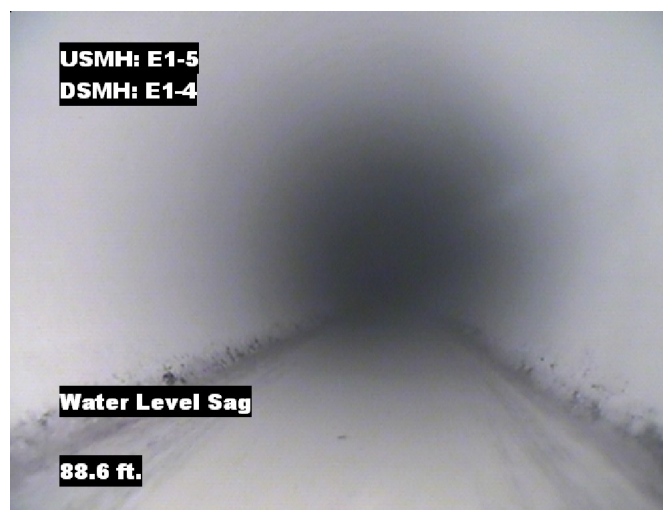
Distance: 88.6 ft. Grade: 2
Condition: Water Level Sag
Remarks: N/A

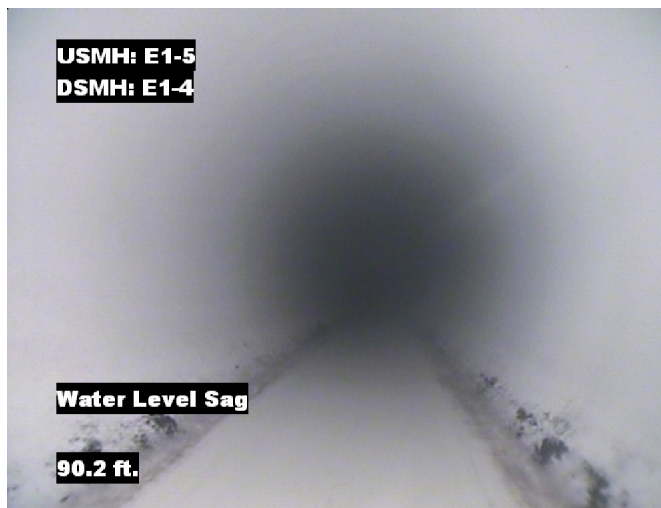
Distance: 90.2 ft. Grade: 2
Condition: Water Level Sag
Remarks: N/A

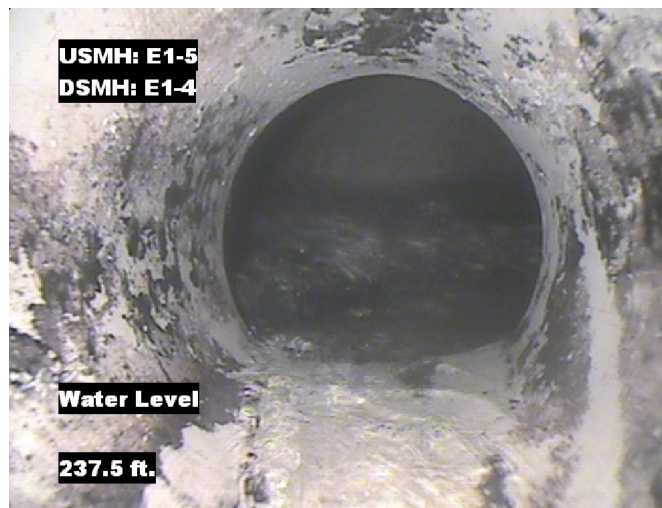
Distance: 237.5 ft. Grade: 0
Condition: Water Level
Remarks: N/A
