Defect Listing

Pipe Segment Refere... E1-6_E1-5	City Oliver Springs	Street Hwy 62	Material PolyVinyl Chloride	Location C... Yard	Sewer Use Sanitary
Upstream MH E1-6	Total Length 354.9	Year Laid	Shape Circular	Location Details usmh located in hea...	
DS Manhole E1-5	Length surveyed 354.9	Year Renewed	Height 8	Width 8	Pipe Joint... 13

SPR N/A	MPR 31	PO Number 4397-03		Customer GRW	
SPRI N/A	MPRI 2.2	Work Order 4397-02		Purpose Pre-Rehabilitation Survey	
QSR N/A	QMR 4131				
OPR 31	Surveyed By David_brown	Direction Downstream	Date 20150620	Media label	
OPRI 2.2	Certificate Number U-607-5202	Pre-Cleaning Jetting	Time 12:56	Weather Saturated	
Date Cleaned 20150620			End Time 13:04	Additional Info map was off observa...

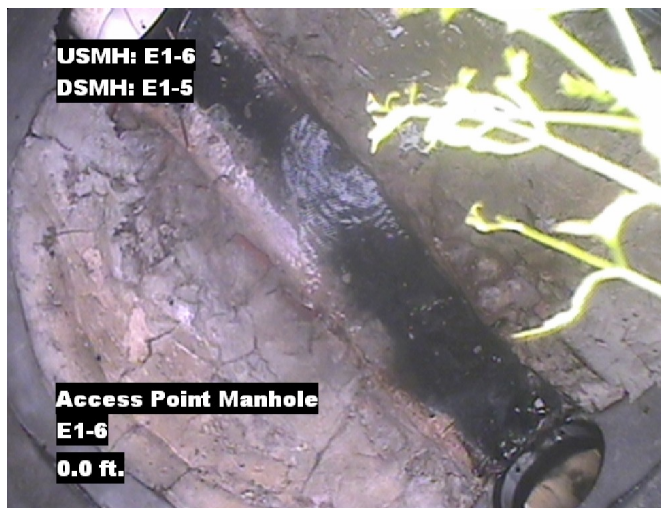
Distance: 0.0 ft. Grade: 0
Condition: Access Point Manhole
Remarks: E1-6

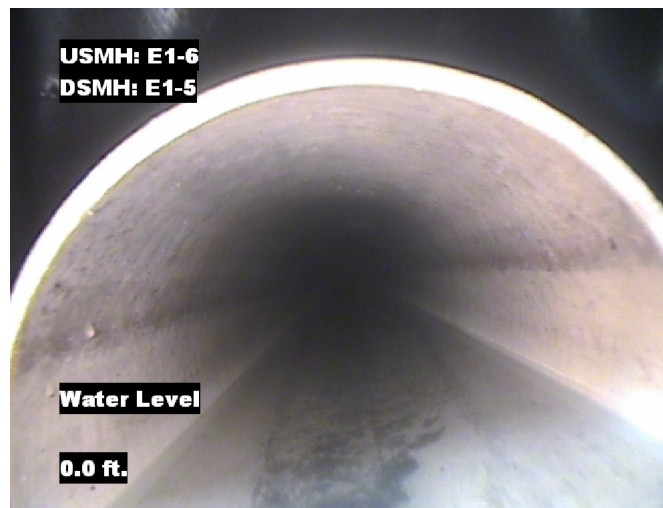
Distance: 0.0 ft. Grade: 0
Condition: Water Level
Remarks: N/A

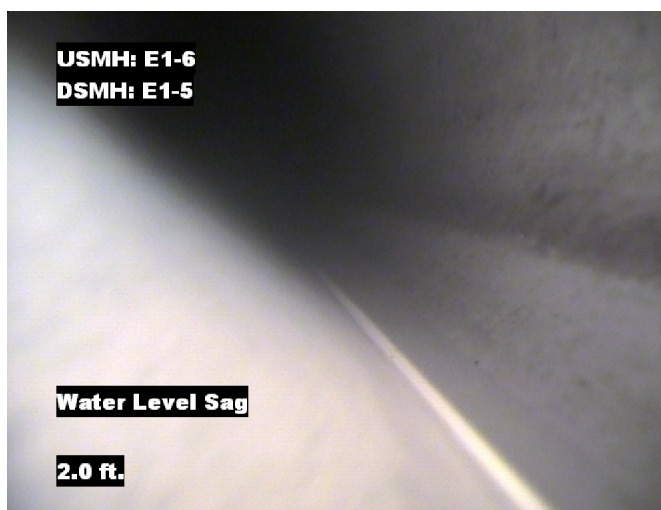
Distance: 2.0 ft. Grade: 3
Condition: Water Level Sag
Remarks: N/A

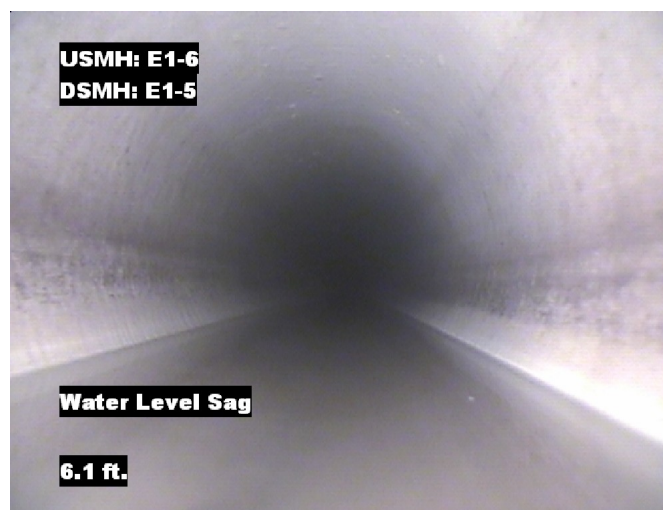
Distance: 6.1 ft. Grade: 2
Condition: Water Level Sag
Remarks: N/A

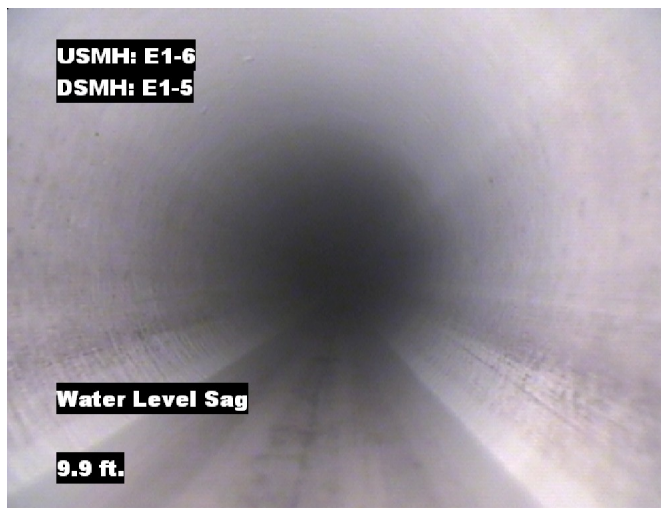
Distance: 9.9 ft. Grade: 2
Condition: Water Level Sag
Remarks: N/A

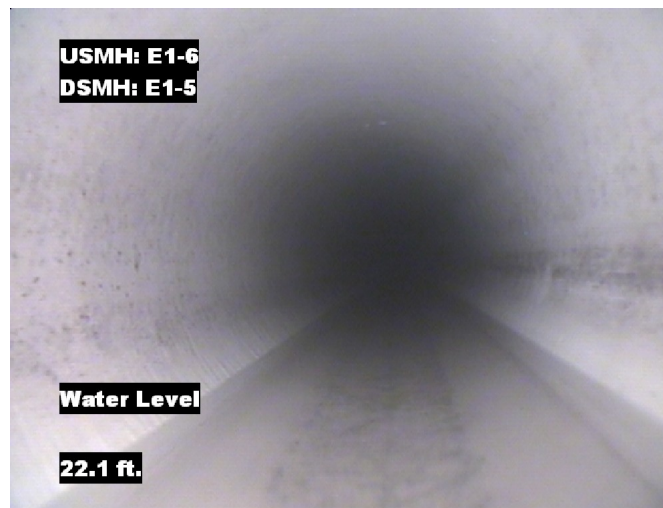
Distance: 22.1 ft. Grade: 0
Condition: Water Level
Remarks: N/A

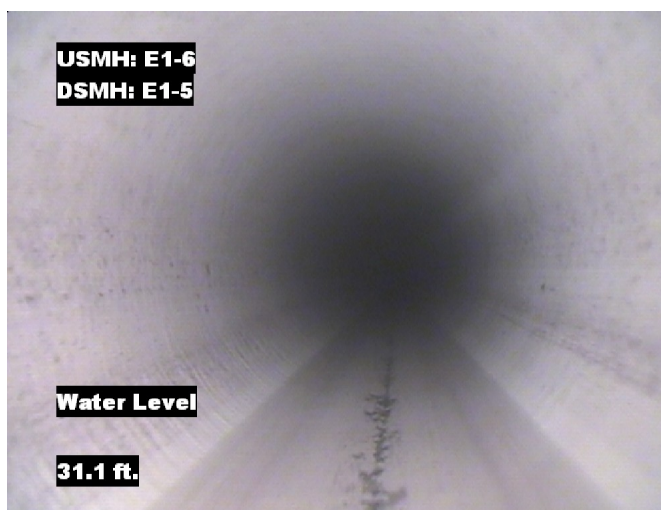
Distance: 31.1 ft. Grade: 0
Condition: Water Level
Remarks: N/A

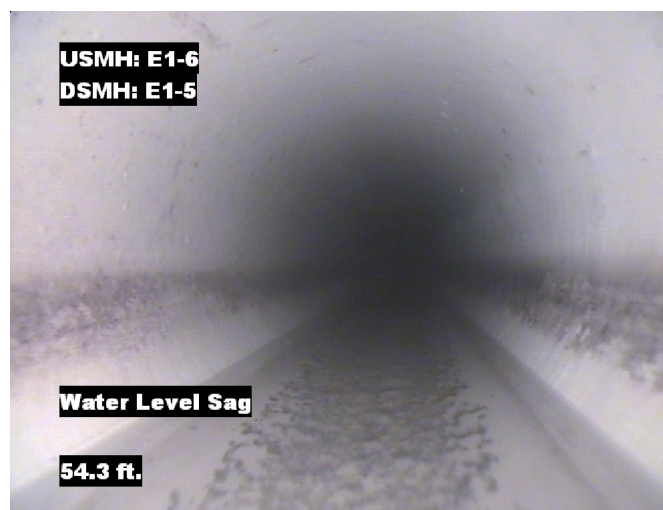
Distance: 54.3 ft. Grade: 2
Condition: Water Level Sag
Remarks: N/A

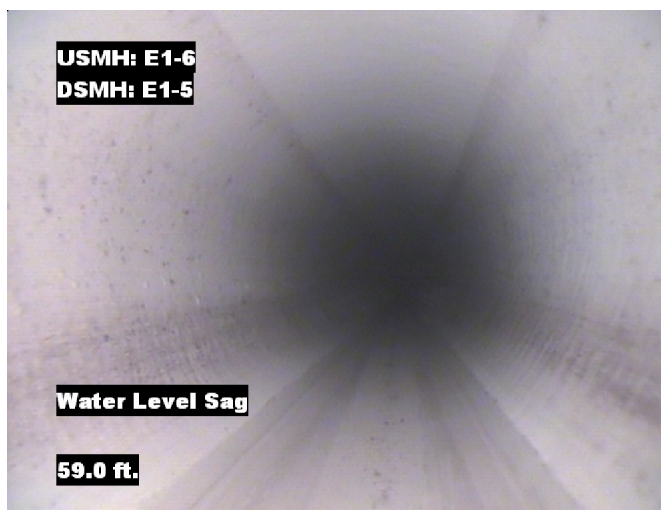
Distance: 59.0 ft. Grade: 2
Condition: Water Level Sag
Remarks: N/A

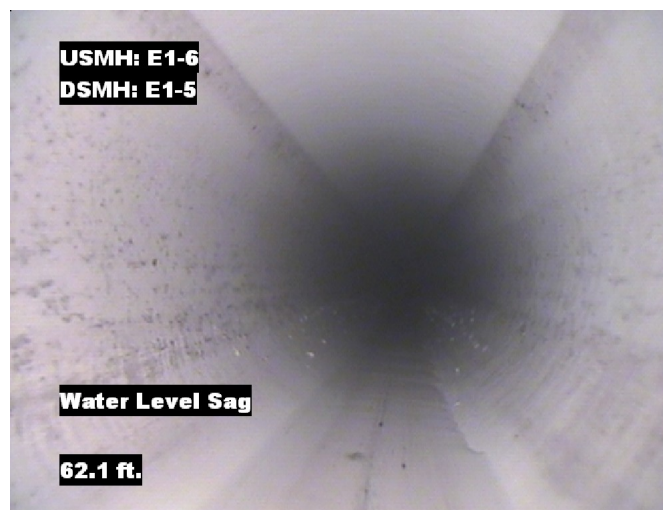
Distance: 62.1 ft. Grade: 2
Condition: Water Level Sag
Remarks: N/A

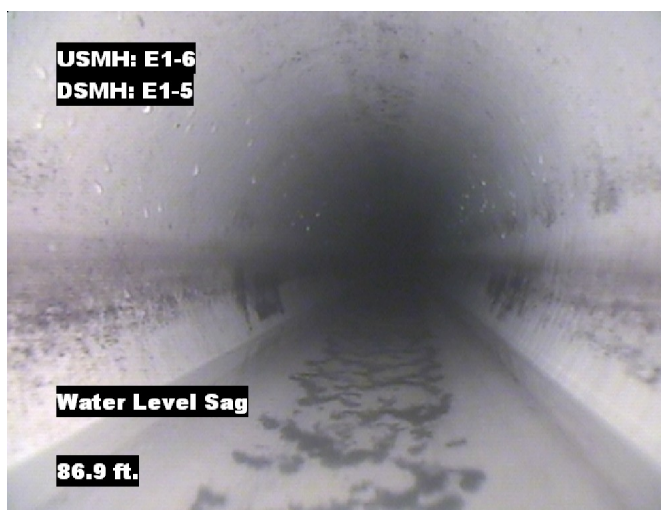
Distance: 86.9 ft. Grade: 2
Condition: Water Level Sag
Remarks: N/A

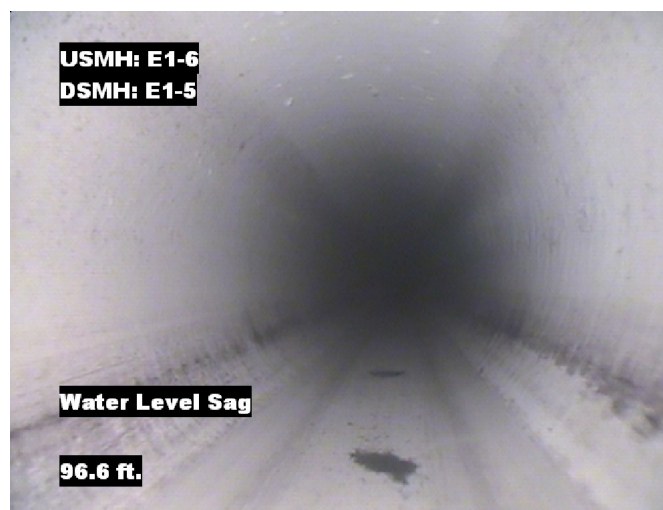
Distance: 96.6 ft. Grade: 2
Condition: Water Level Sag
Remarks: N/A

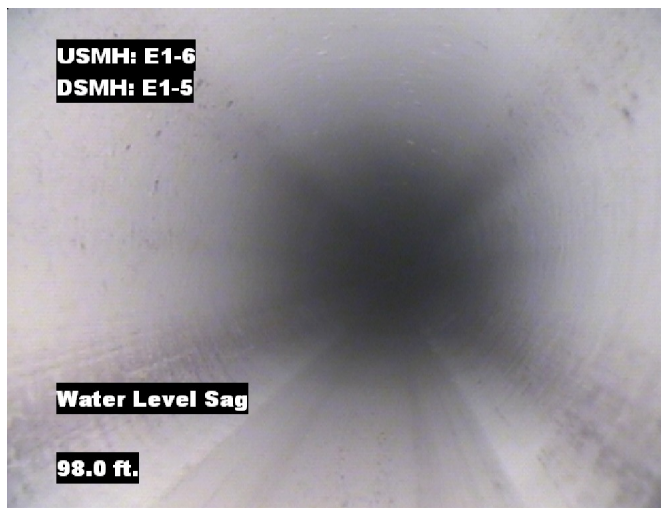
Distance: 98.0 ft. Grade: 2
Condition: Water Level Sag
Remarks: N/A

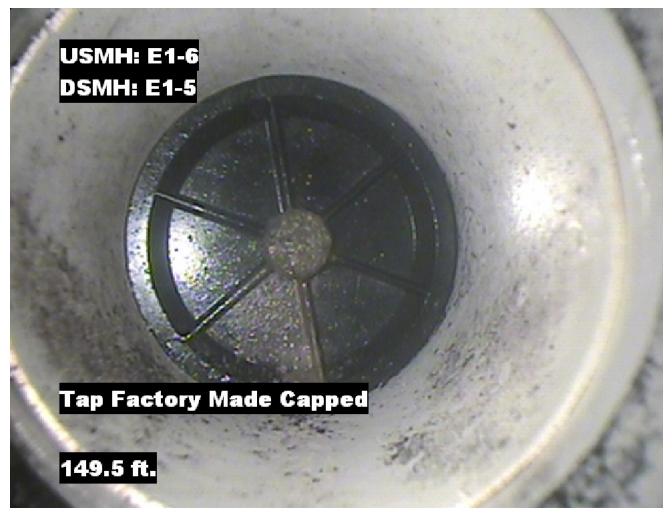
Distance: 149.5 ft. Grade: 0
Condition: Tap Factory Made Capped
Remarks: N/A

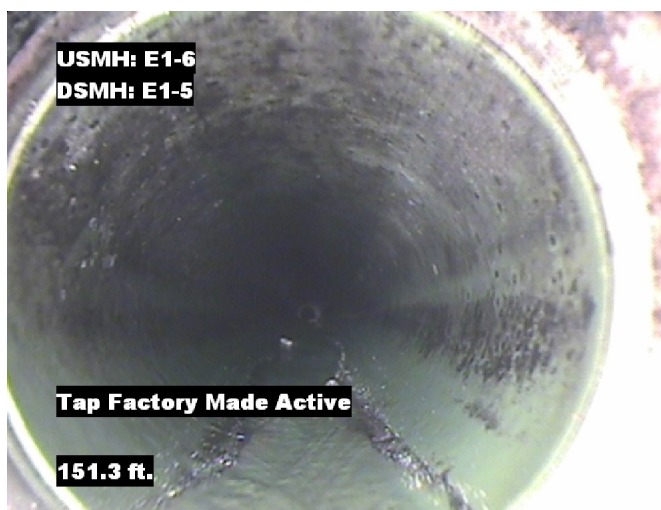
Distance: 151.3 ft. Grade: 0
Condition: Tap Factory Made Active
Remarks: N/A

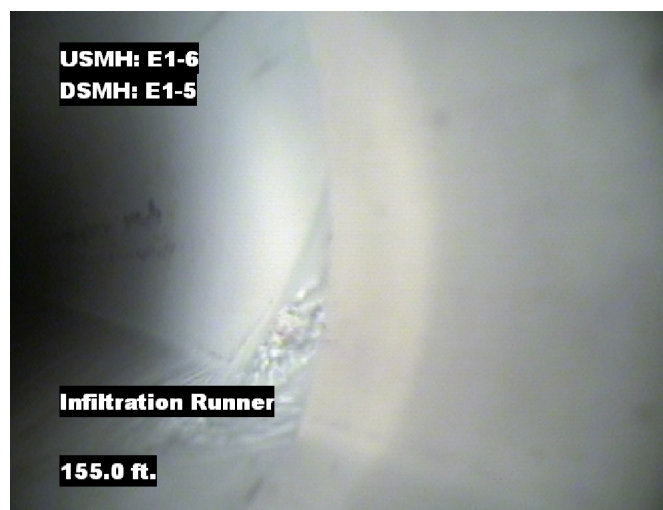
Distance: 155.0 ft. Grade: 4
Condition: Infiltration Runner
Remarks: N/A

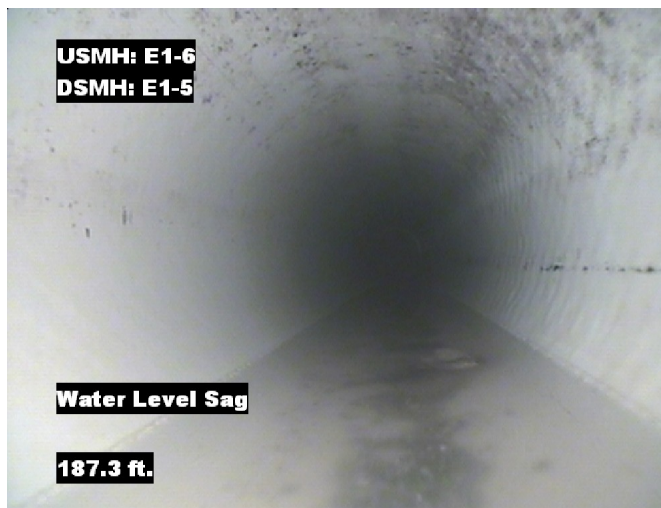
Distance: 187.3 ft. Grade: 2
Condition: Water Level Sag
Remarks: N/A

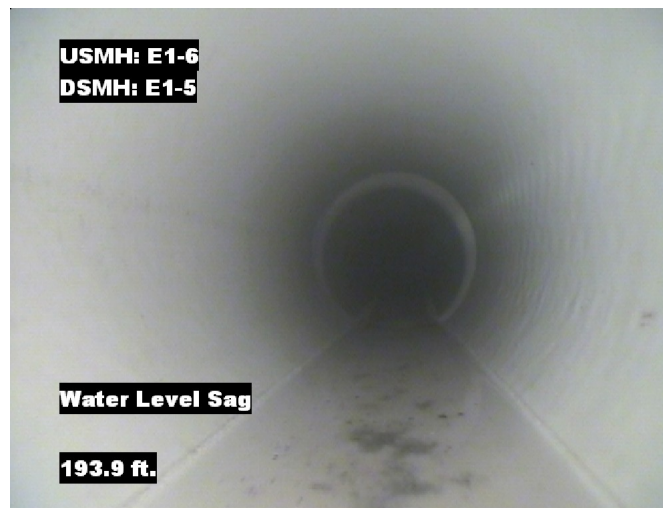
Distance: 193.9 ft. Grade: 2
Condition: Water Level Sag
Remarks: N/A

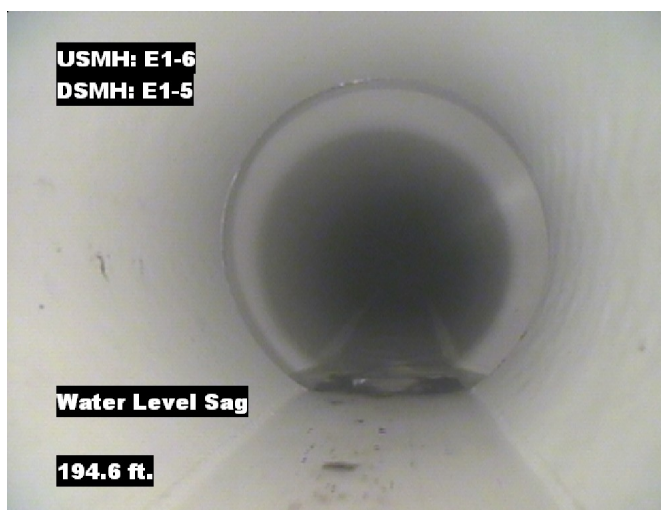
Distance: 194.6 ft. Grade: 2
Condition: Water Level Sag
Remarks: N/A

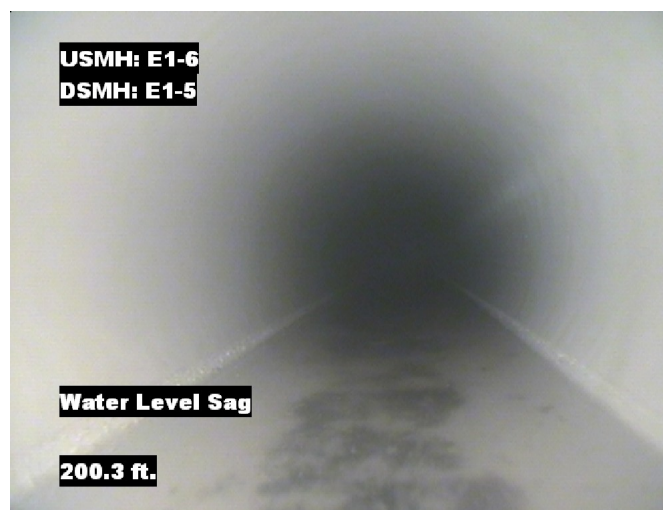
Distance: 200.3 ft. Grade: 2
Condition: Water Level Sag
Remarks: N/A

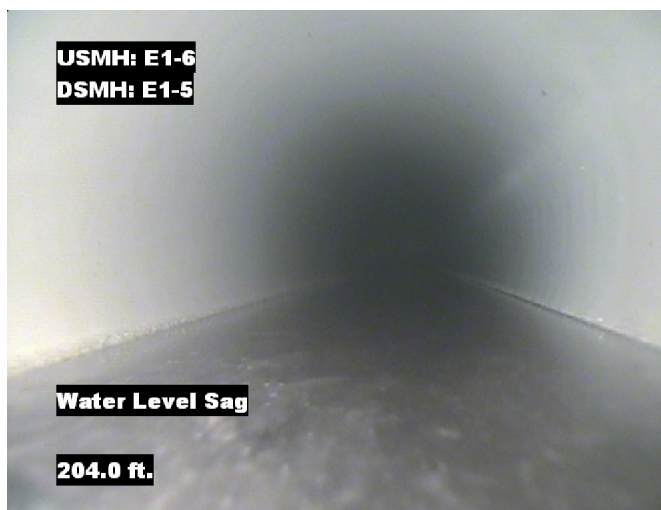
Distance: 204.0 ft. Grade: 2
Condition: Water Level Sag
Remarks: N/A

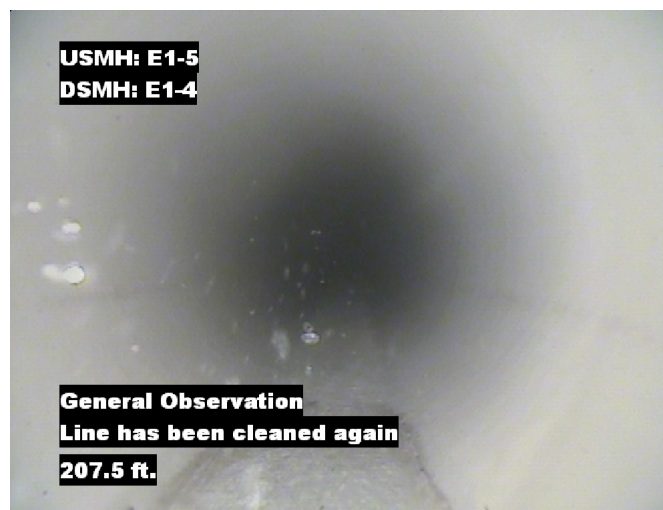
Distance: 207.5 ft. Grade: 0
Condition: General Observation
Remarks: Line has been cleaned again

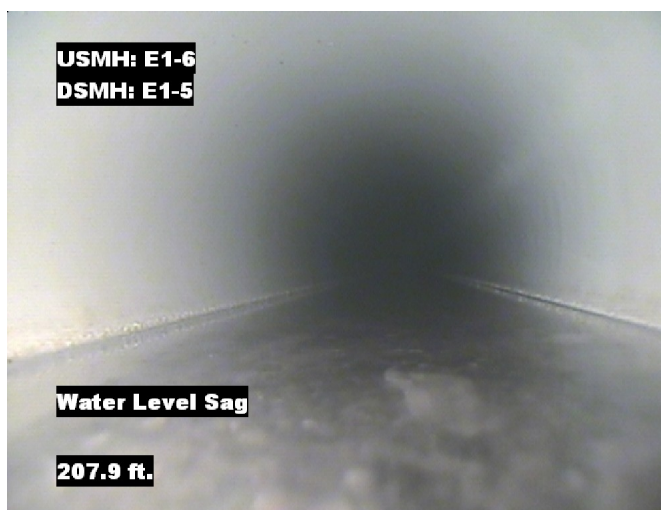
Distance: 207.9 ft. Grade: 2
Condition: Water Level Sag
Remarks: N/A

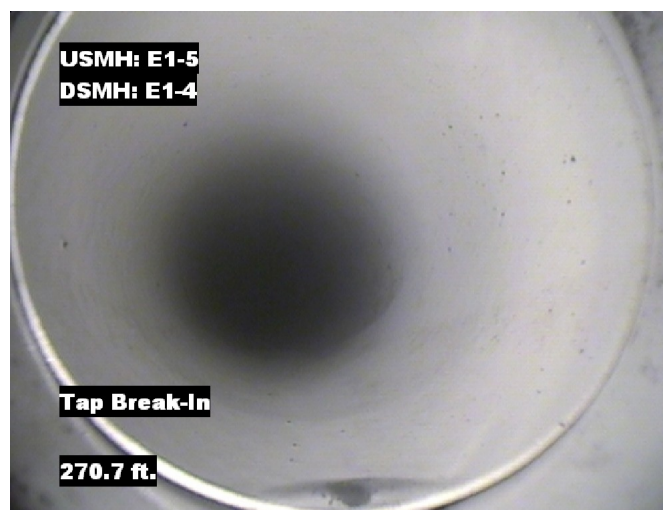
Distance: 270.7 ft. Grade: 0
Condition: Tap Break-In
Remarks: N/A

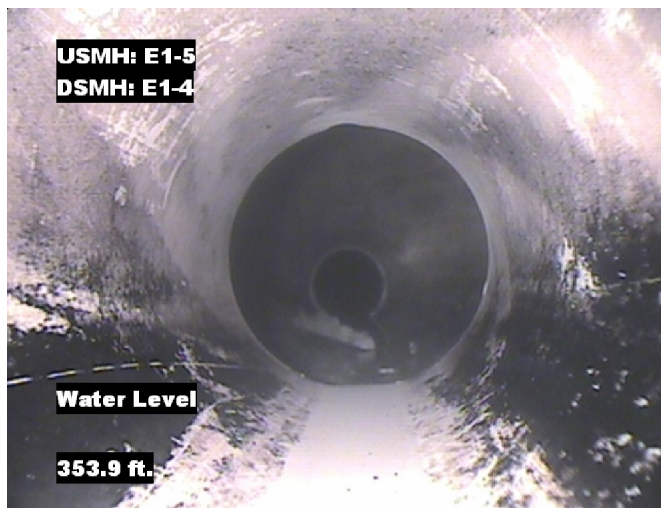
Distance: 353.9 ft. Grade: 0
Condition: Water Level
Remarks: N/A

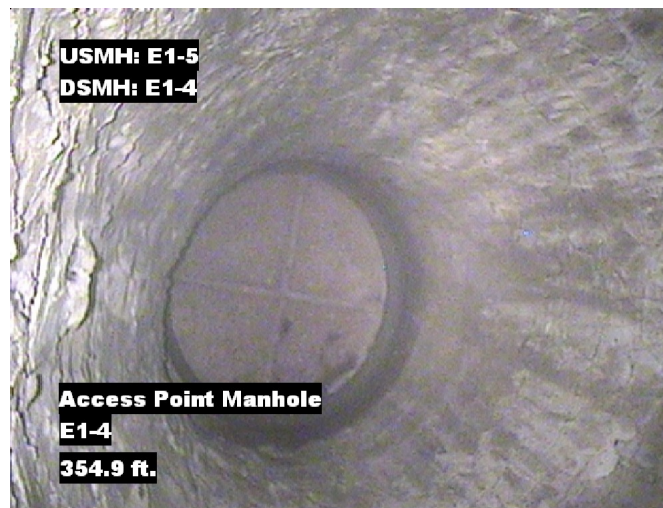
Distance: 354.9 ft. Grade: 0
Condition: Access Point Manhole
Remarks: e1-5
