Defect Listing

Pipe Segment Refere... E1-6EOL_E1-6	City Oliver Springs	Street HWY 62	Material PolyVinyl Chloride	Location C... Yard	Sewer Use Sanitary
Upstream MH E1-6EOL	Total Length 404.2	Year Laid	Shape Circular	Location Details	
DS Manhole E1-6	Length surveyed 404.2	Year Renewed	Height 8	Width 8	Pipe Joint... 13

SPR N/A	MPR 25	PO Number 4397-03	Customer GRW
SPRI N/A	MPRI 2.1	Work Order 4397-02	Purpose Pre-Rehabilitation Survey
QSR N/A	QMR 312A		
OPR 25	Surveyed By David_brown	Direction Upstream	Date 20150620
OPRI 2.1	Certificate Number U-607-5202	Pre-Cleaning Jetting	Time 13:30
	Date Cleaned 20150620	End Time 13:55	Weather Saturated
		Additional Info UNMAPPED LINE/ line...

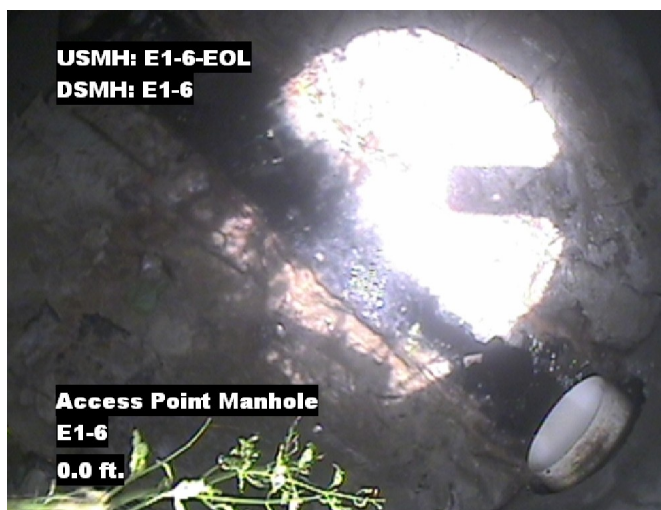
Distance: 0.0 ft. Grade: 0
Condition: Access Point Manhole
Remarks: E1-6

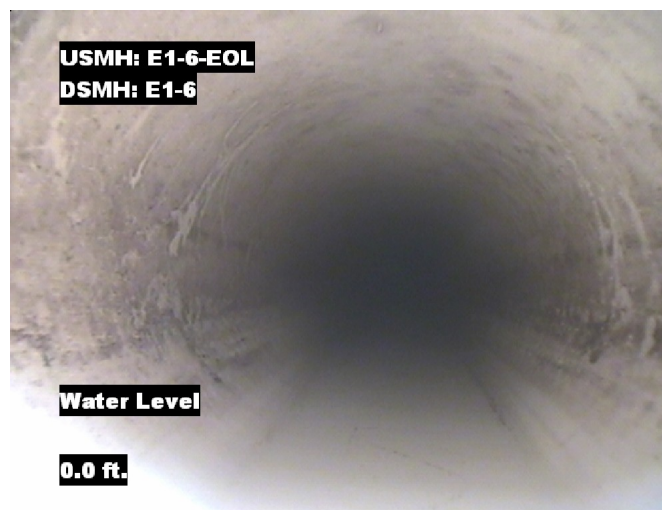
Distance: 0.0 ft. Grade: 0
Condition: Water Level
Remarks: N/A

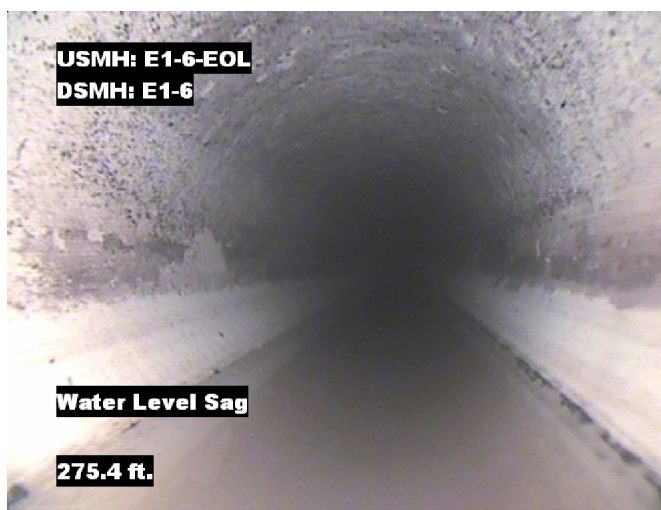
Distance: 275.4 ft. Grade: 2
Condition: Water Level Sag
Remarks: N/A

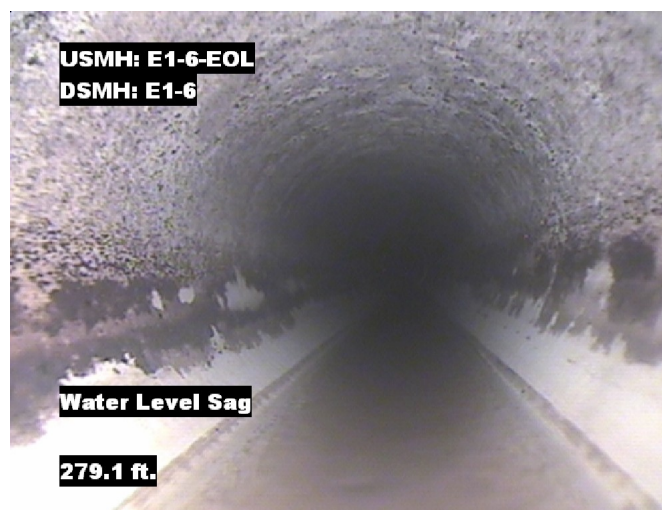
Distance: 279.1 ft. Grade: 2
Condition: Water Level Sag
Remarks: N/A

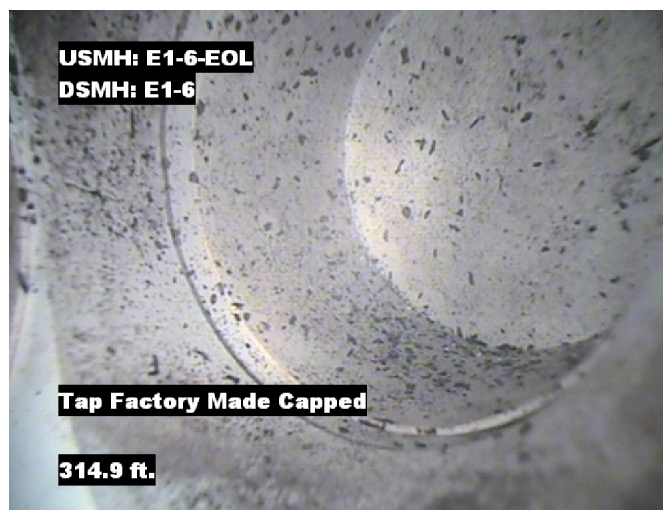
Distance: 314.9 ft. Grade: 0
Condition: Tap Factory Made Capped
Remarks: N/A

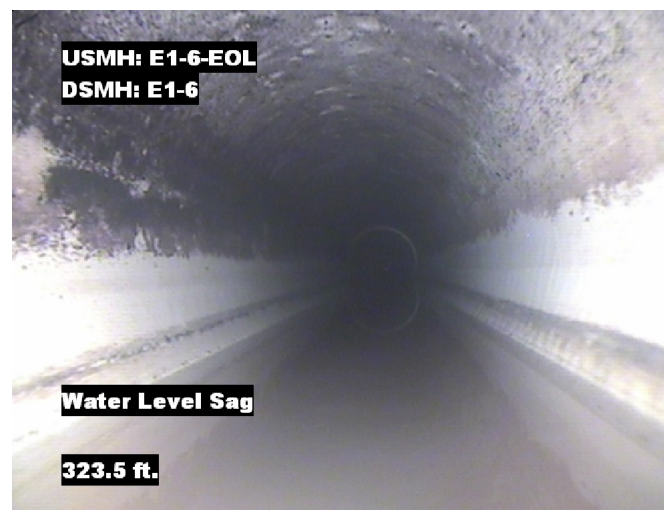
Distance: 323.5 ft. Grade: 2
Condition: Water Level Sag
Remarks: N/A

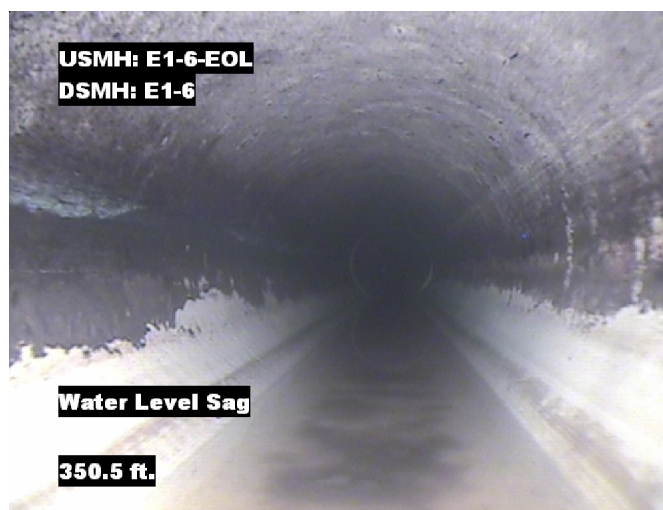
Distance: 350.5 ft. Grade: 2
Condition: Water Level Sag
Remarks: N/A

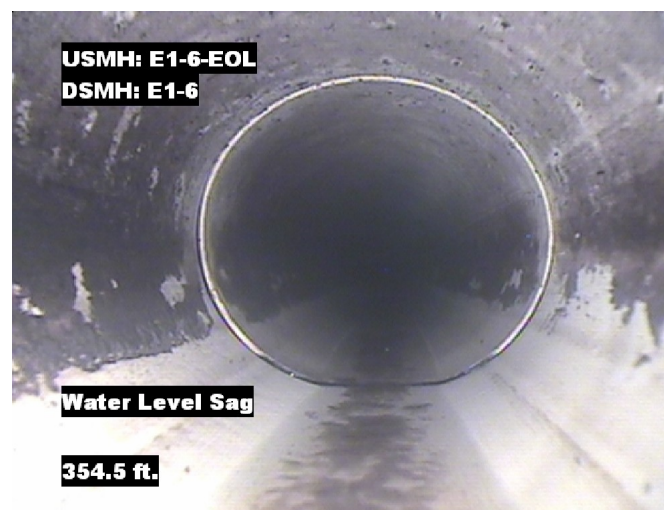
Distance: 354.5 ft. Grade: 2
Condition: Water Level Sag
Remarks: N/A

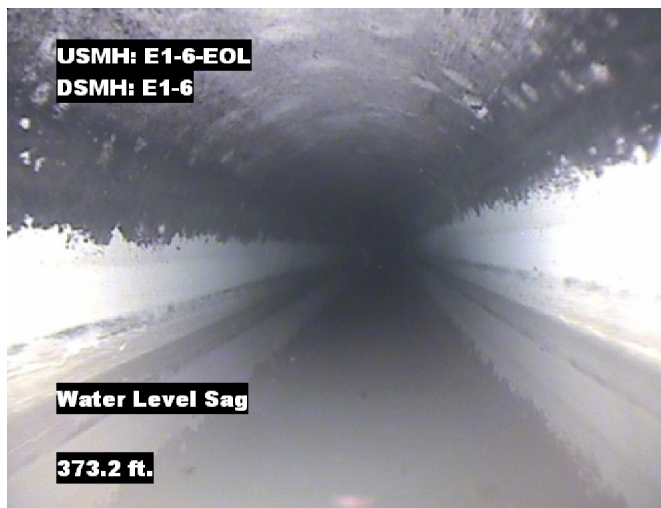
Distance: 373.2 ft. Grade: 2
Condition: Water Level Sag
Remarks: N/A

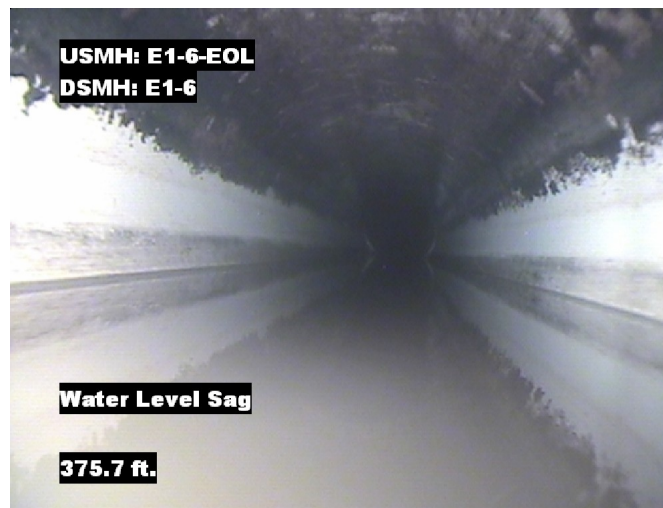
Distance: 375.7 ft. Grade: 3
Condition: Water Level Sag
Remarks: N/A

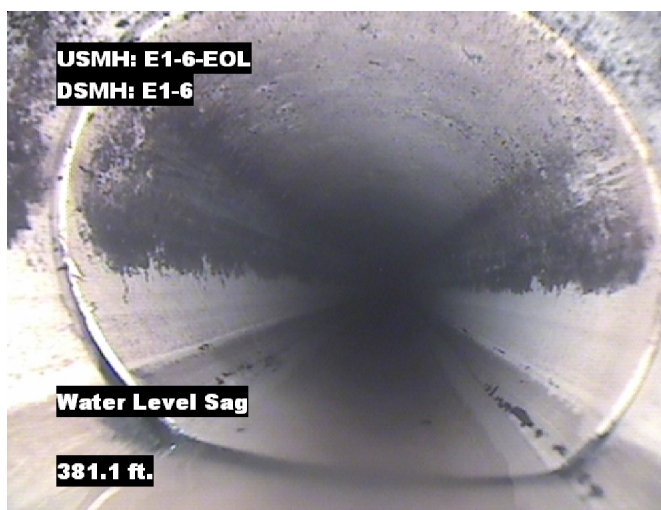
Distance: 381.1 ft. Grade: 2
Condition: Water Level Sag
Remarks: N/A

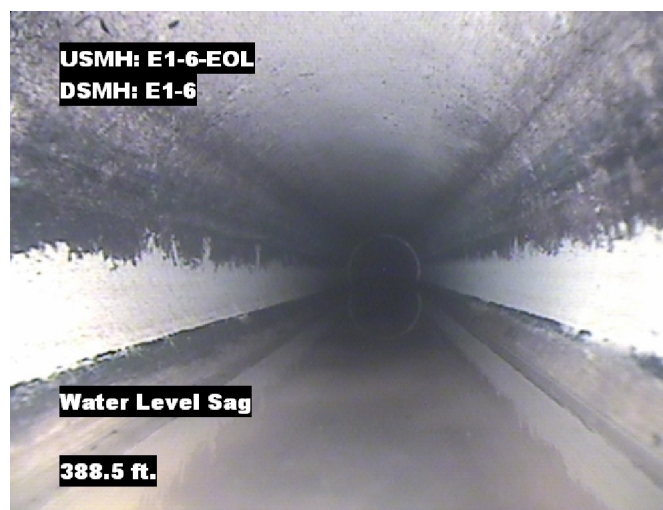
Distance: 388.5 ft. Grade: 2
Condition: Water Level Sag
Remarks: N/A

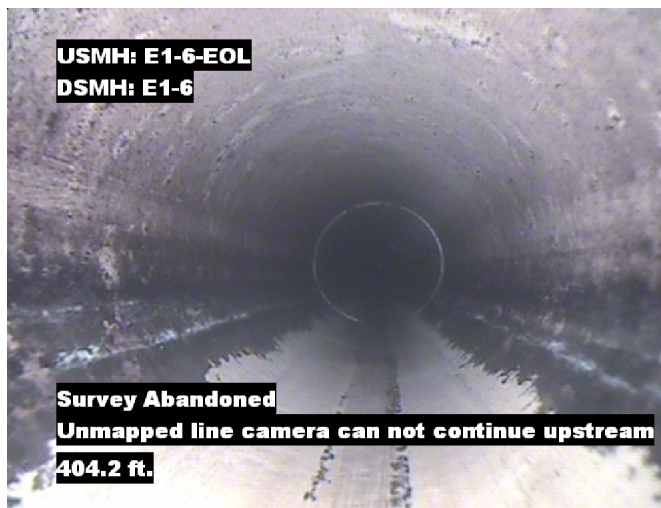
Distance: 404.2 ft. Grade: 0
Condition: Survey Abandoned
Remarks: Unmapped line camera can not continue upstream
